**STATE OF VERMONT  
AGENCY OF TRANSPORTATION**

| Town Of | HARTLAND | Bridge No. | 38 |
| PIER NO. 4 | | | |
| REPAIR AREAS | | | |

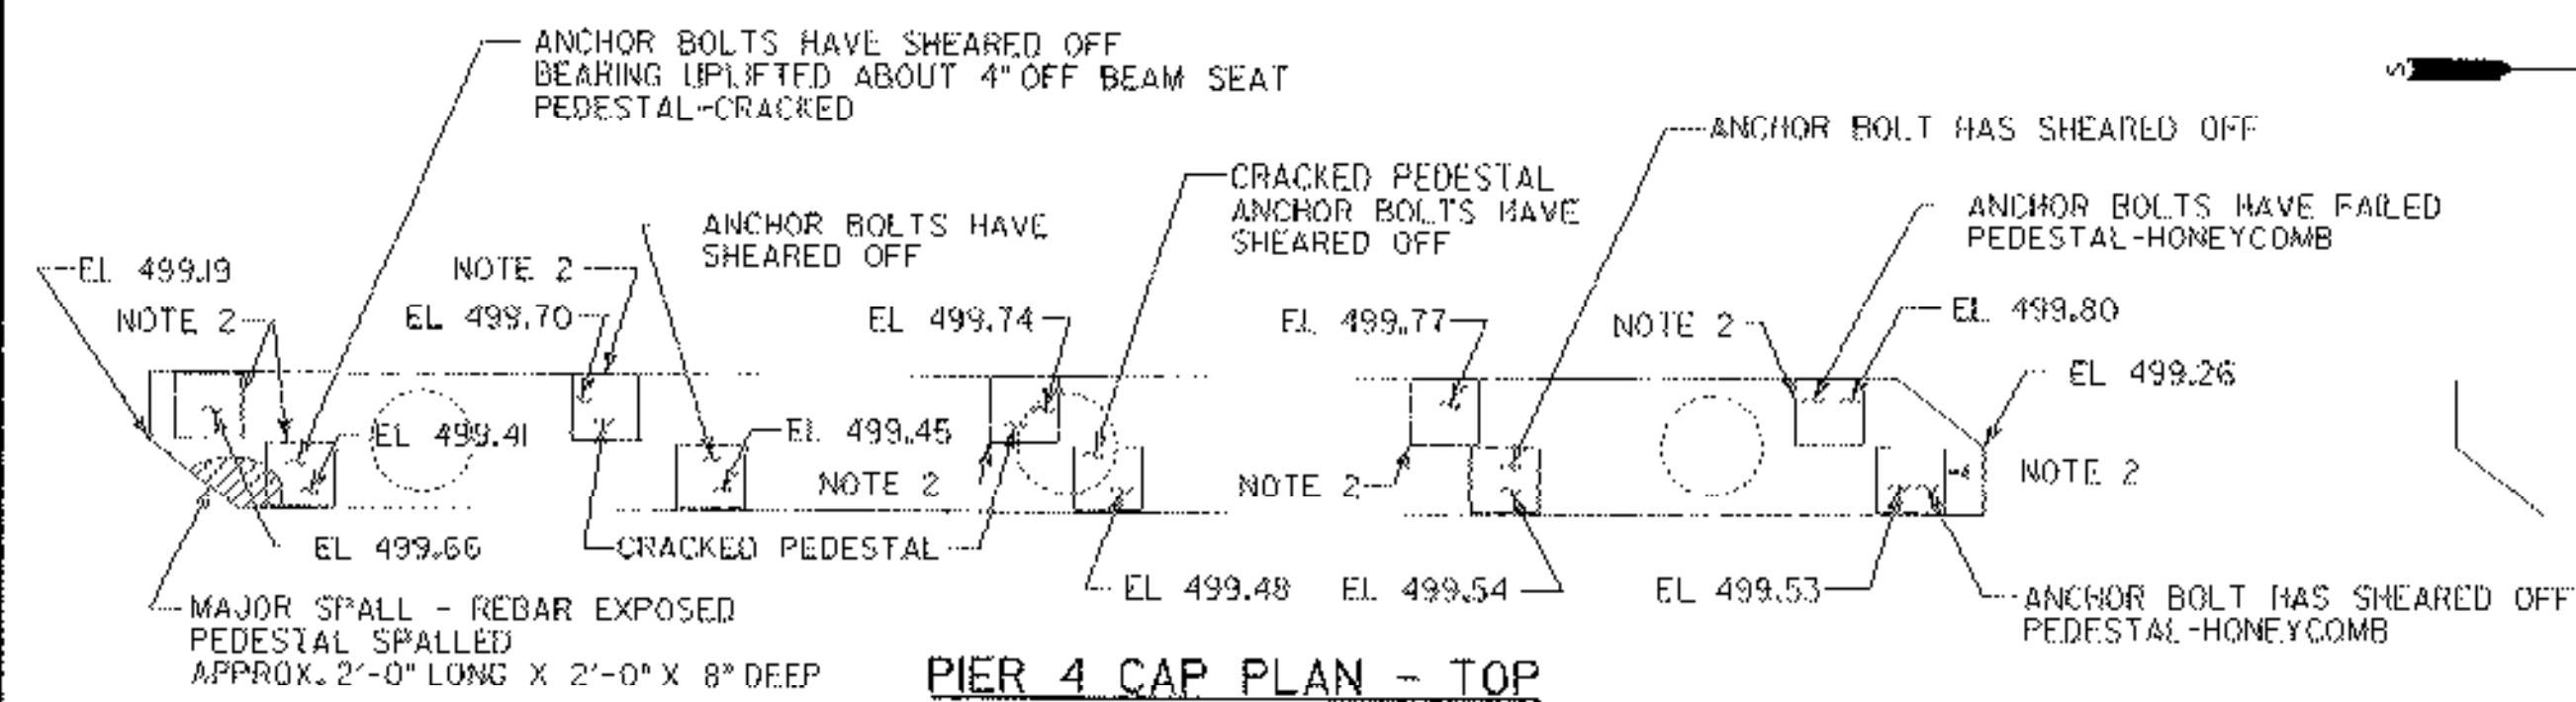
PIER 4 CAP PLAN - BOTTOM (LOOKING UP)

BEARING MASONRY PLATES ARE RECESSED IN ALL PEDESTALS
