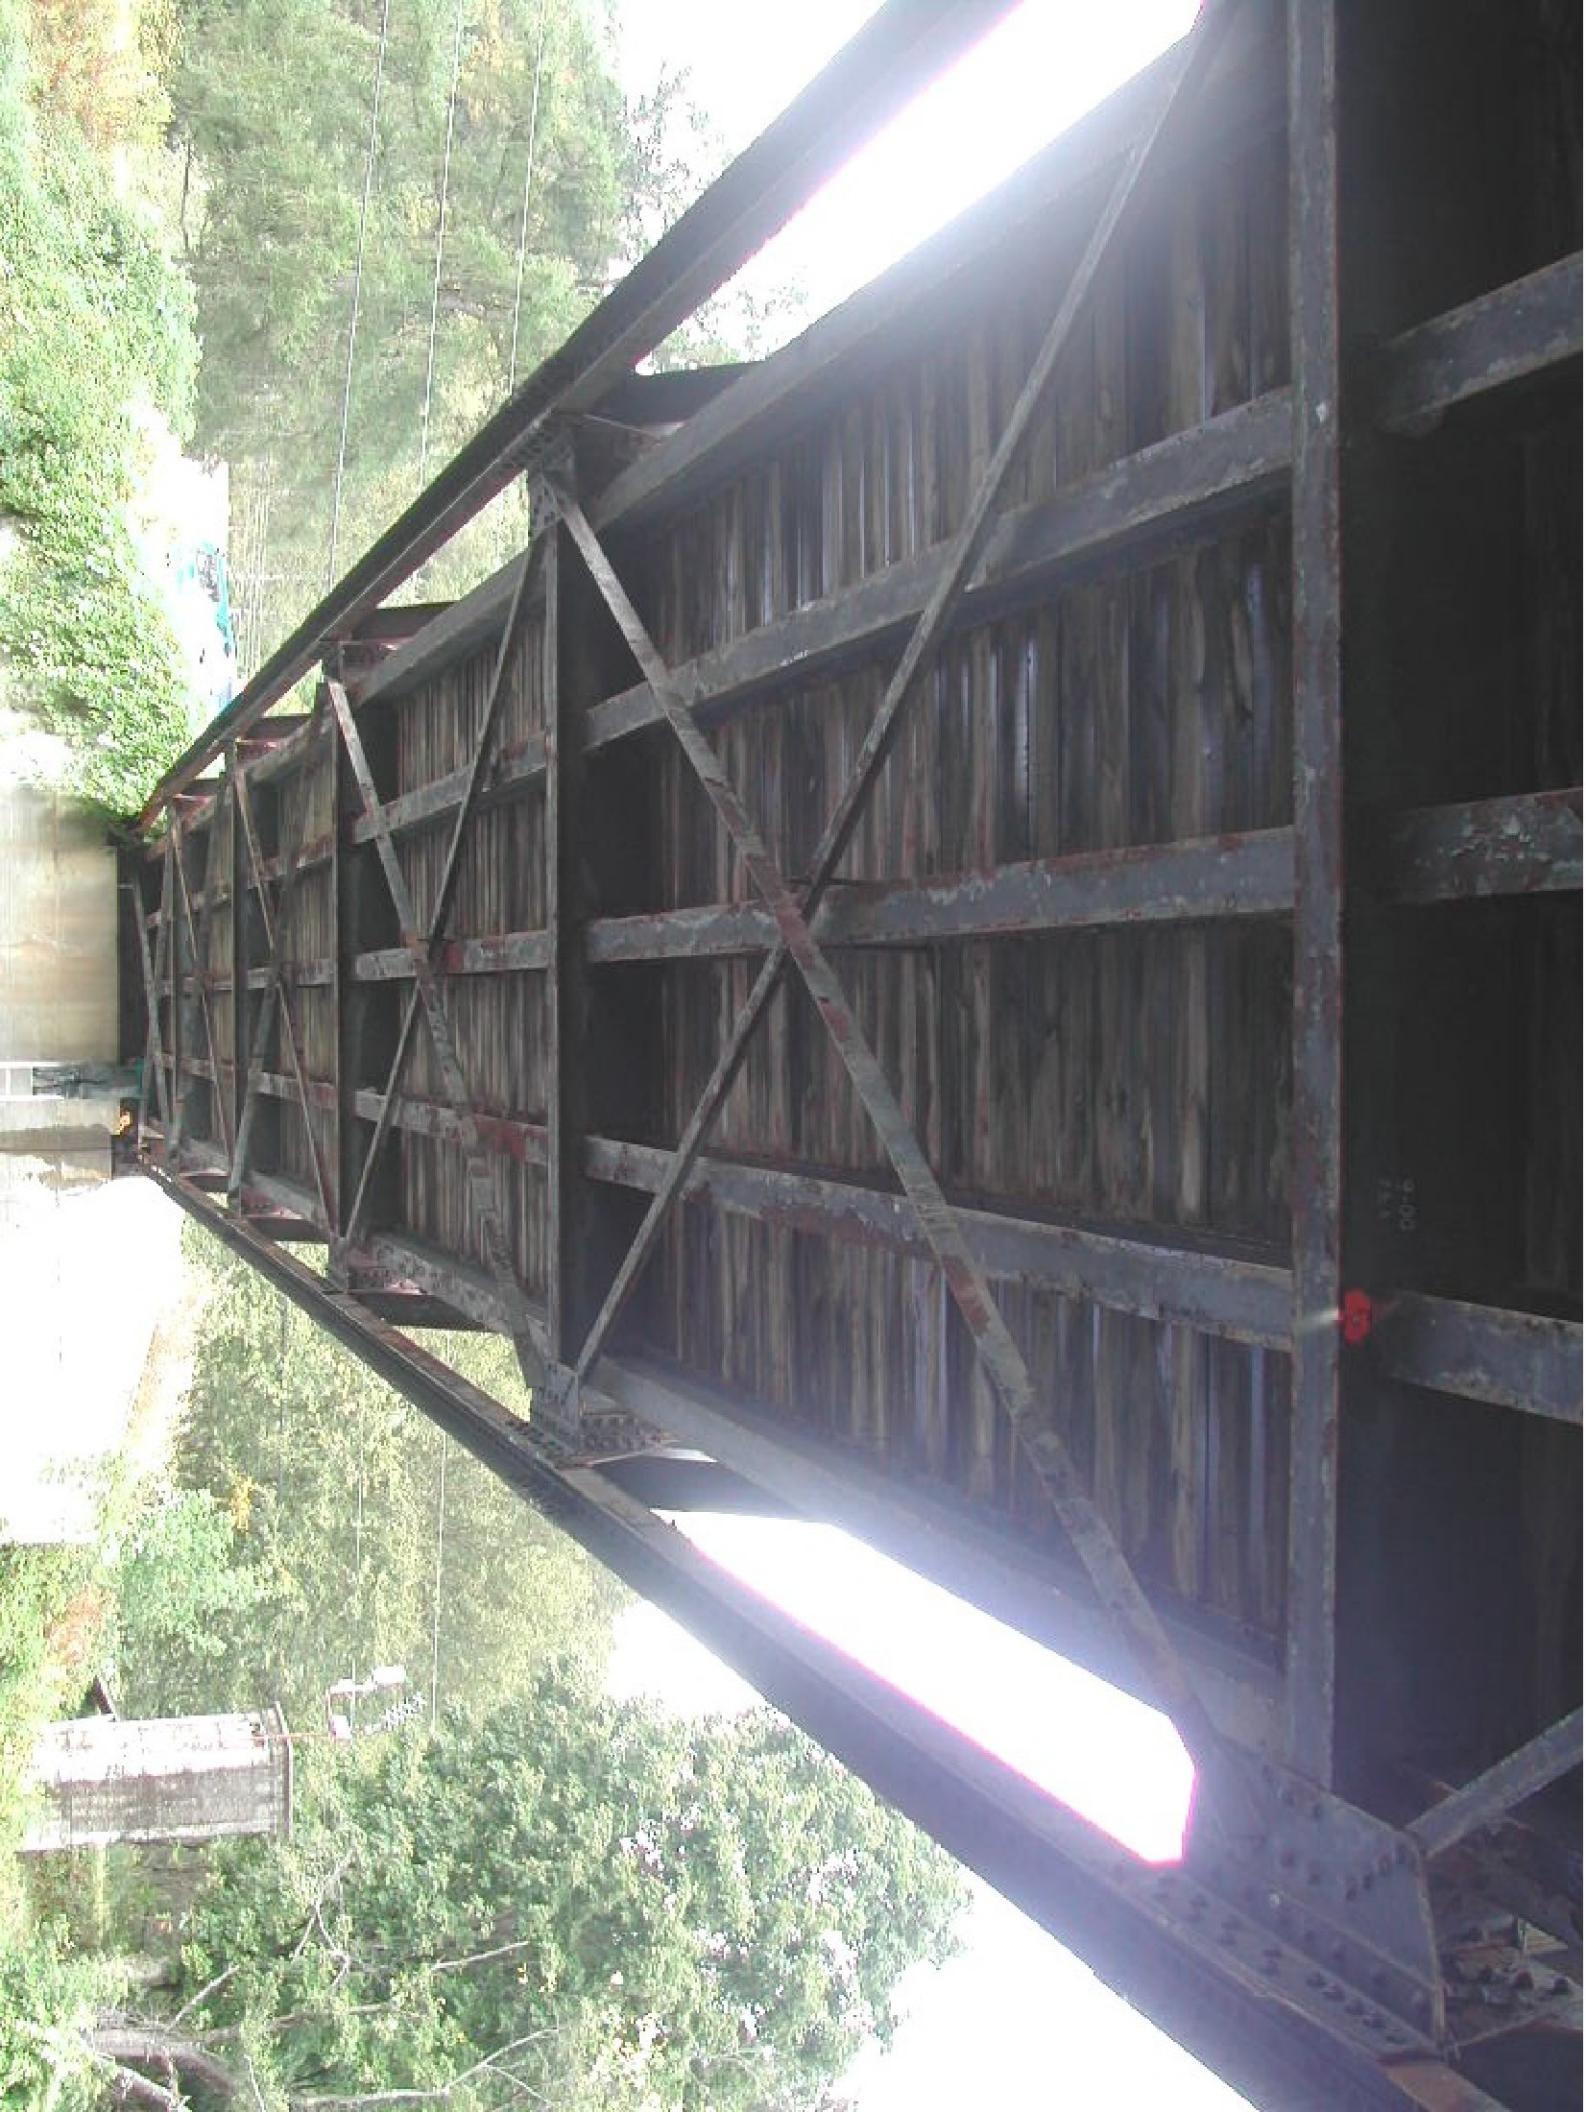
EXTENSIVE DISTORTION ALONG LOWER CHORD  
DUE TO ICE DAMAGE

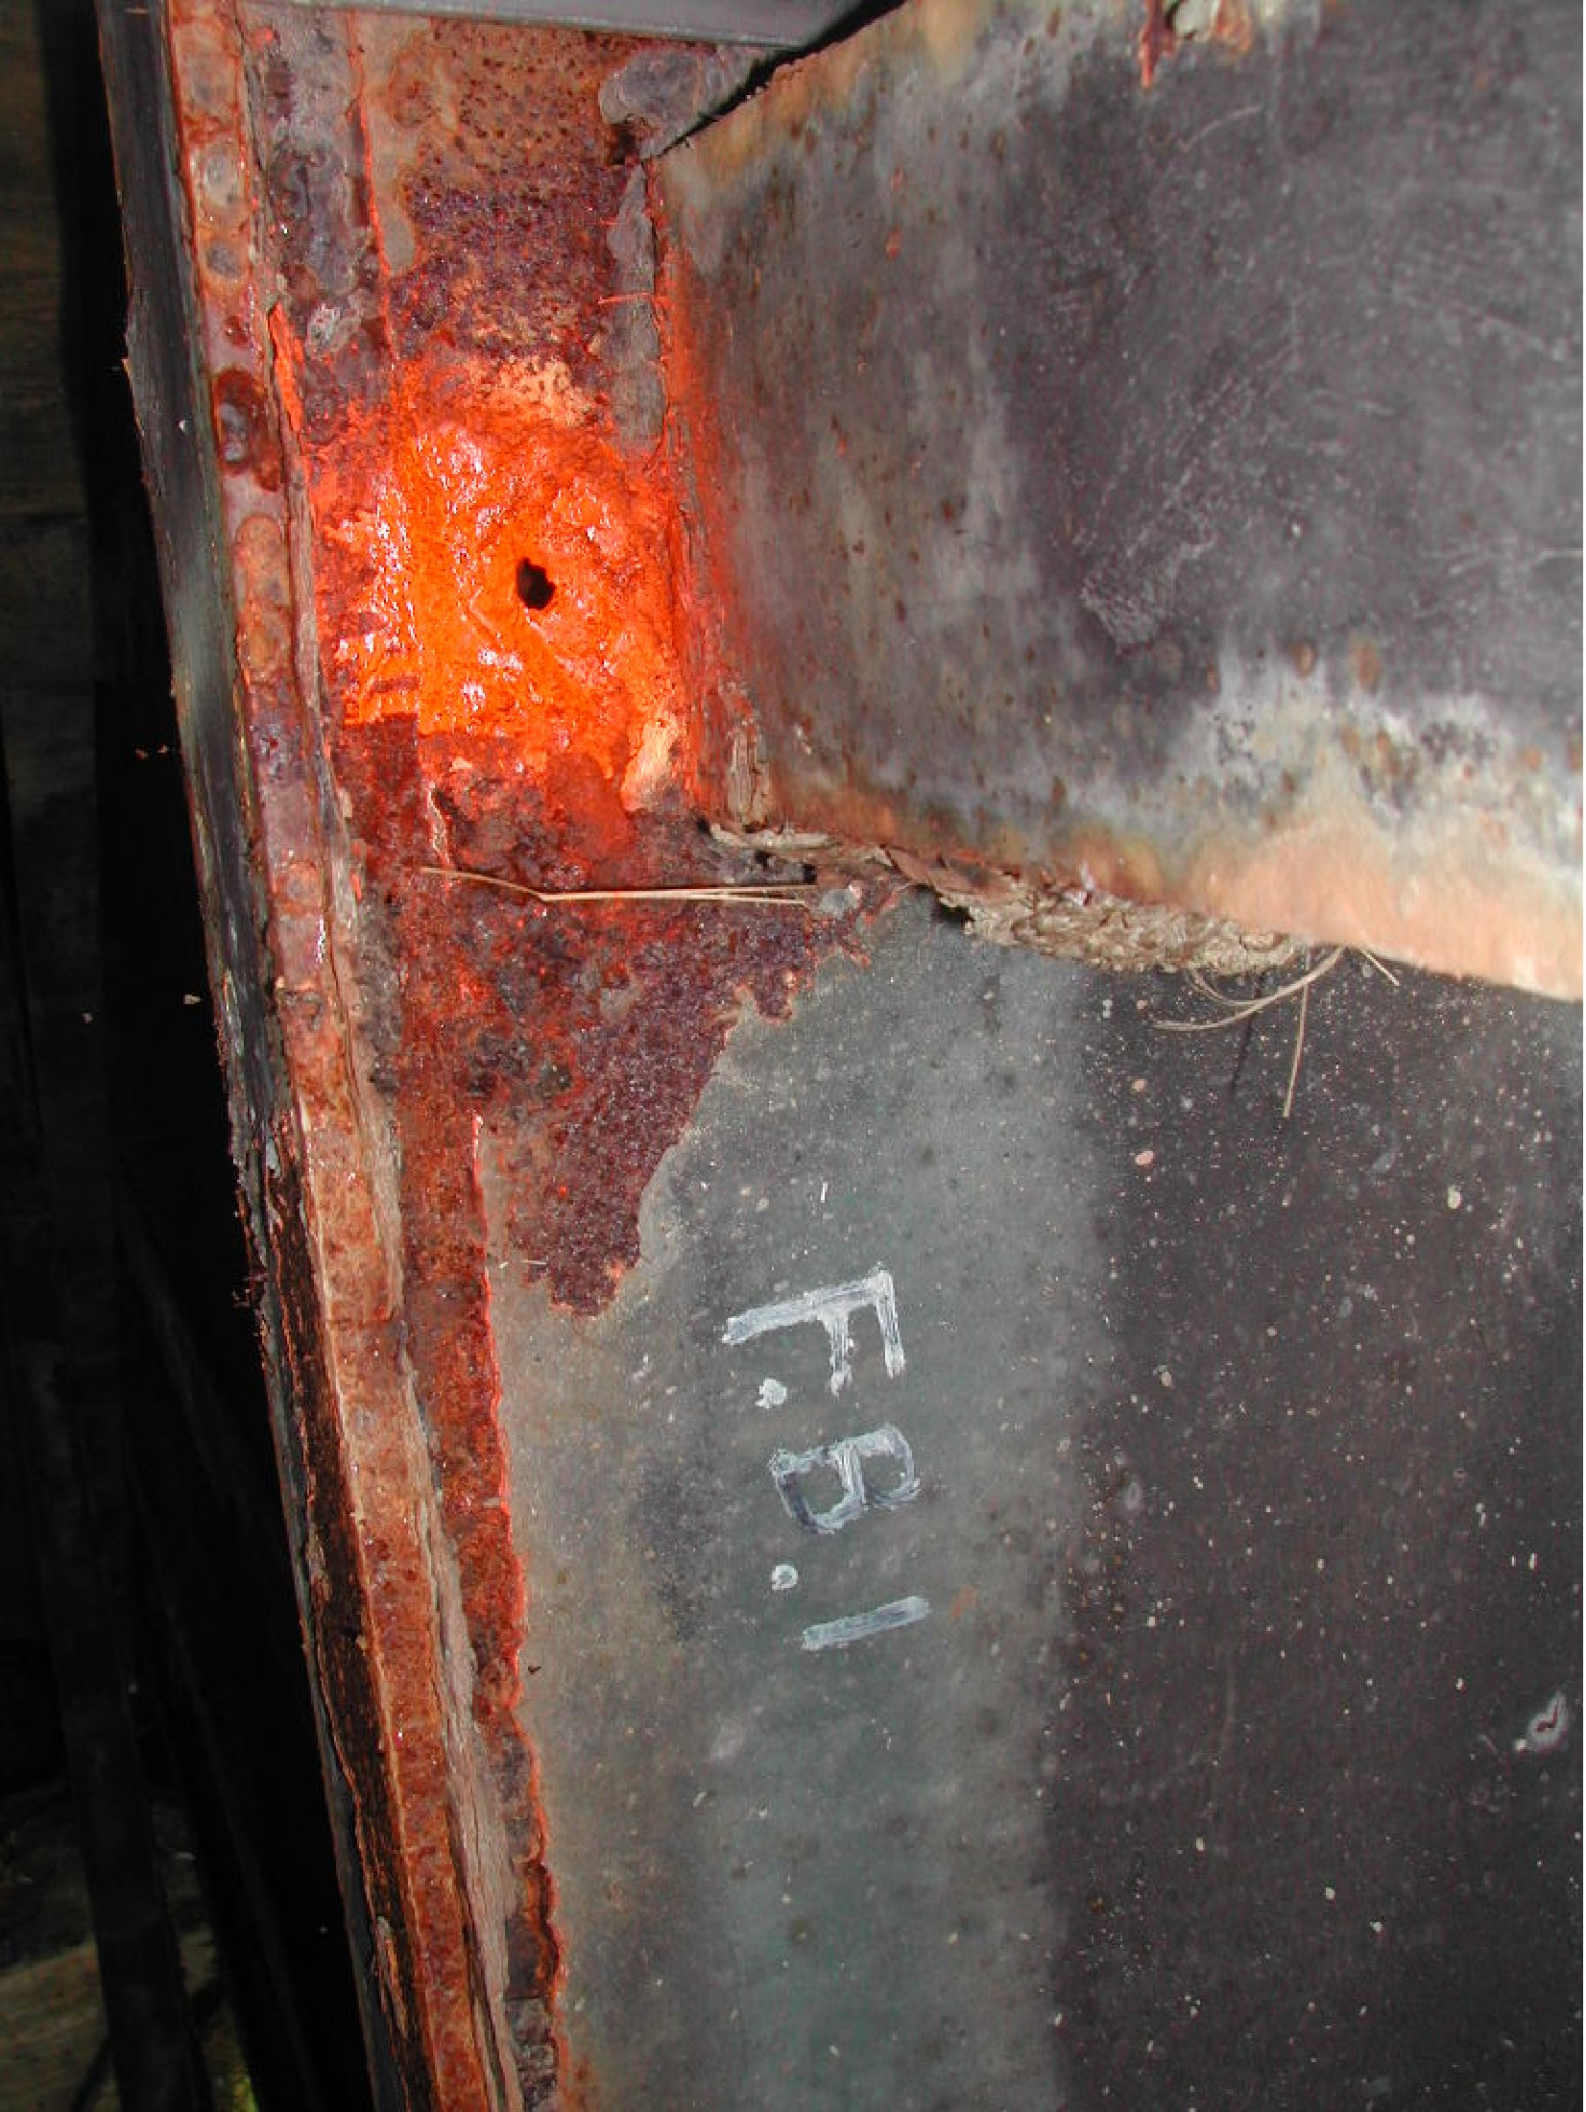
FBI

UPSTREAM FIXED PED. BEARING AT ABUT. 1 HAS  
ROTATED BACKWARDS PULLING UP FROM THE  
BRIDGE SEAT DUE TO PAST SUB. MOVEMENT
