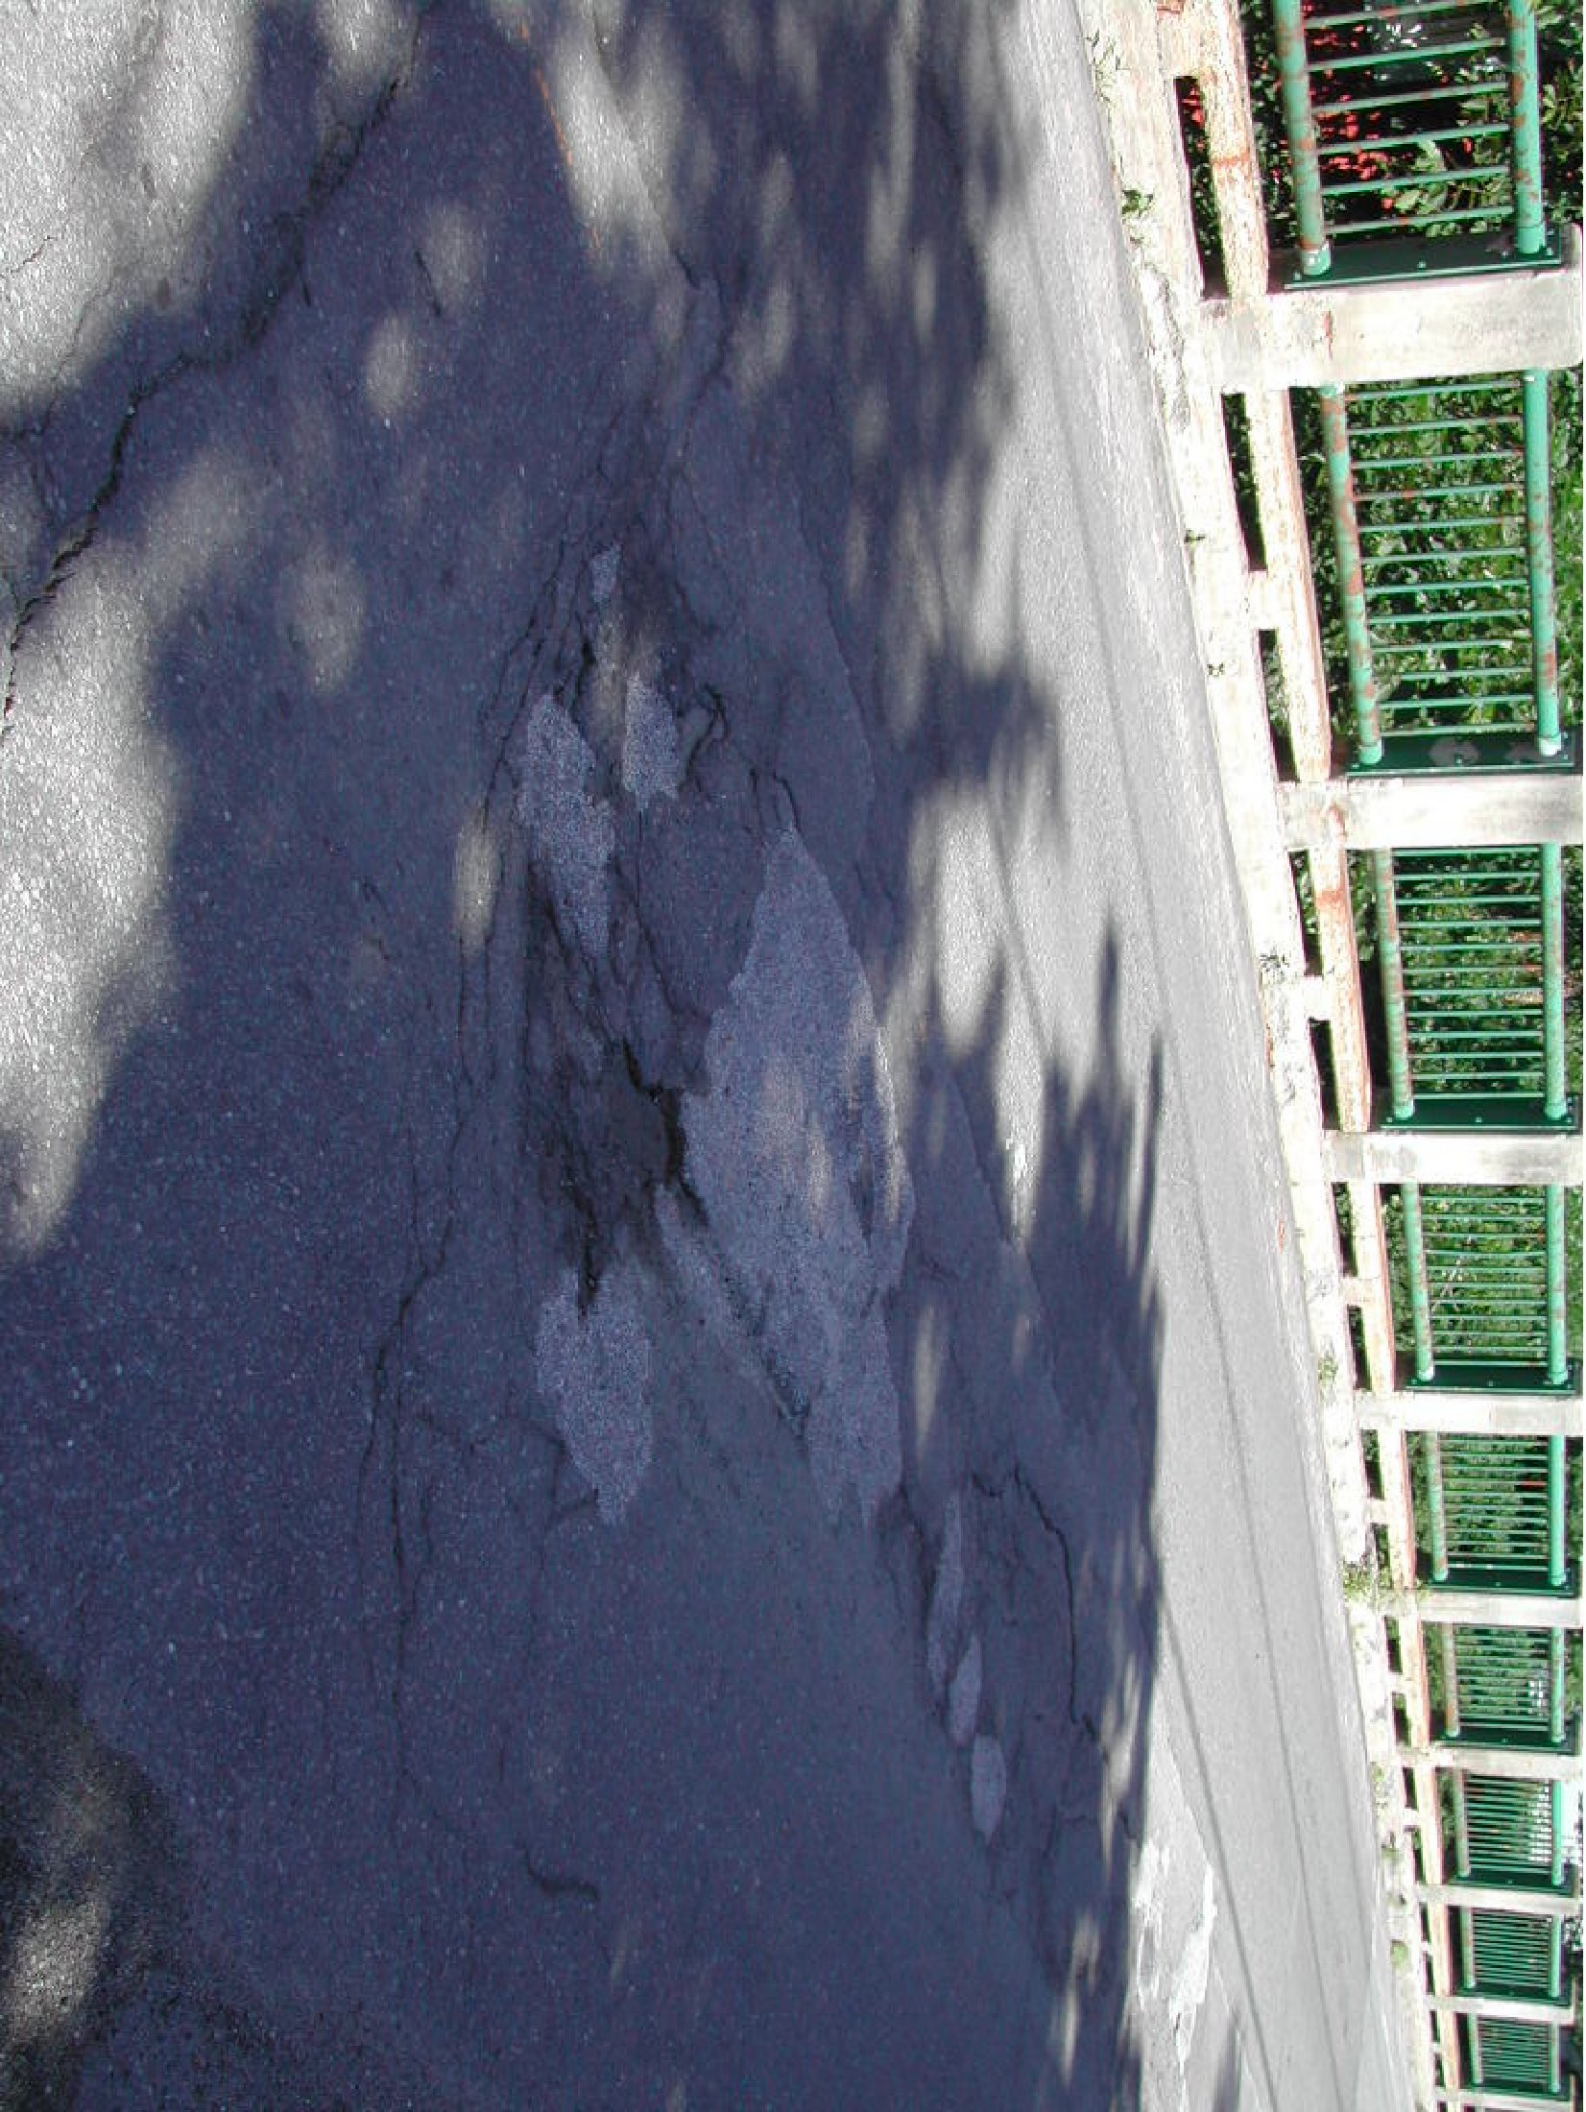
LACK OF APPR. RAIL ALONG WITH BLUNT TERMINUS  
IS A TRAFFIC SAFETY HAZARD

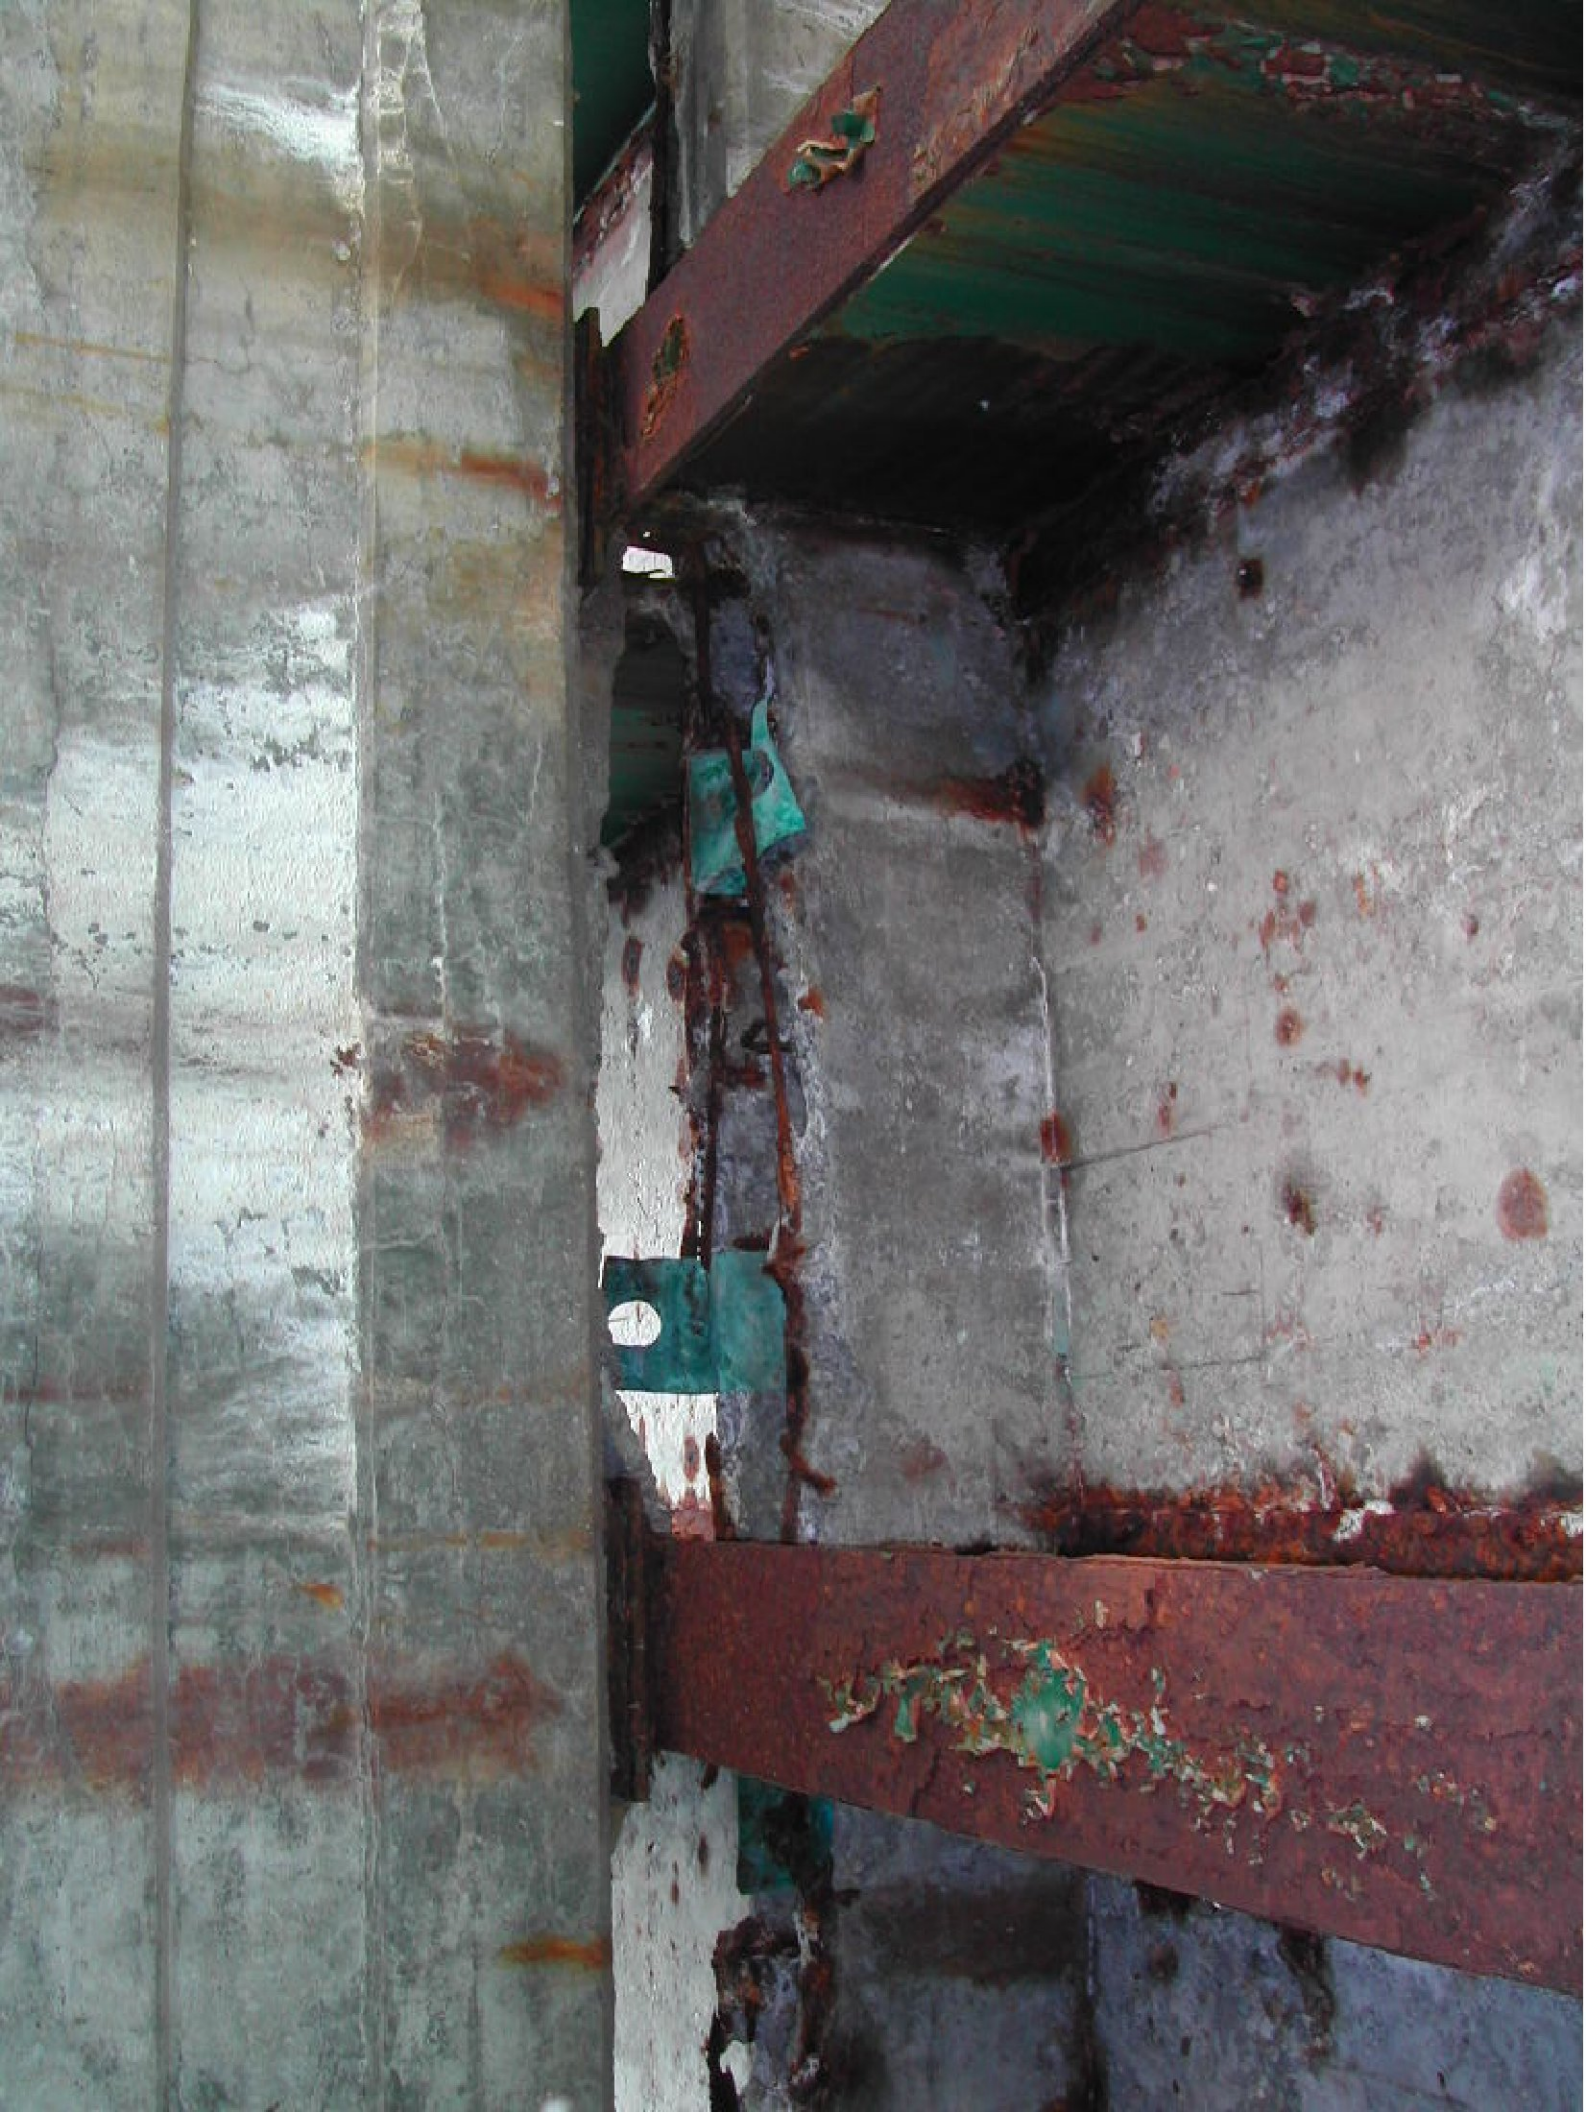
DECK HAS HIGH POTENTIAL FOR RANDOM FULL DEPTH  
FAILURES

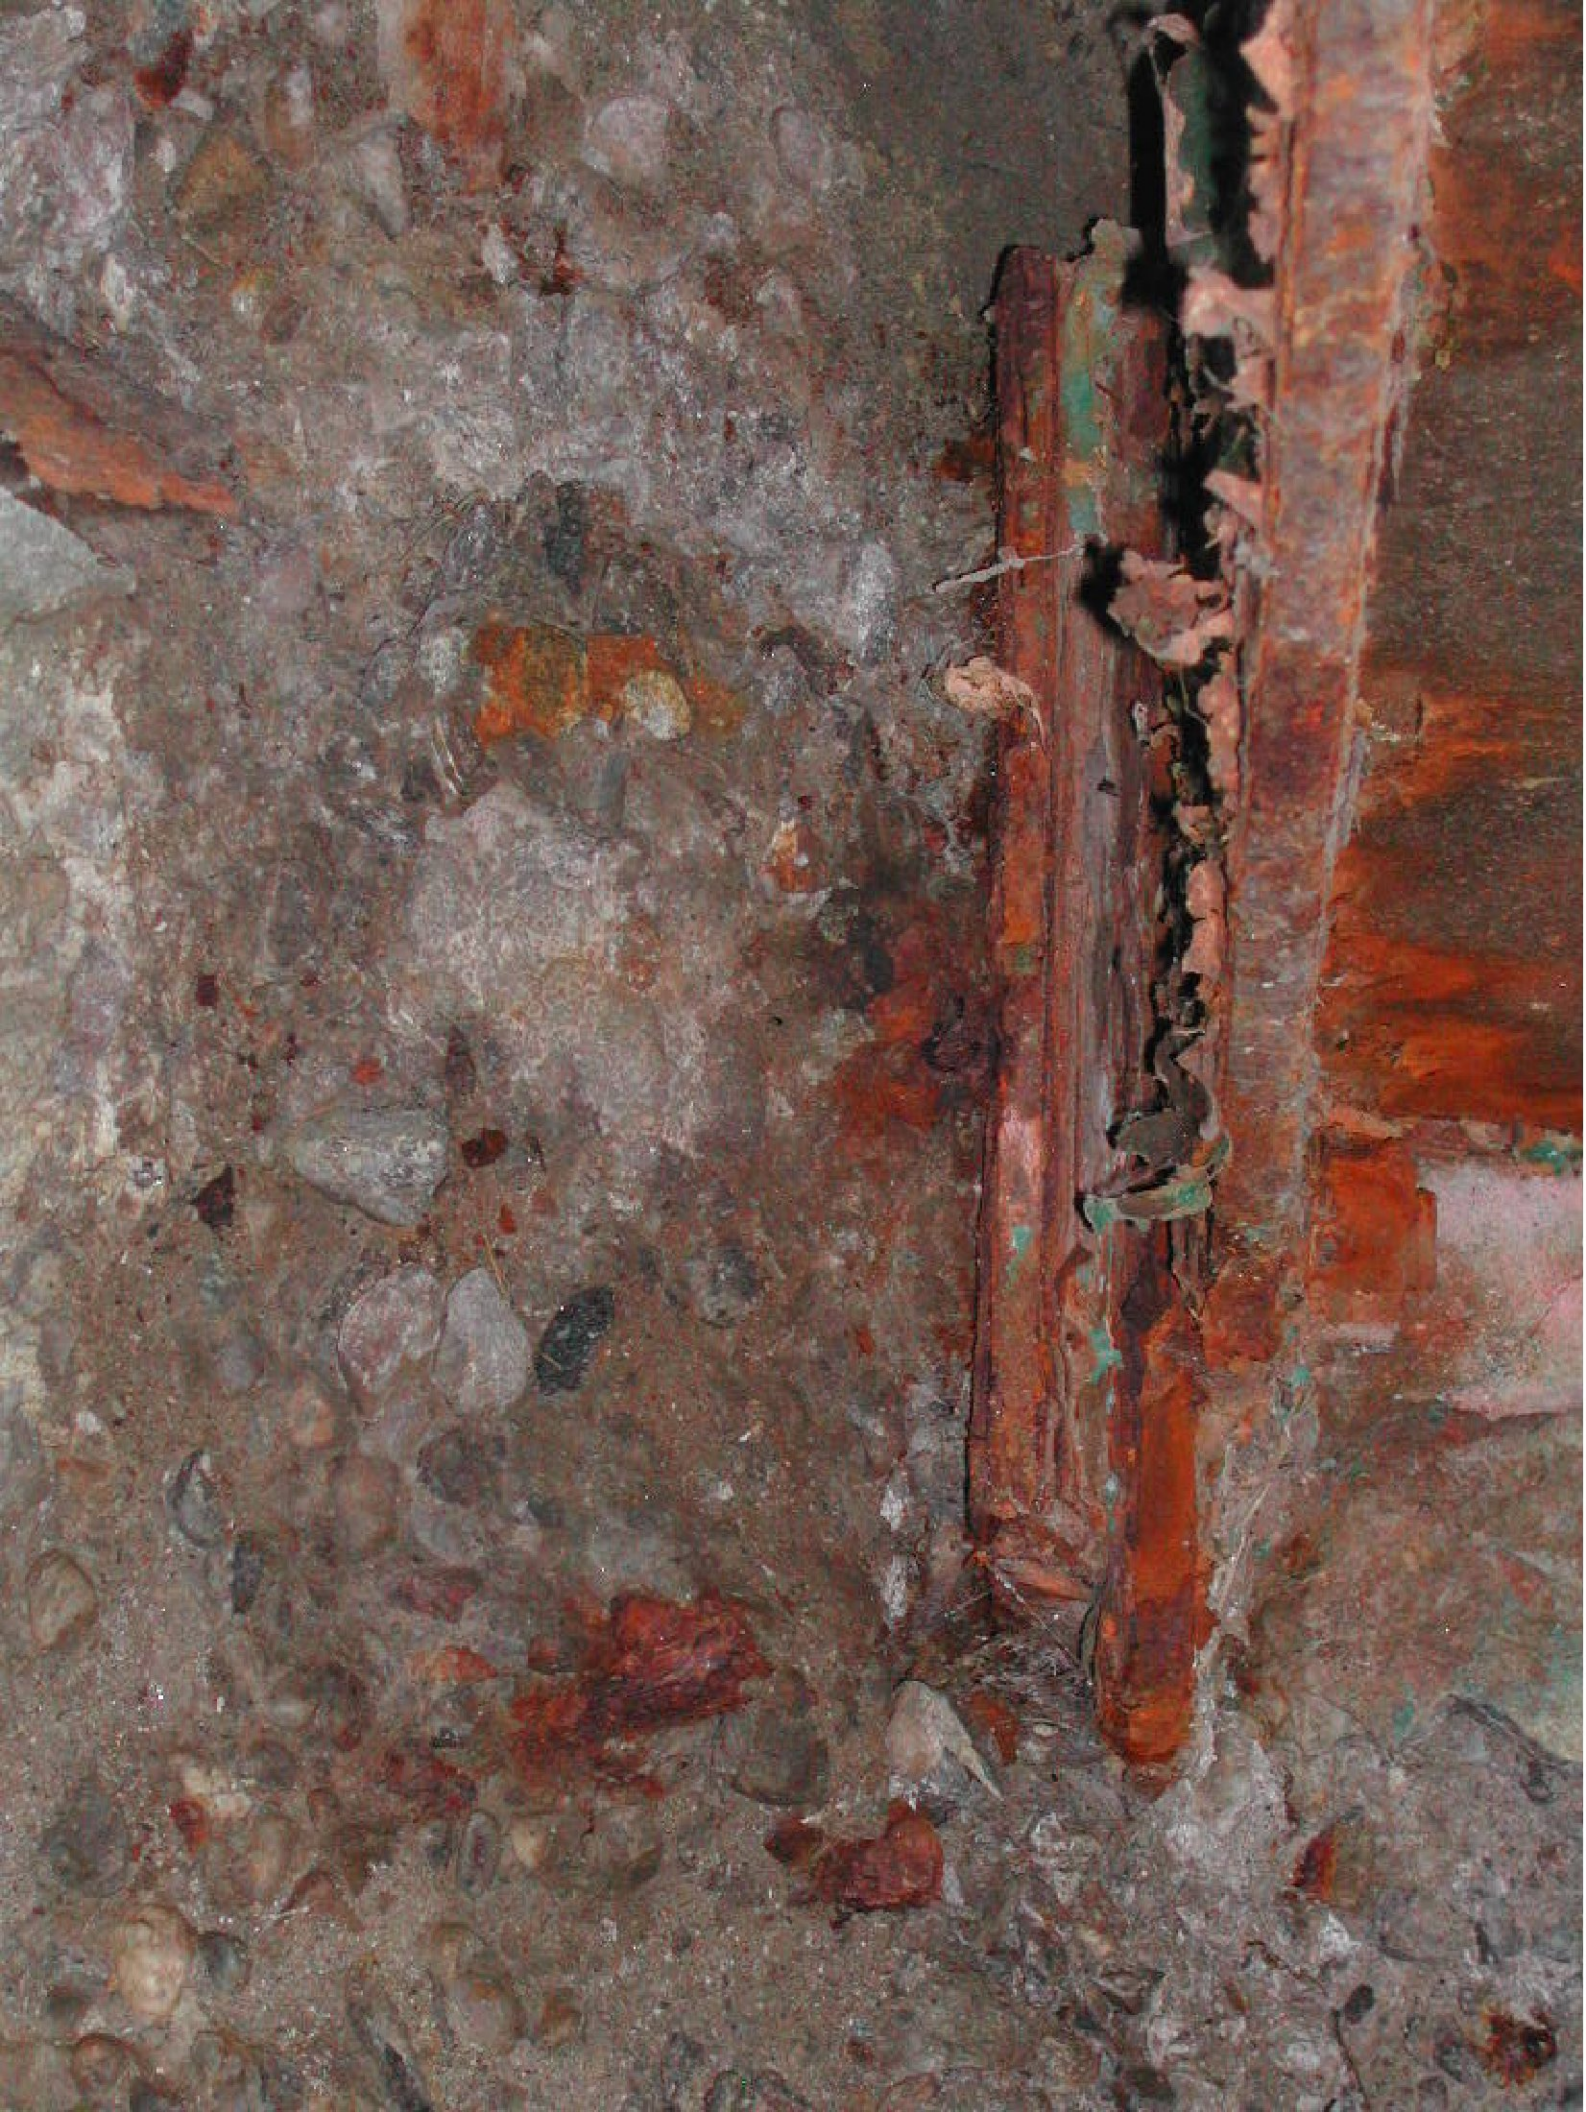
50% OF BEARING #6 IS UNDERMINED DUE TO SEVERE SPALLING ALONG ABUT. #2 BRIDGE SEAT
