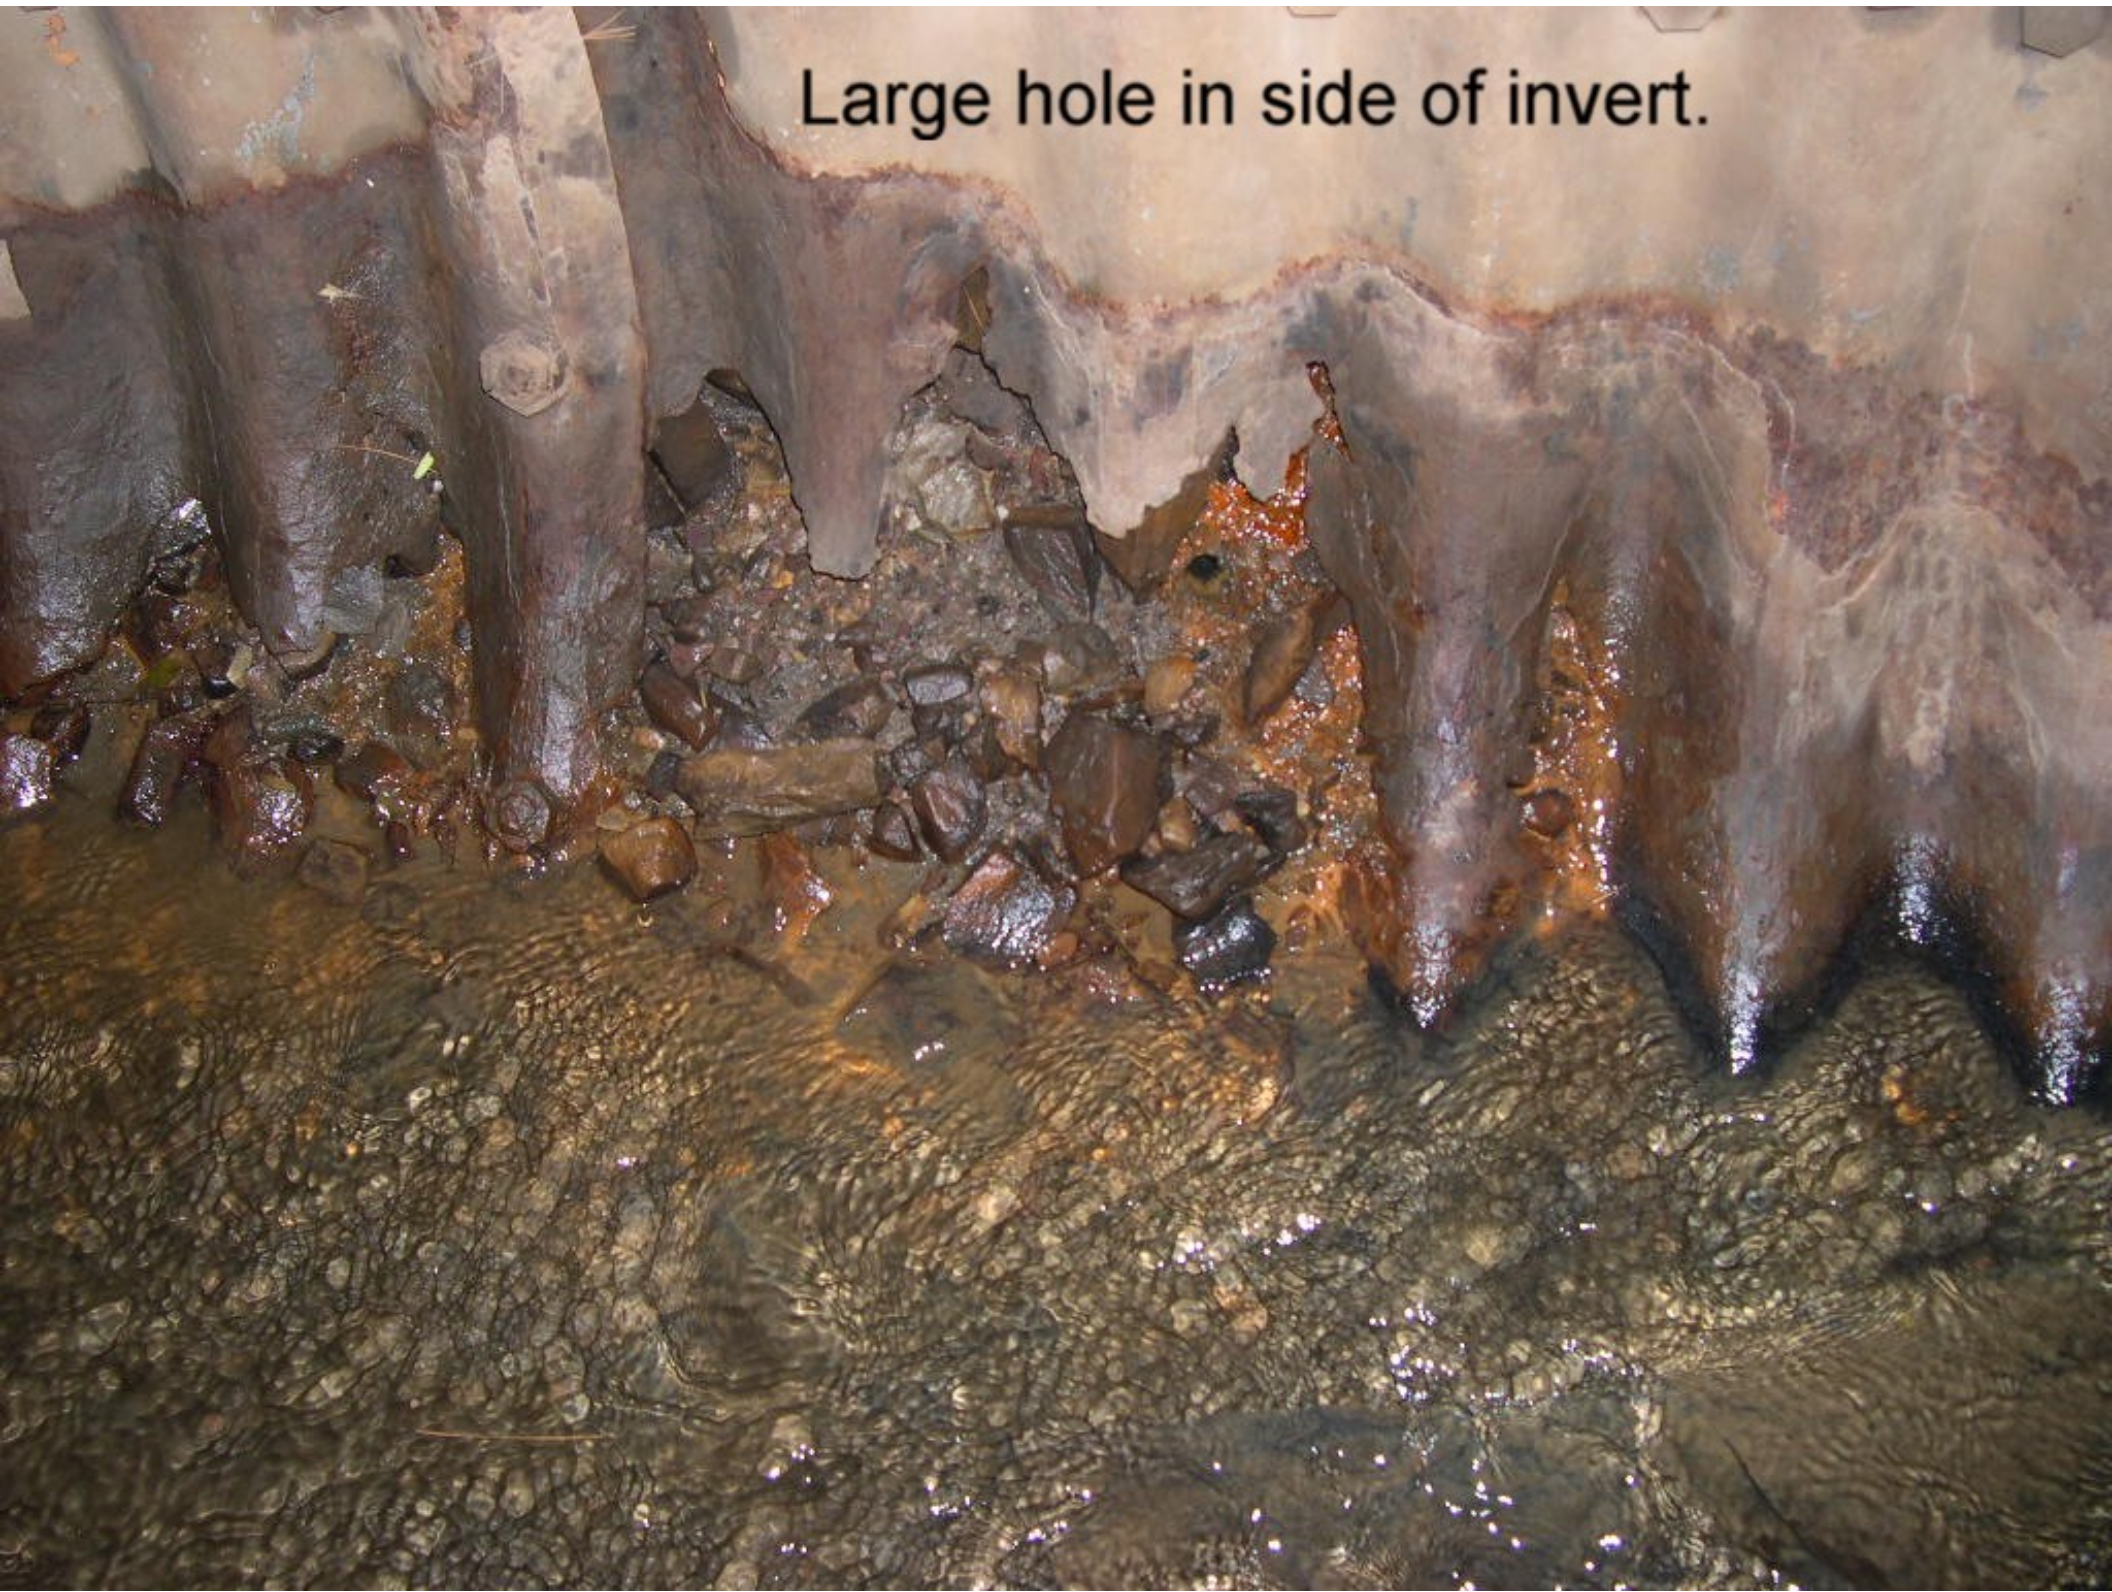
Cracks and small holes and possible crushing.
