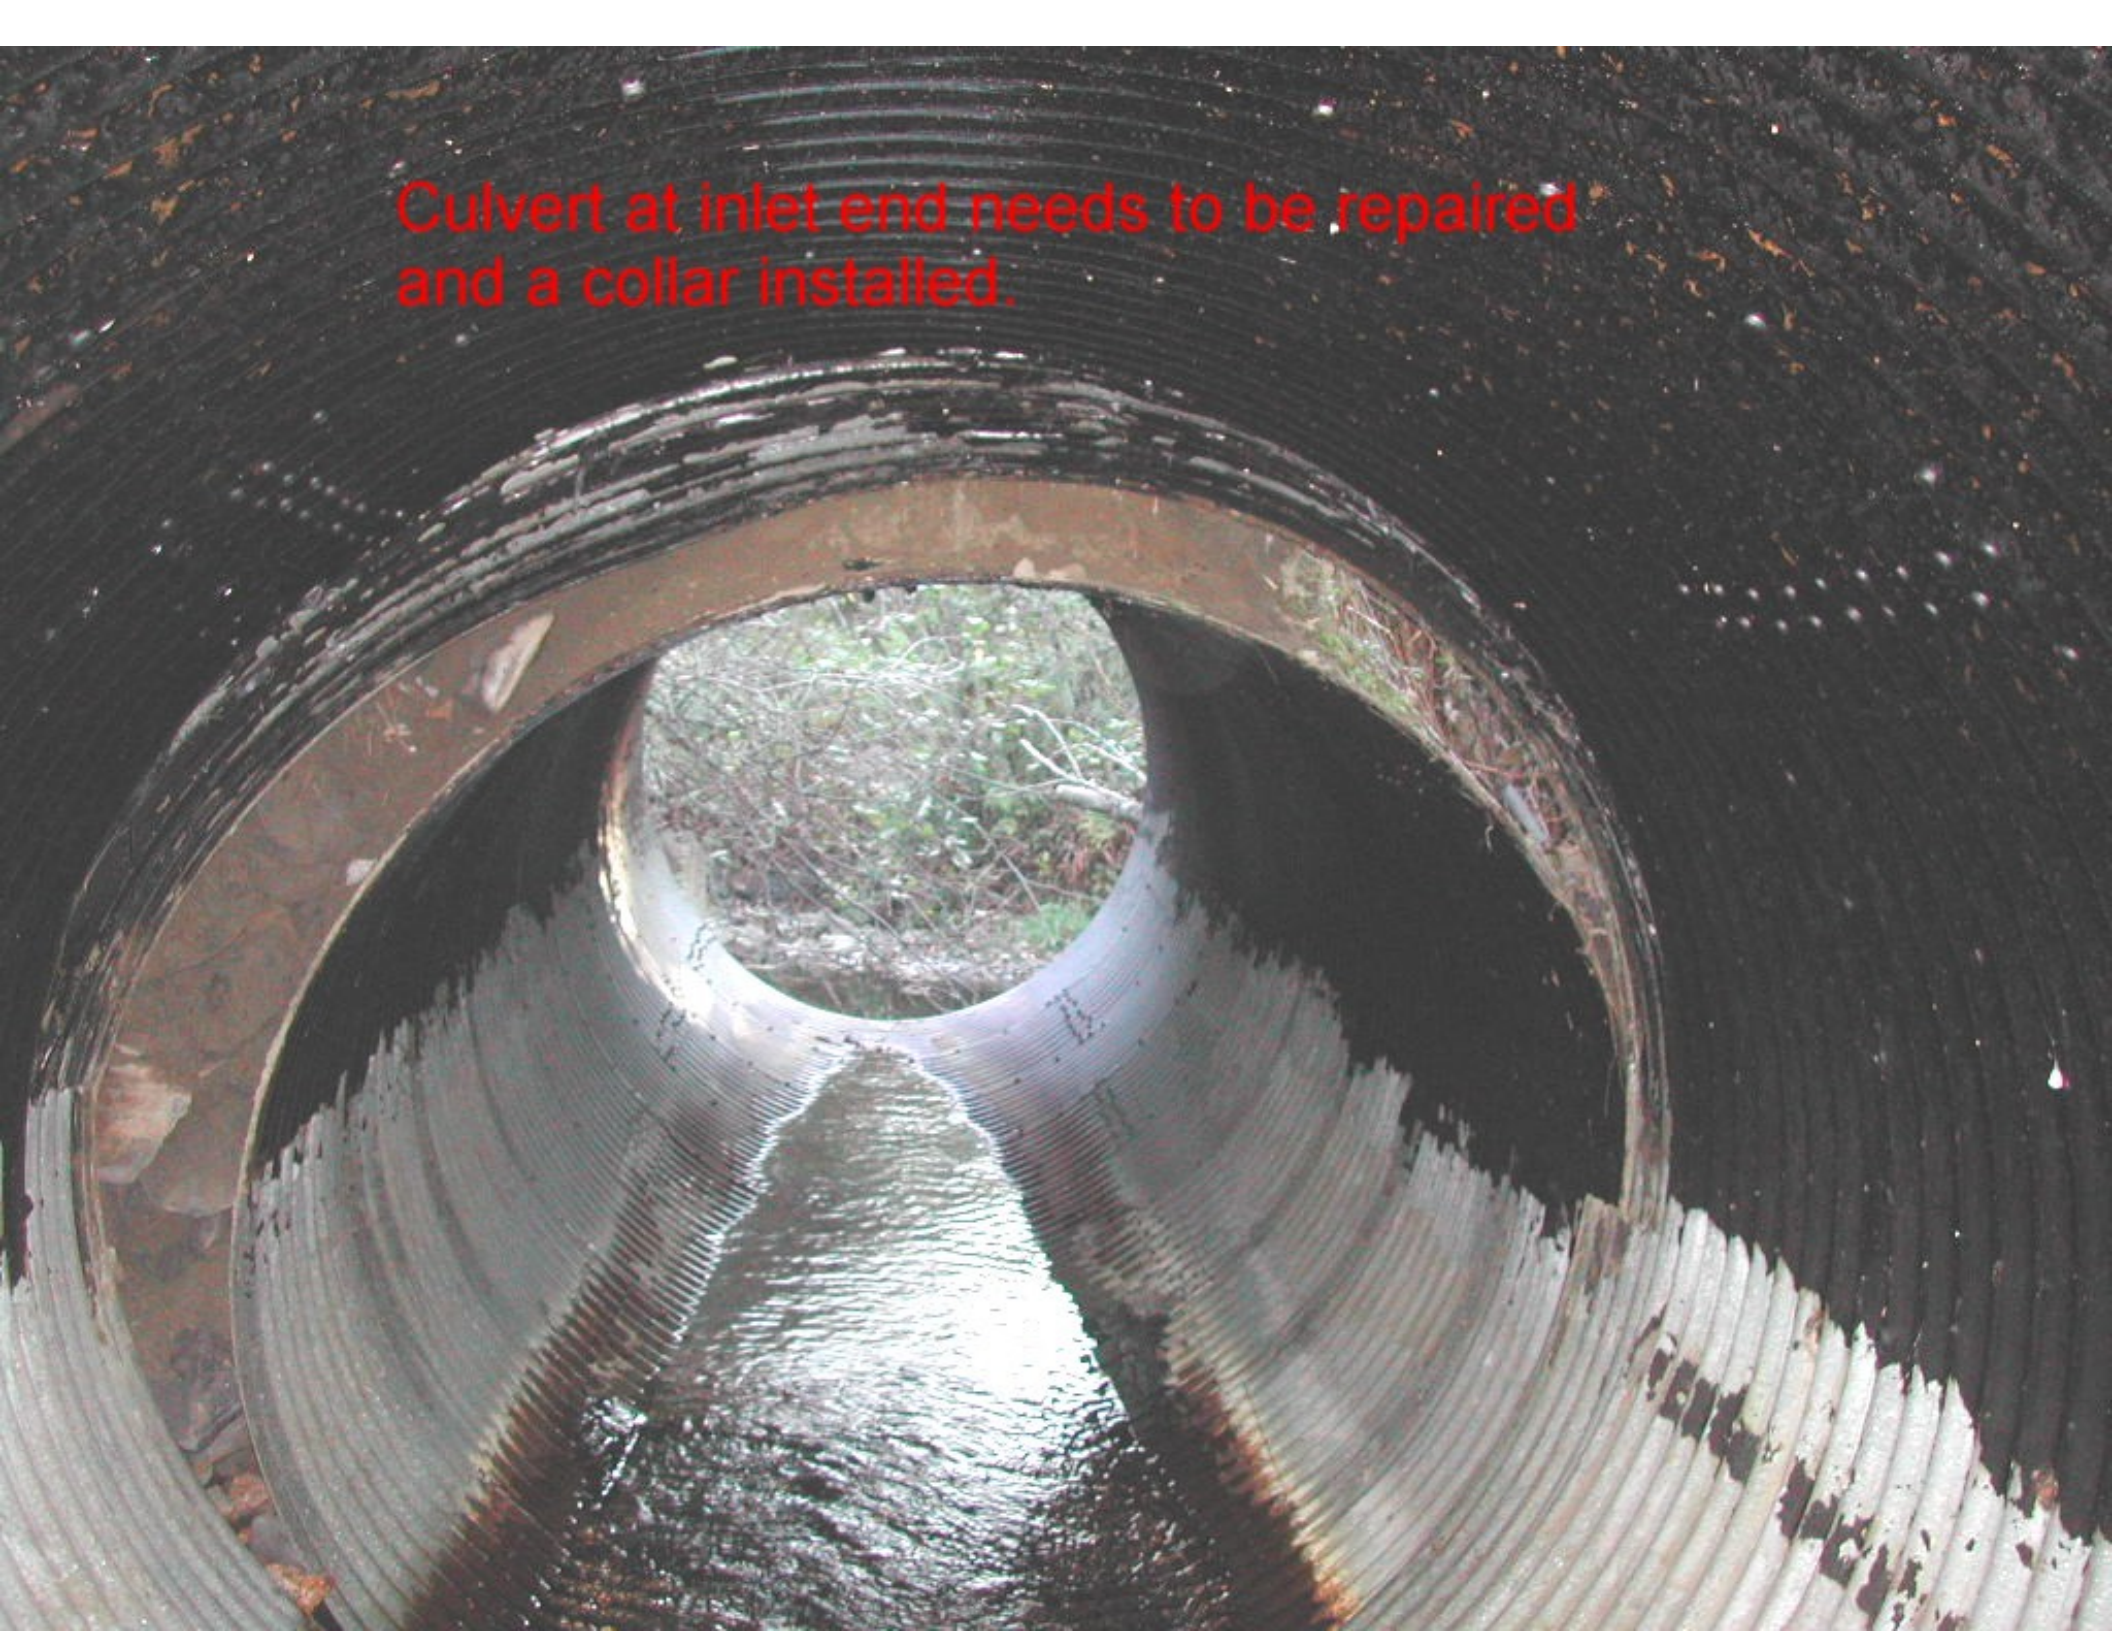
Culvert at inlet end needs to be repaired  
and a collar installed.
