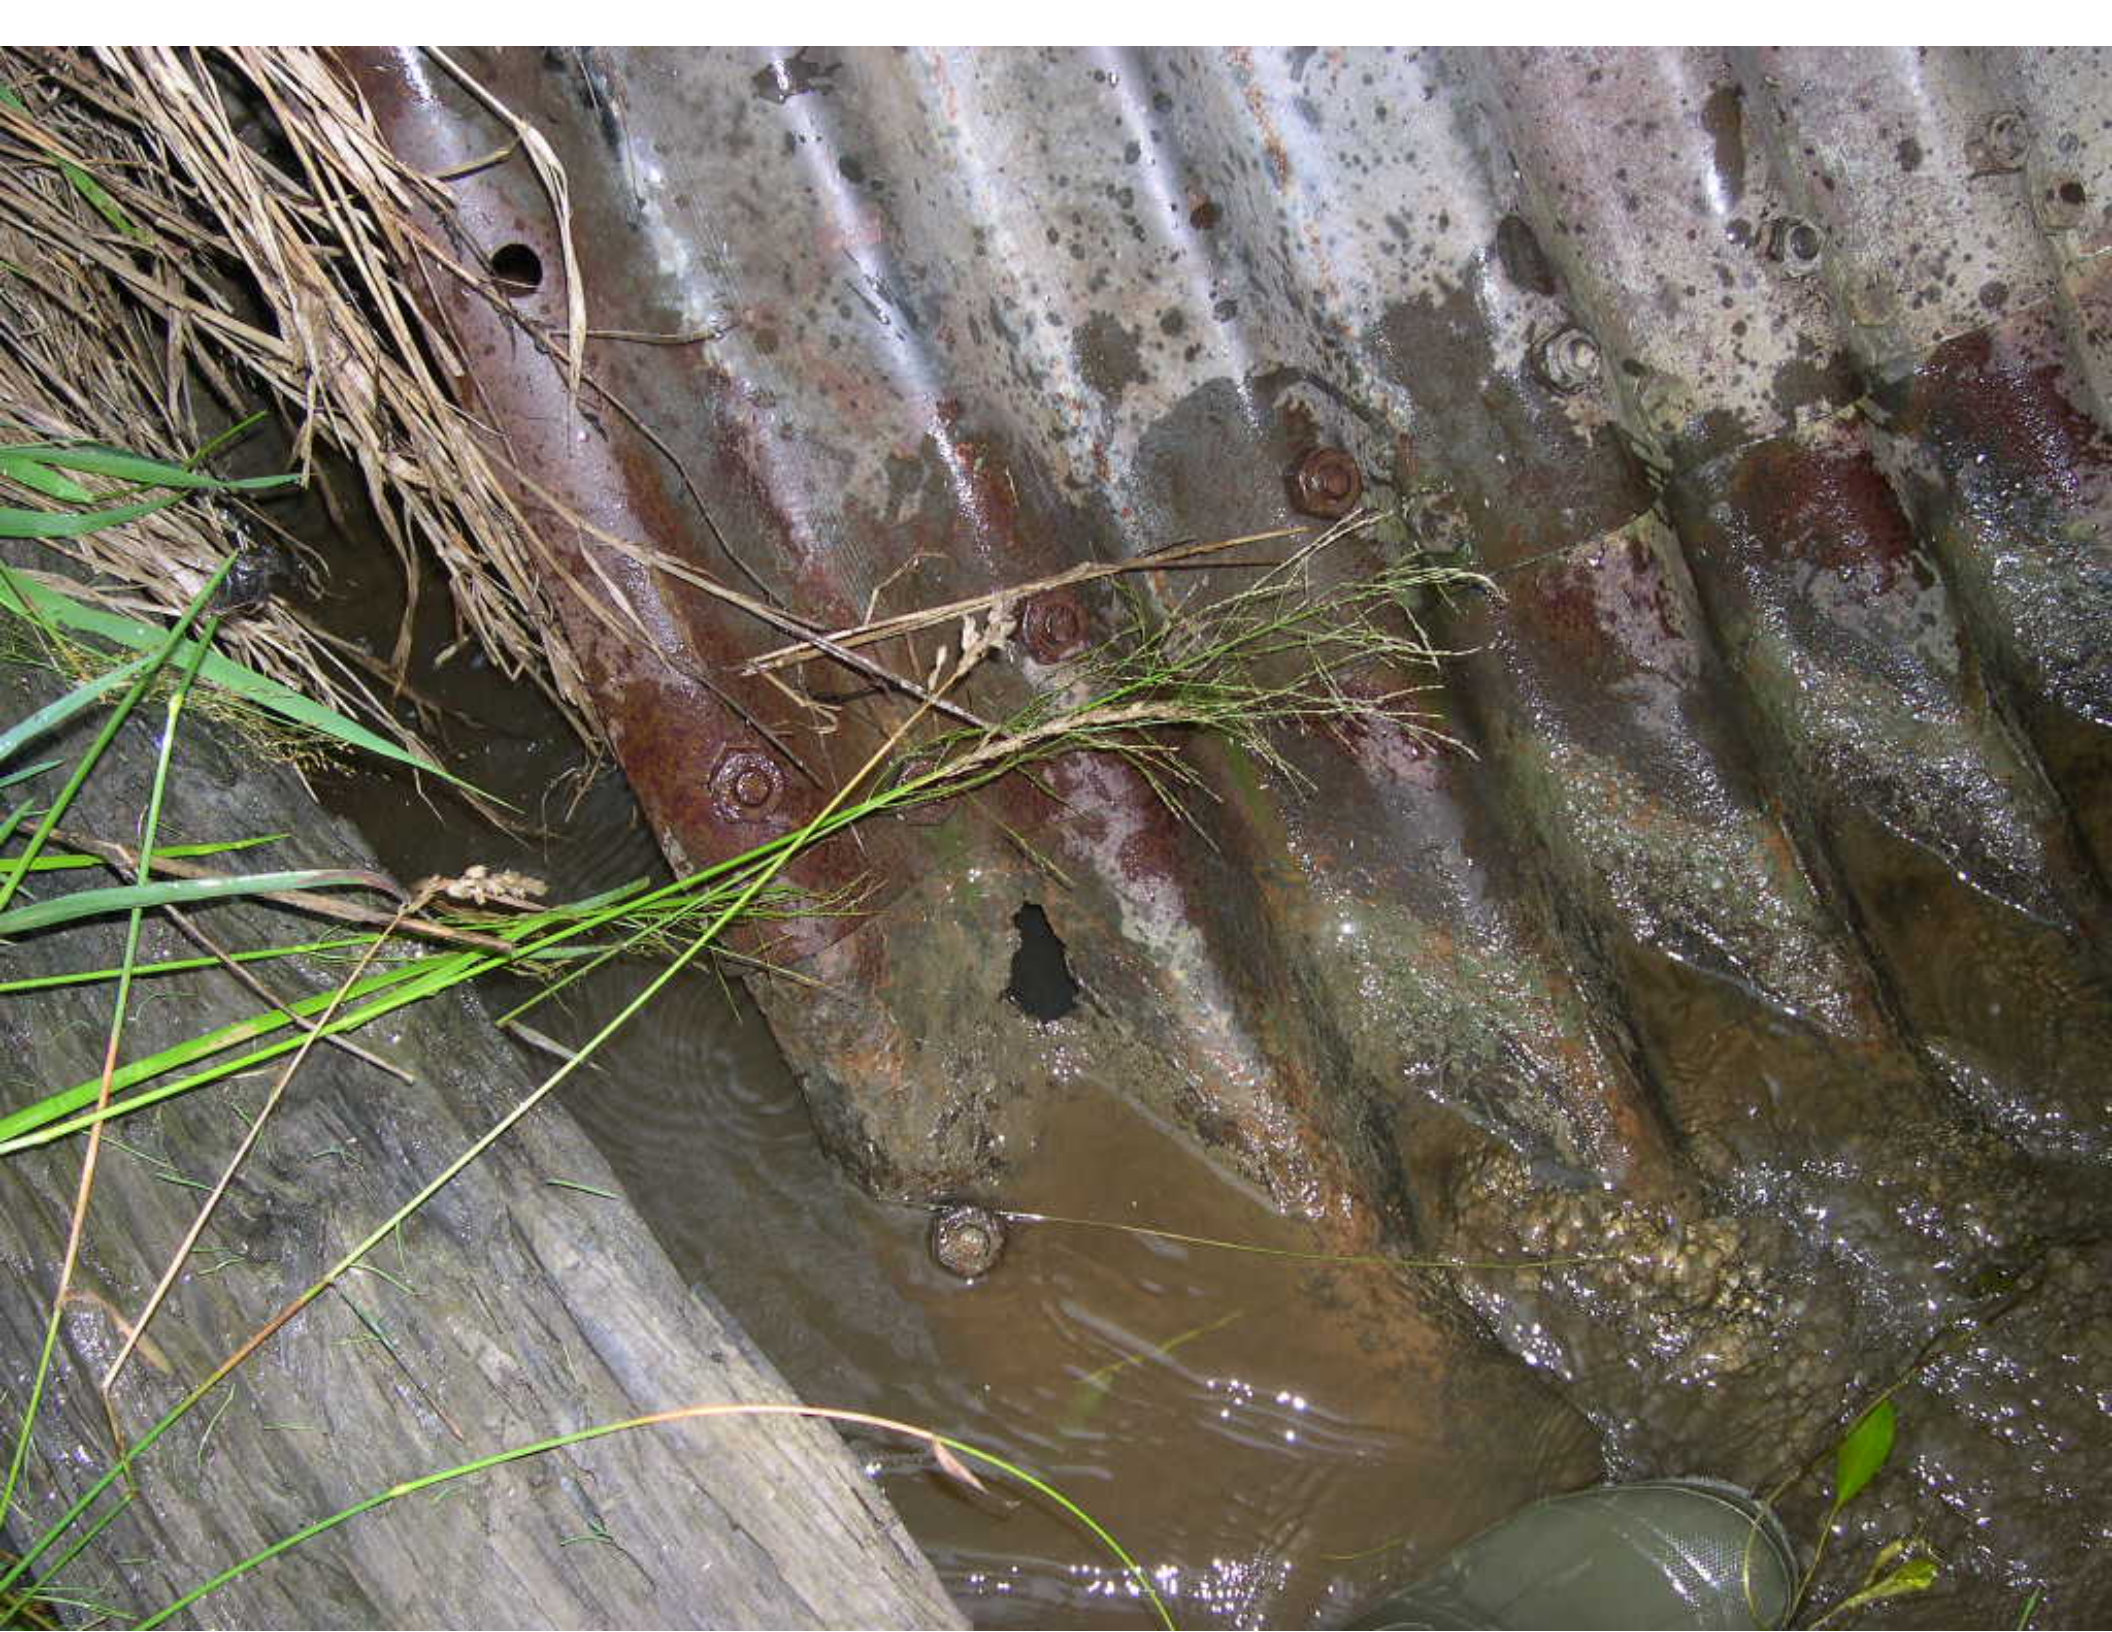
Scattered preforations throughout invert.
