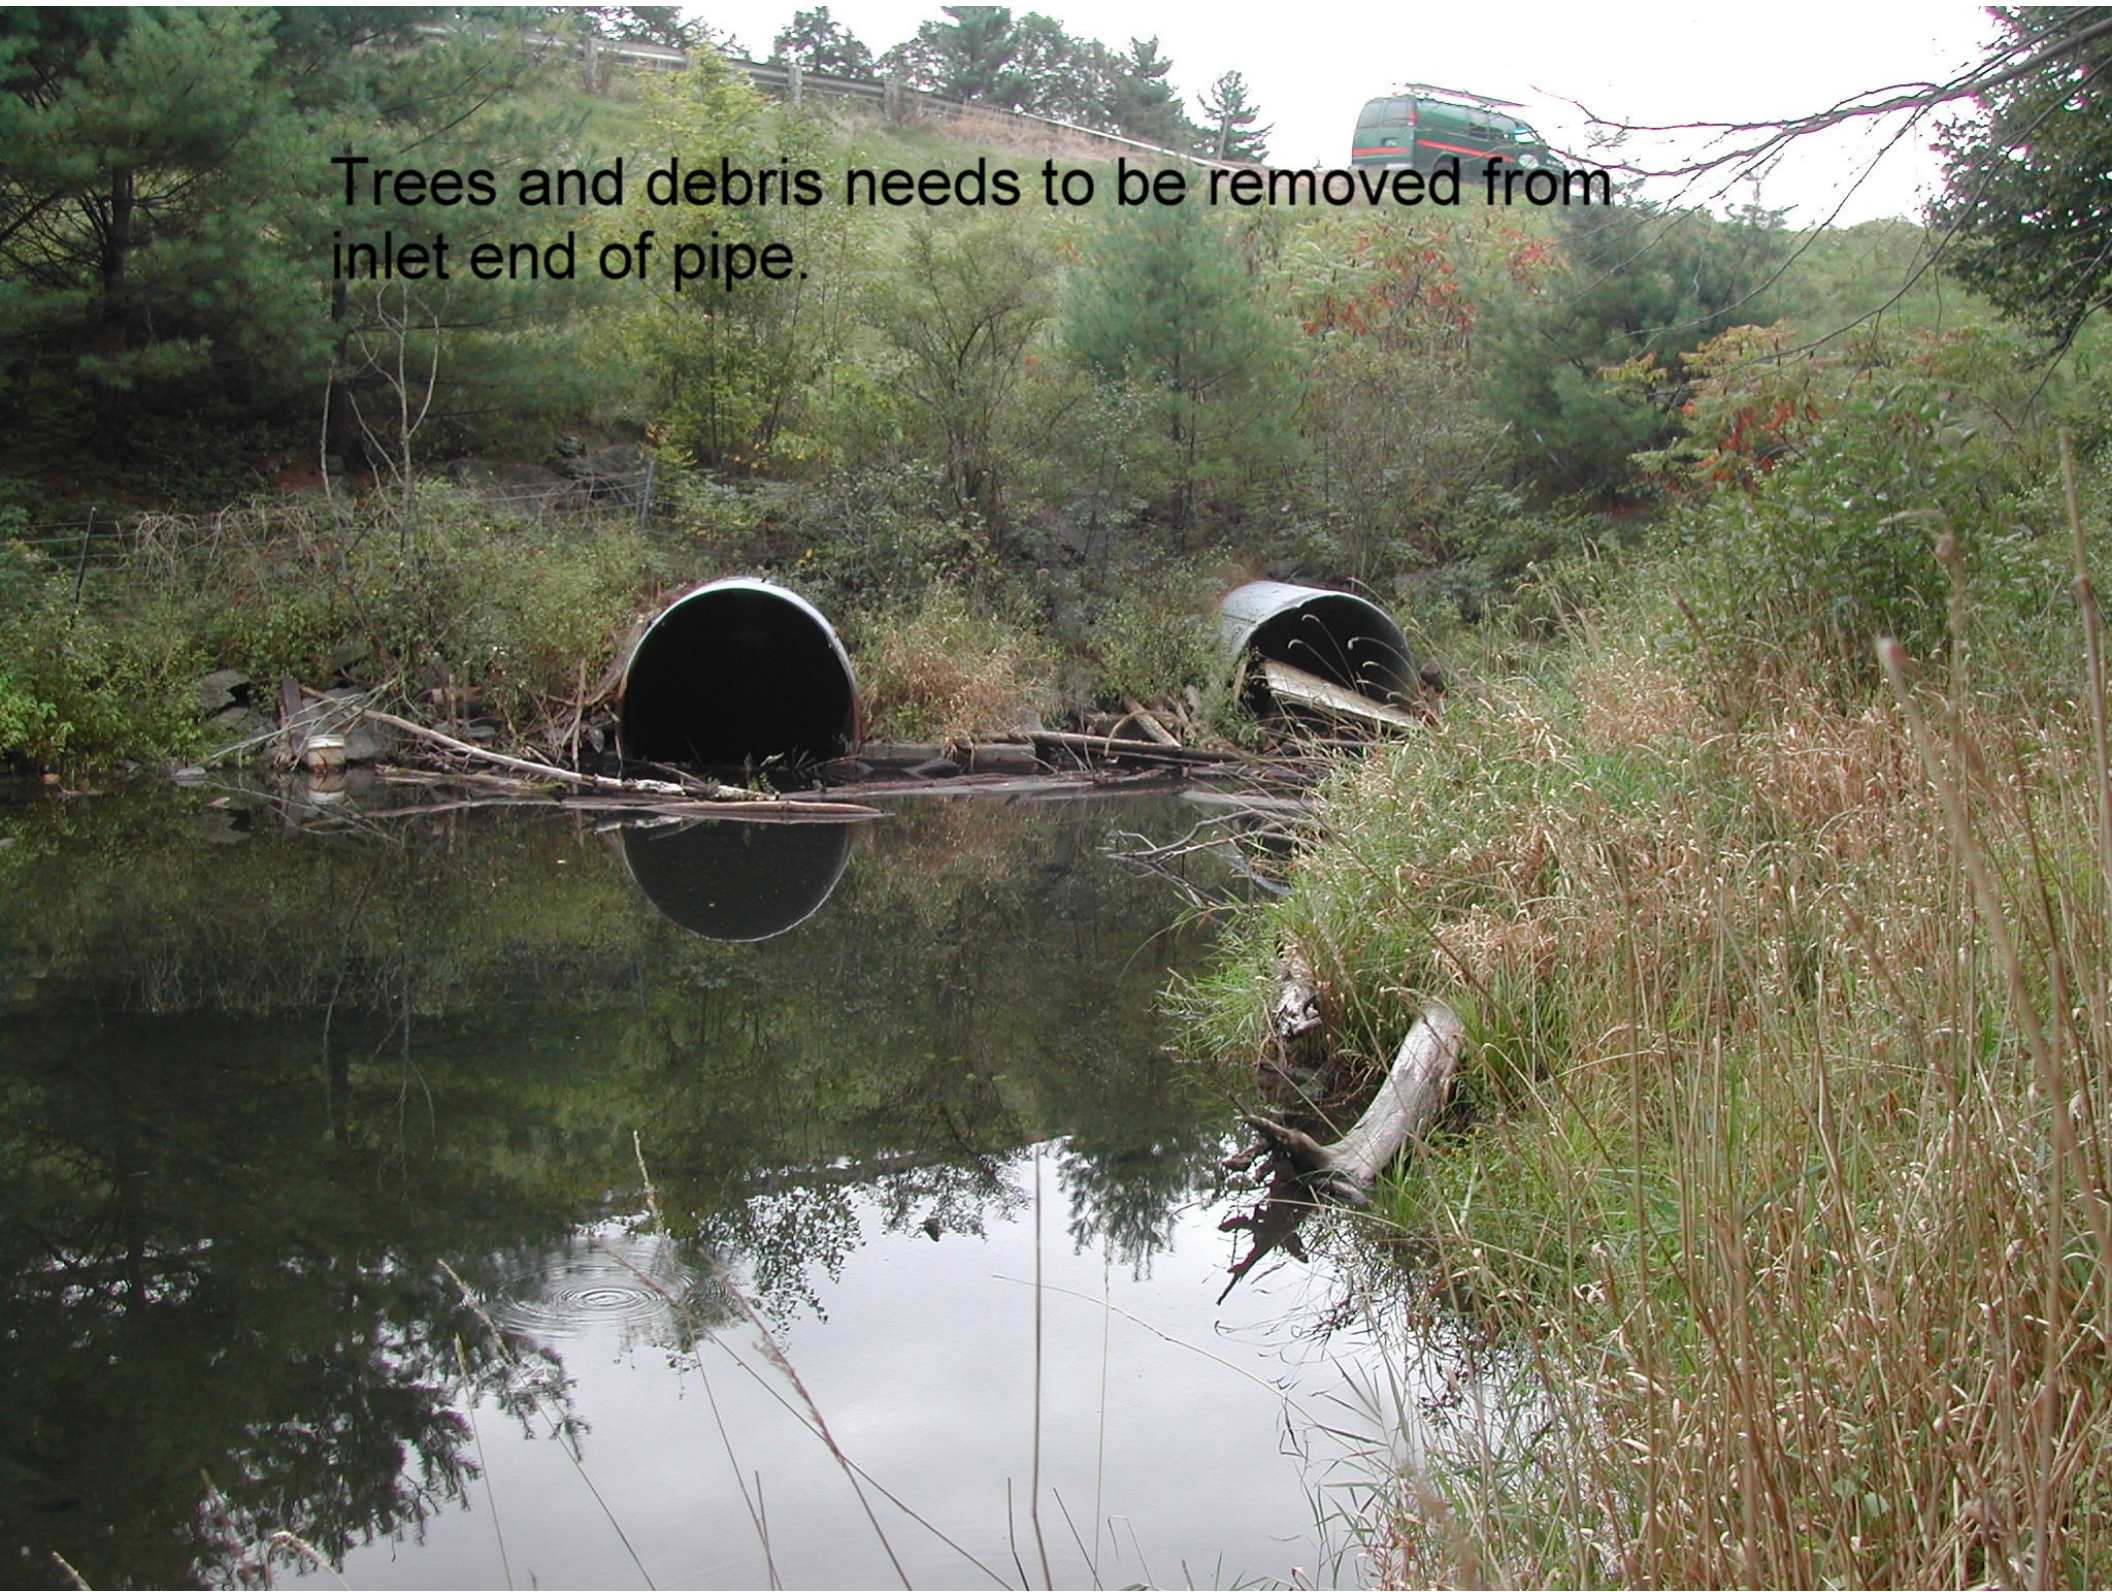
Trees and debris needs to be removed from  
inlet end of pipe.
