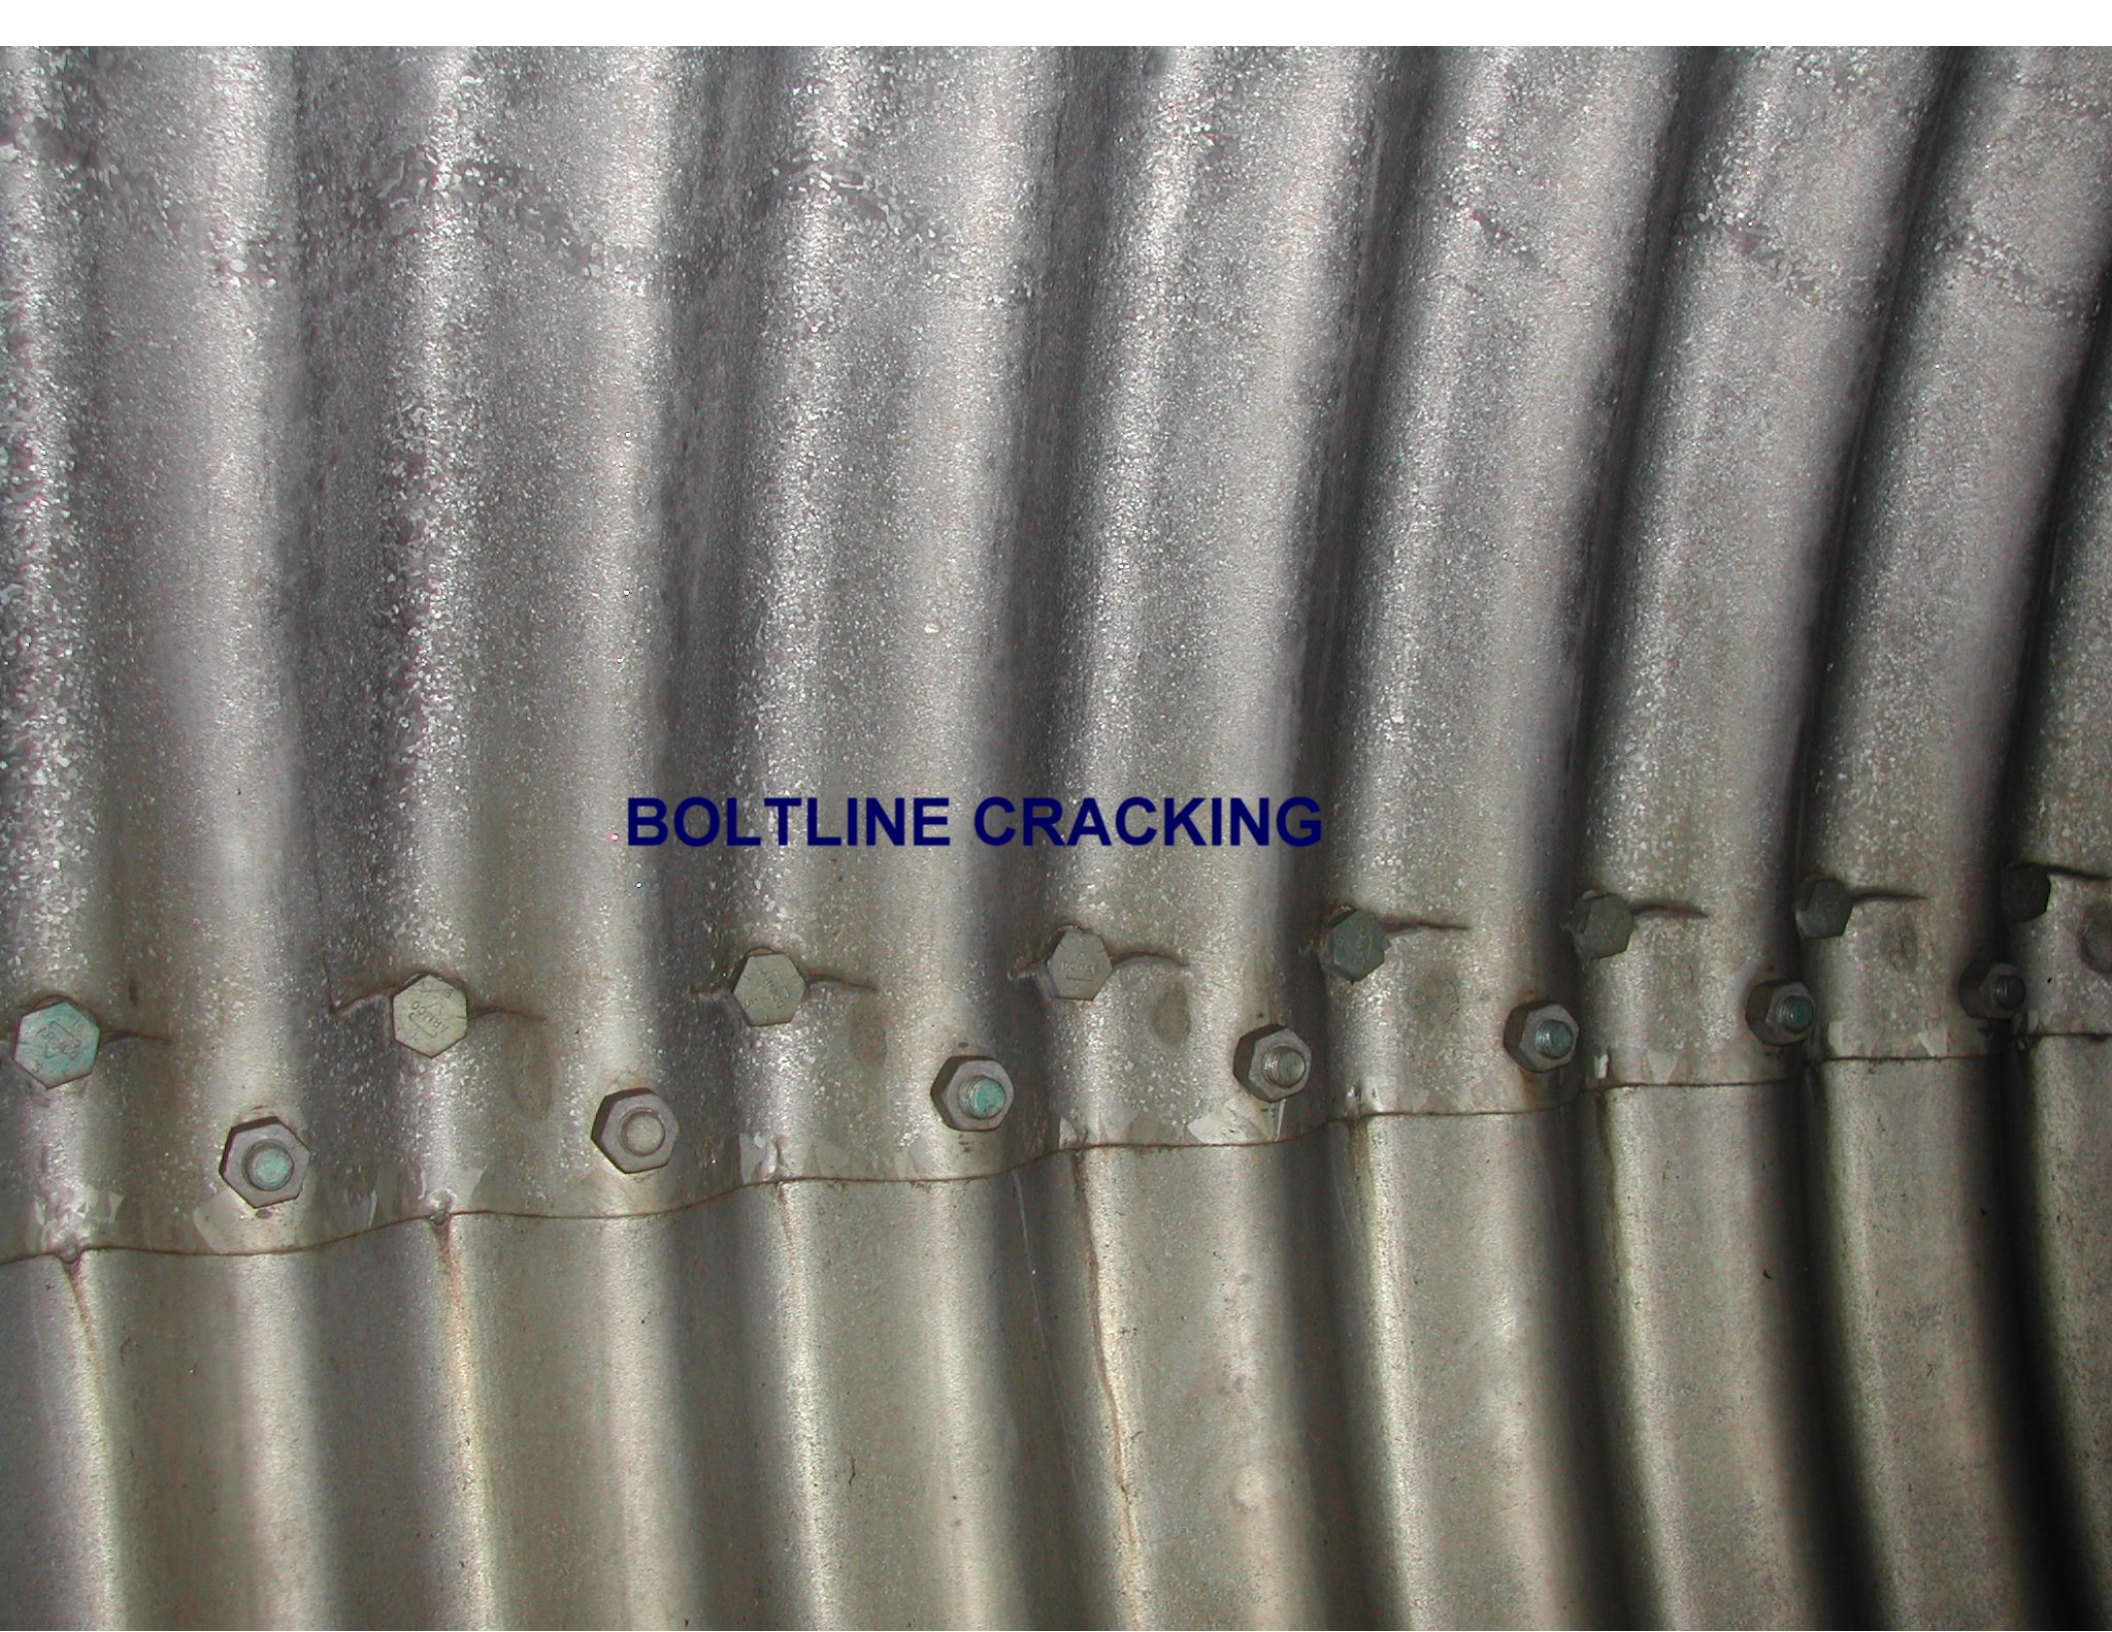
**BOLTLINE CRACKING**
