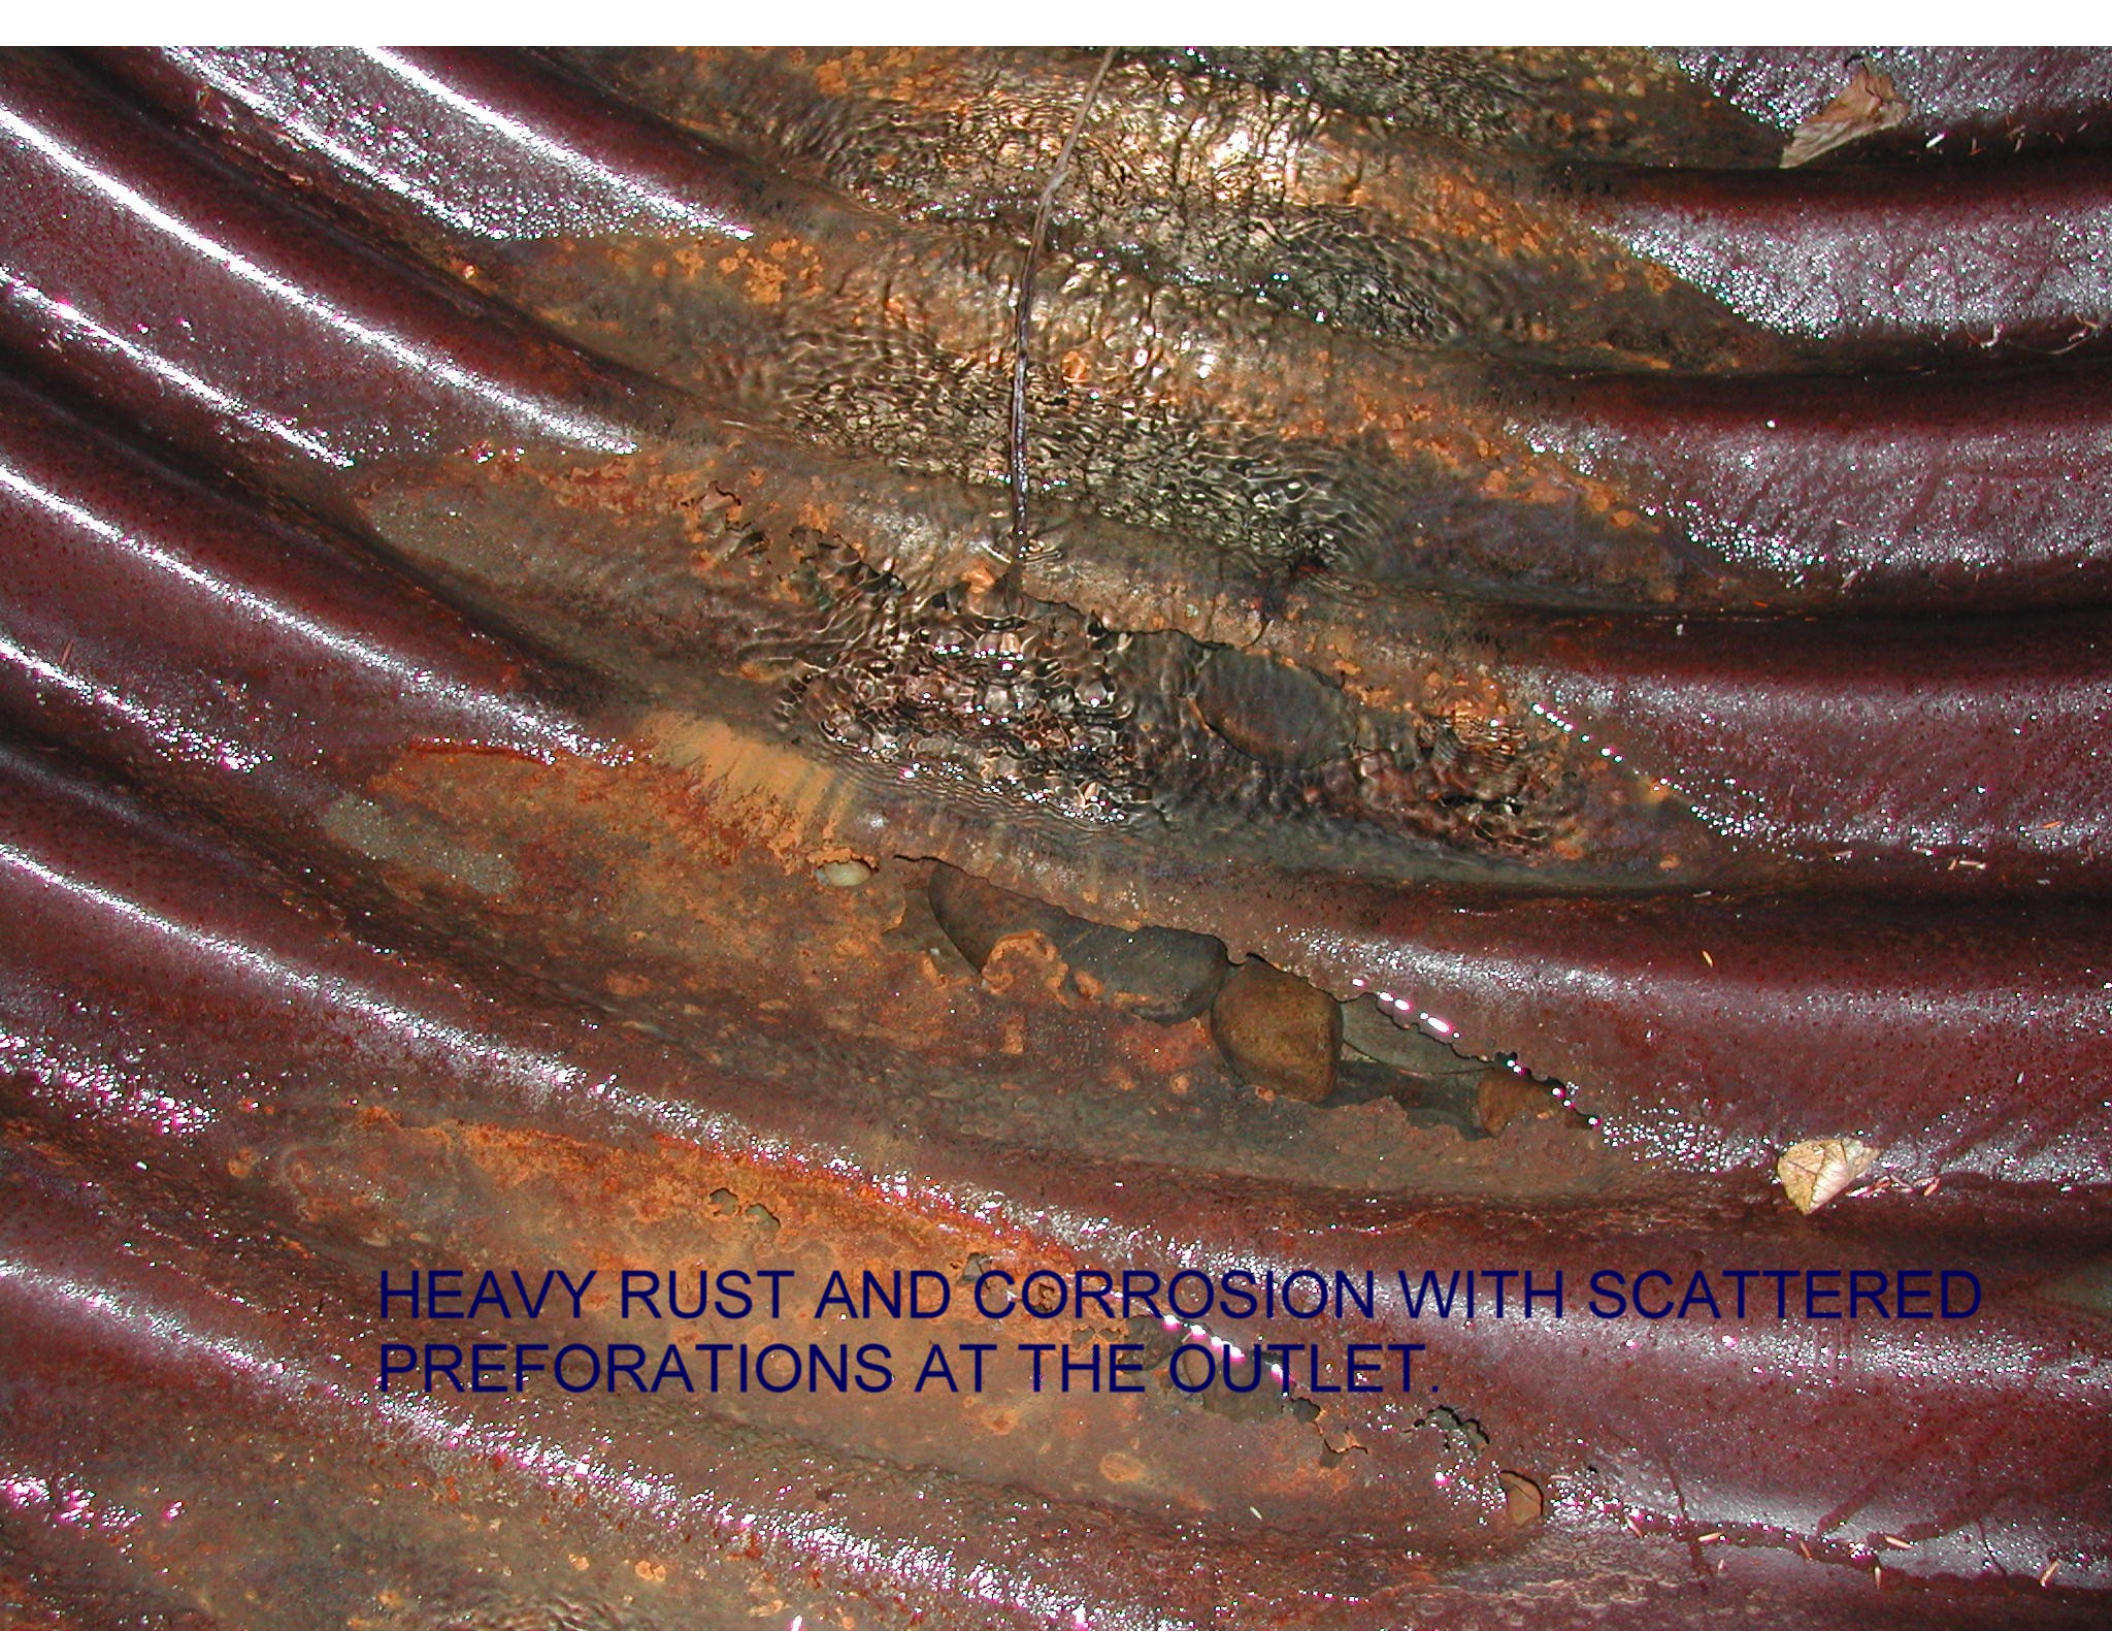
HEAVY RUST AND CORROSION WITH SCATTERED  
PREFORATIONS AT THE OUTLET.
