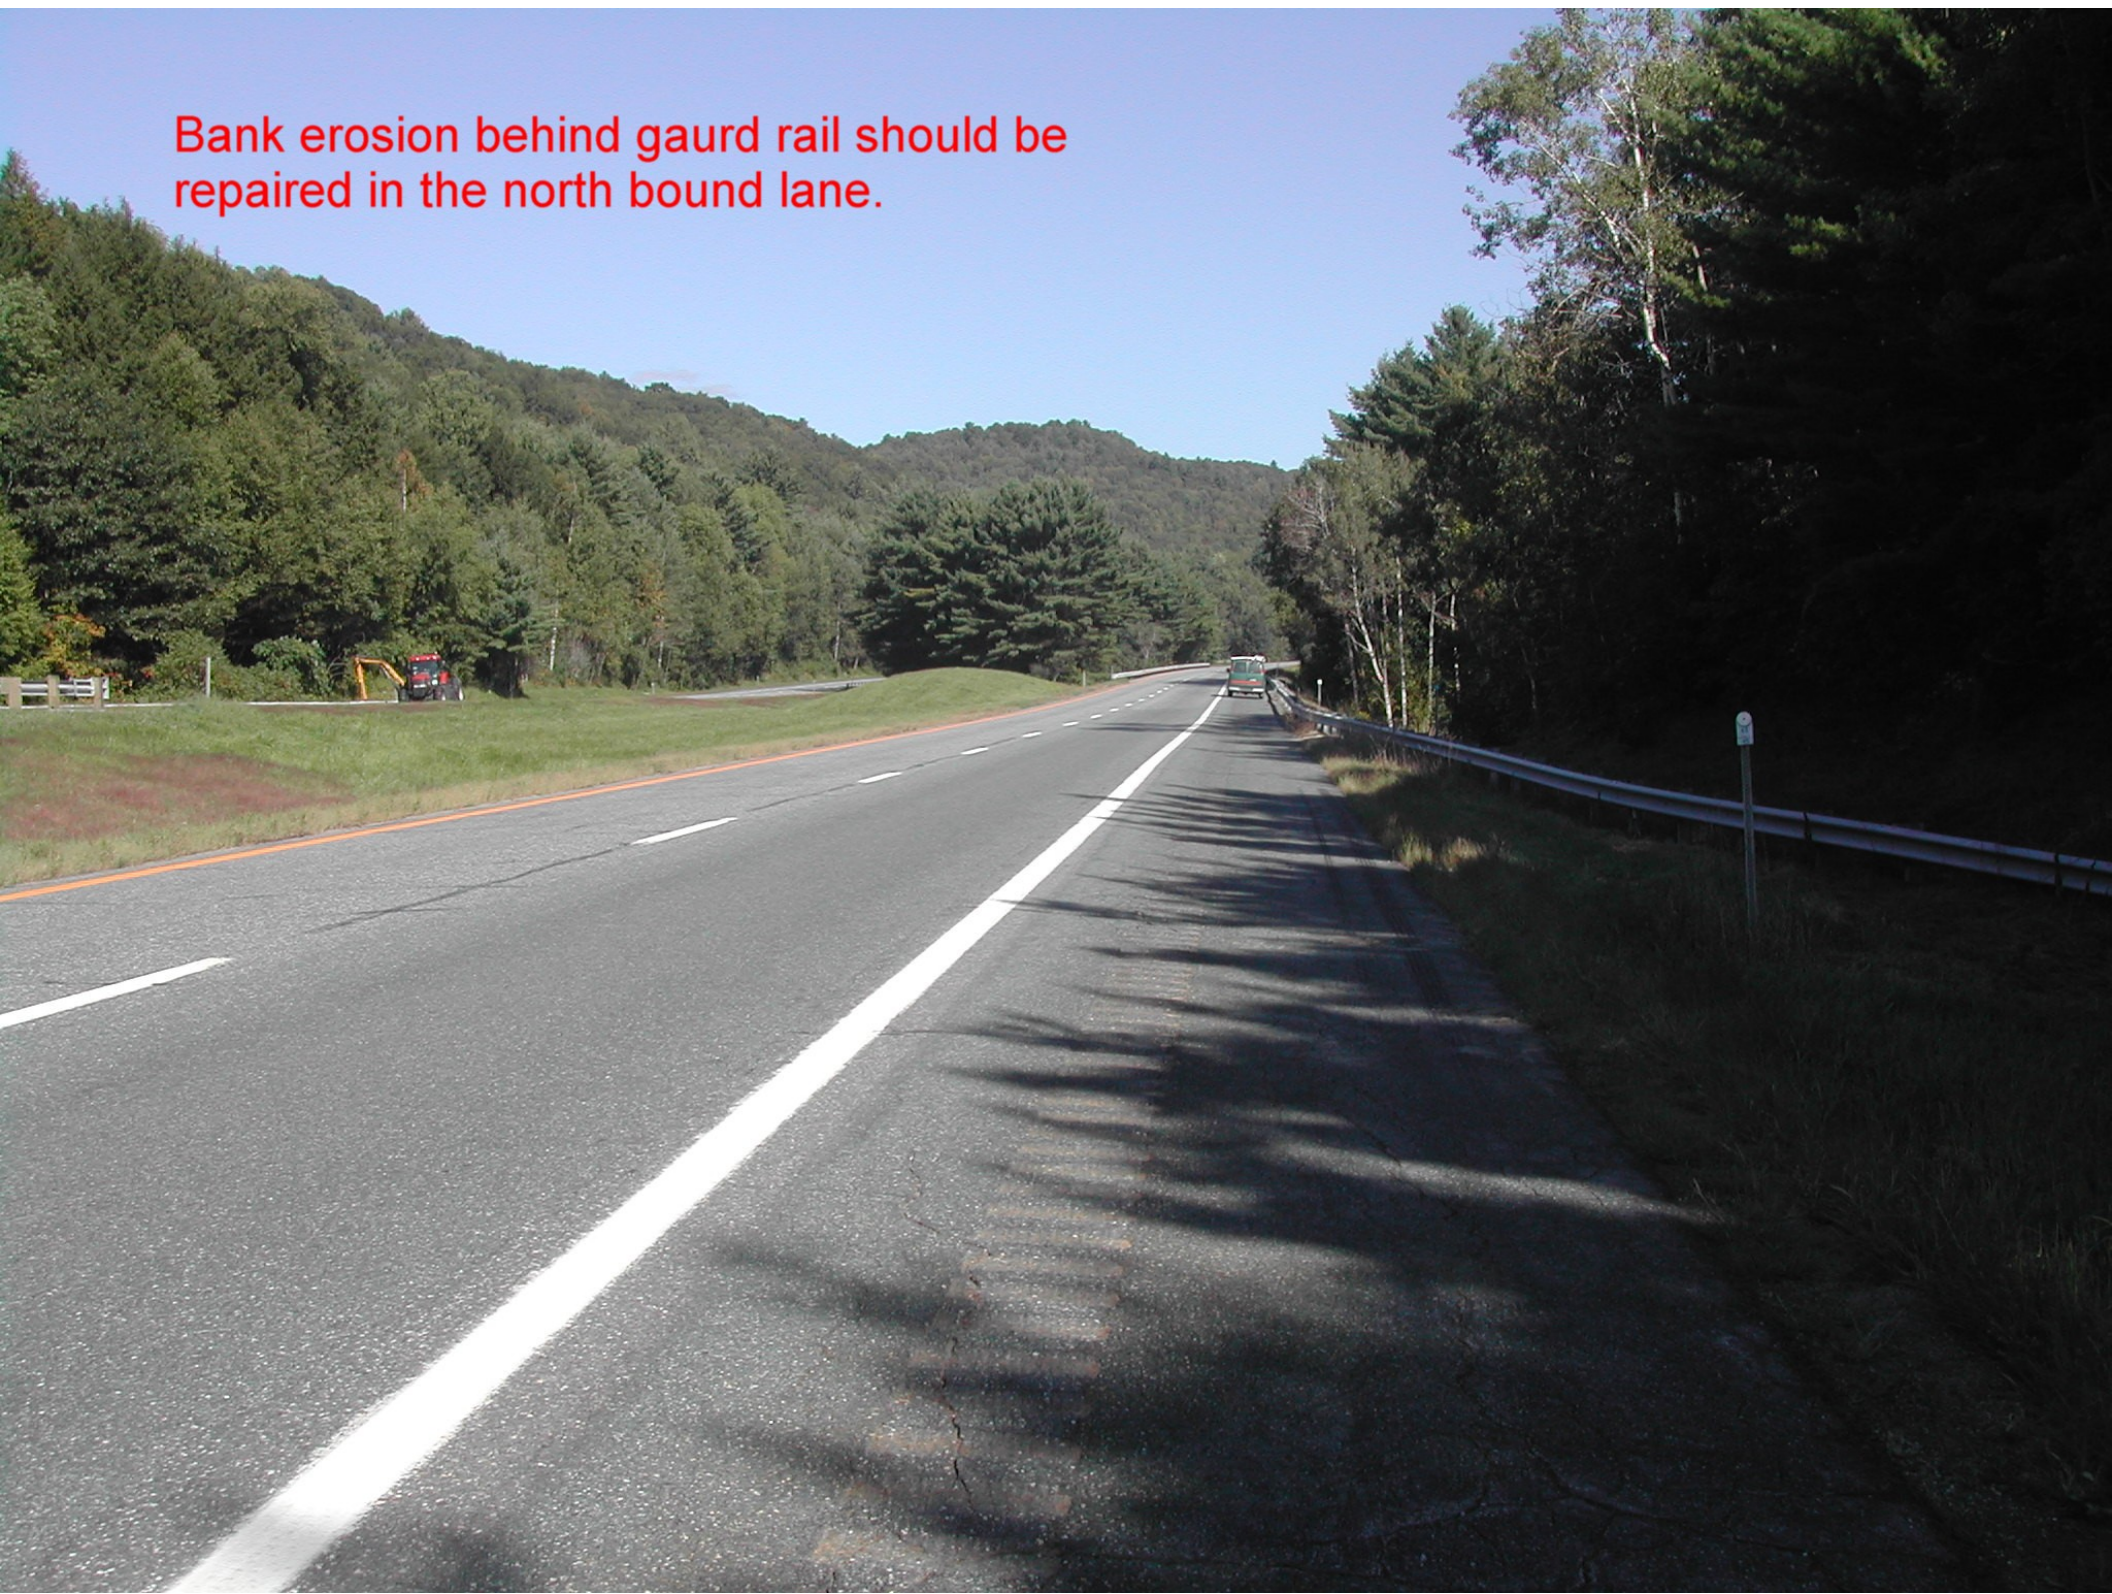
Bank erosion behind guard rail should be repaired in the north bound lane.
