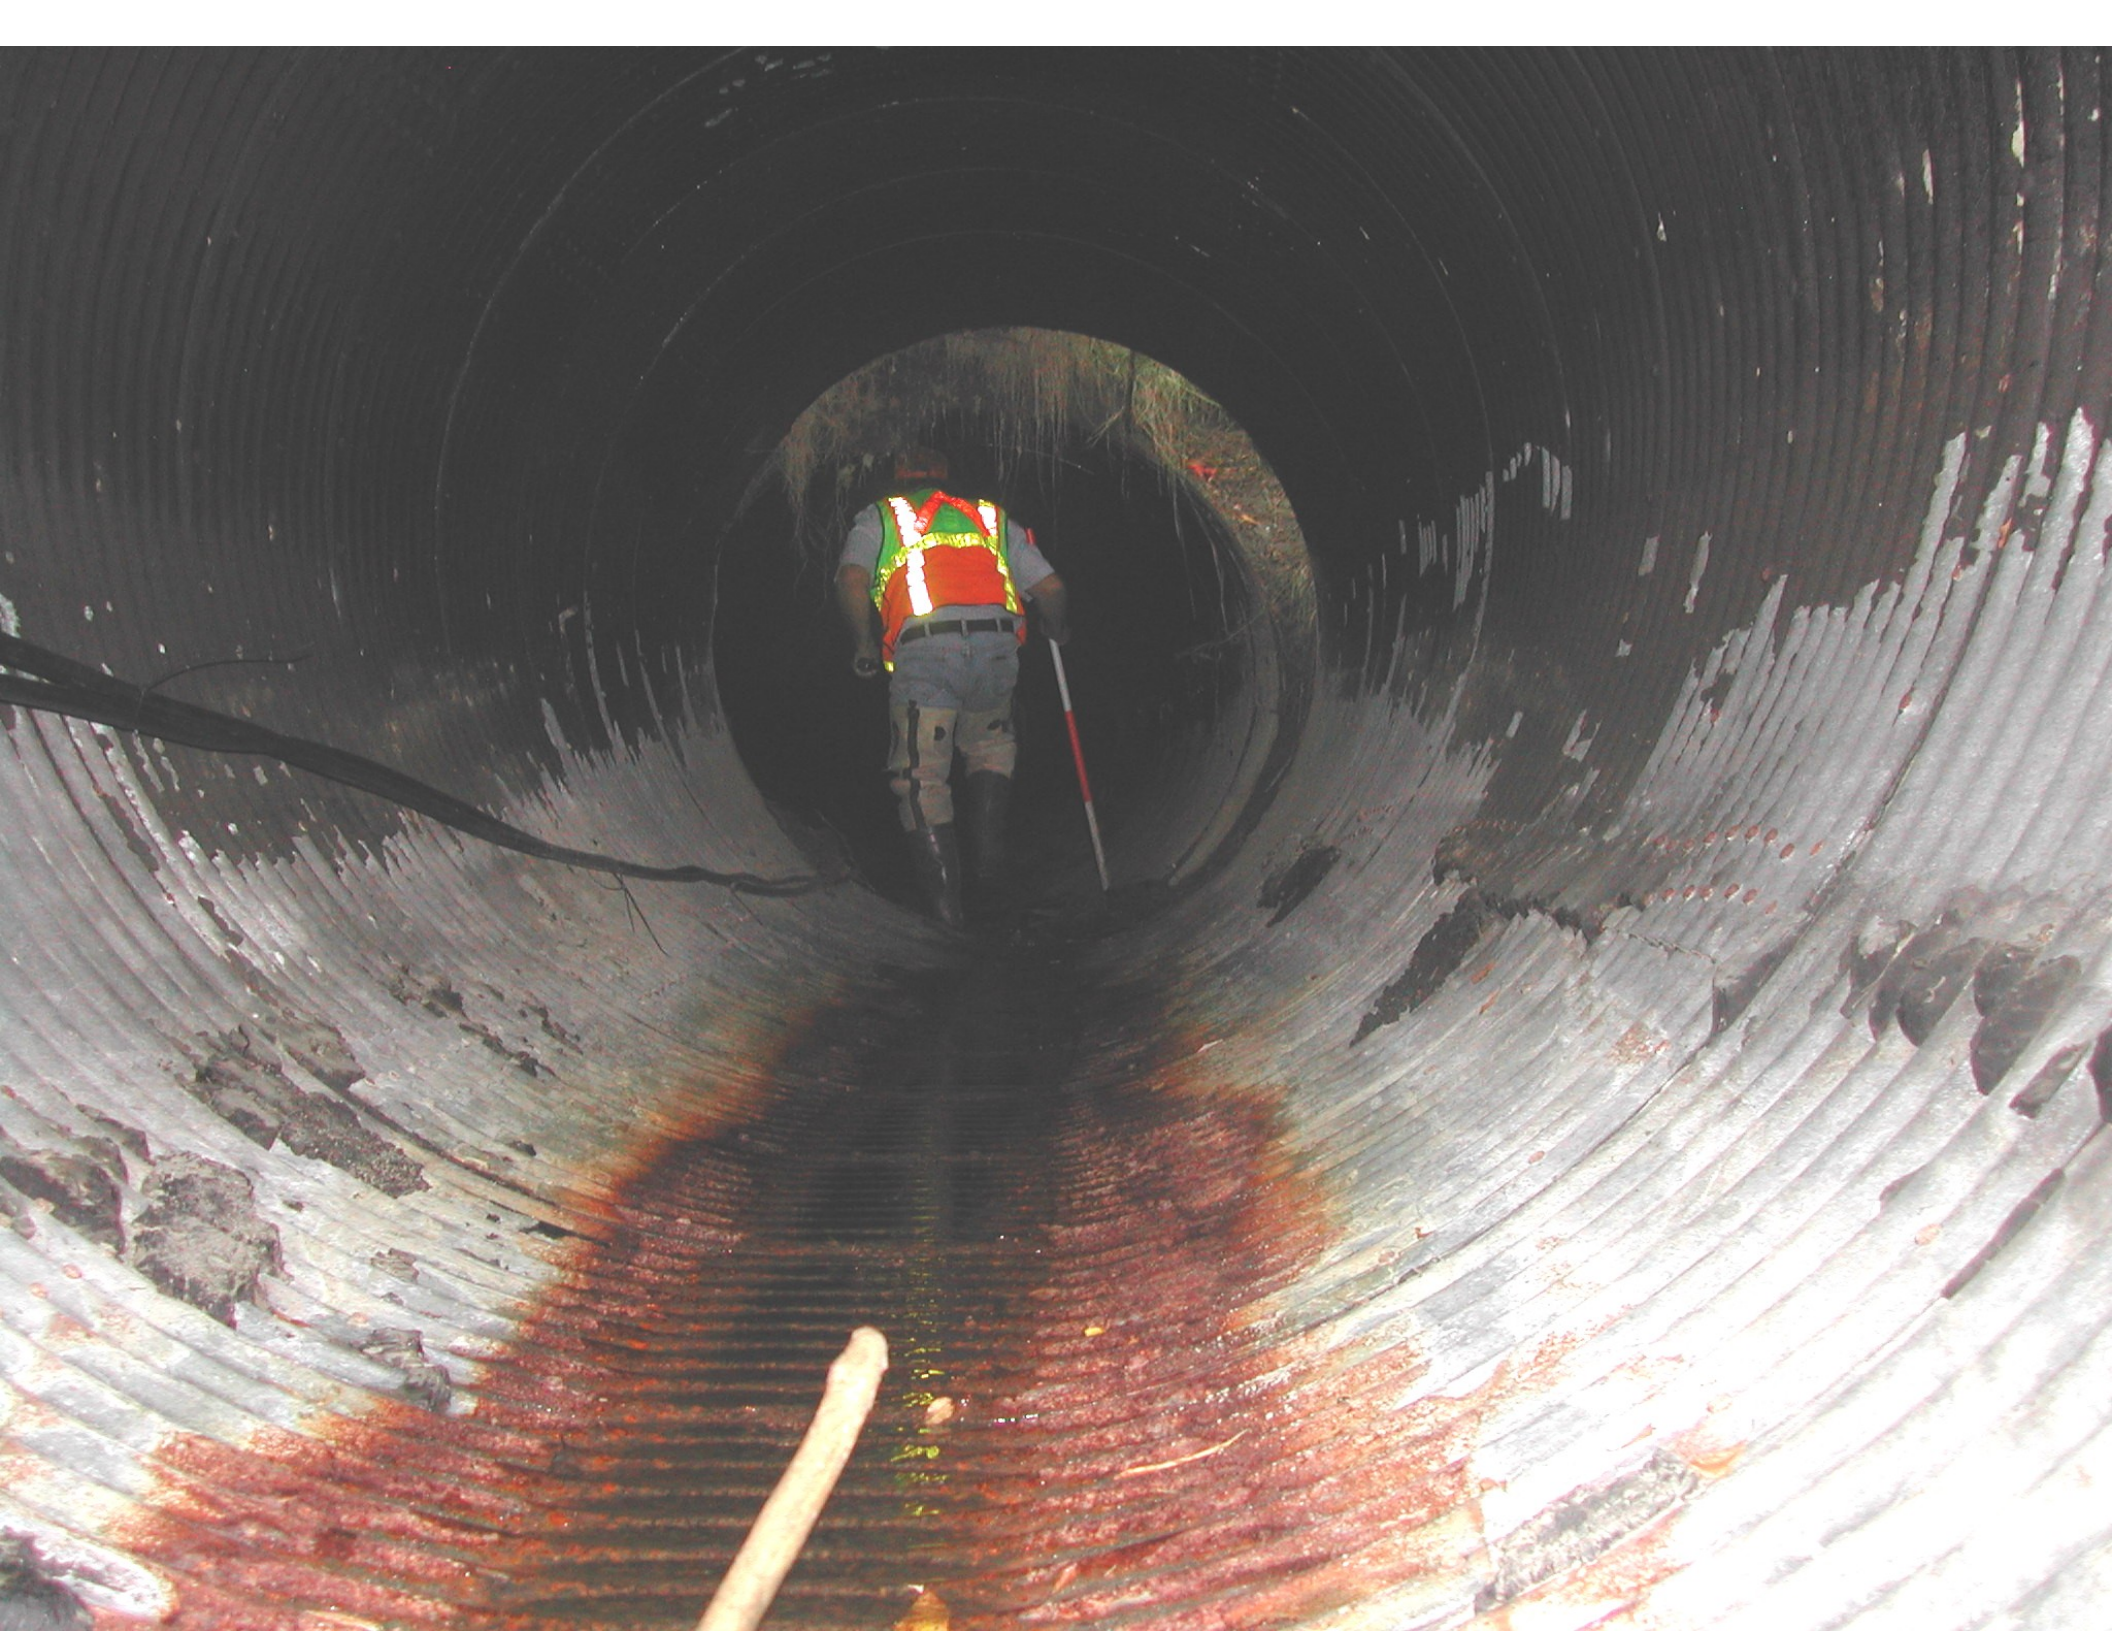
Outlet end of culvert should be repaired  
and a collar installed. Outlet has pulled  
apart and dropped about 1 foot.

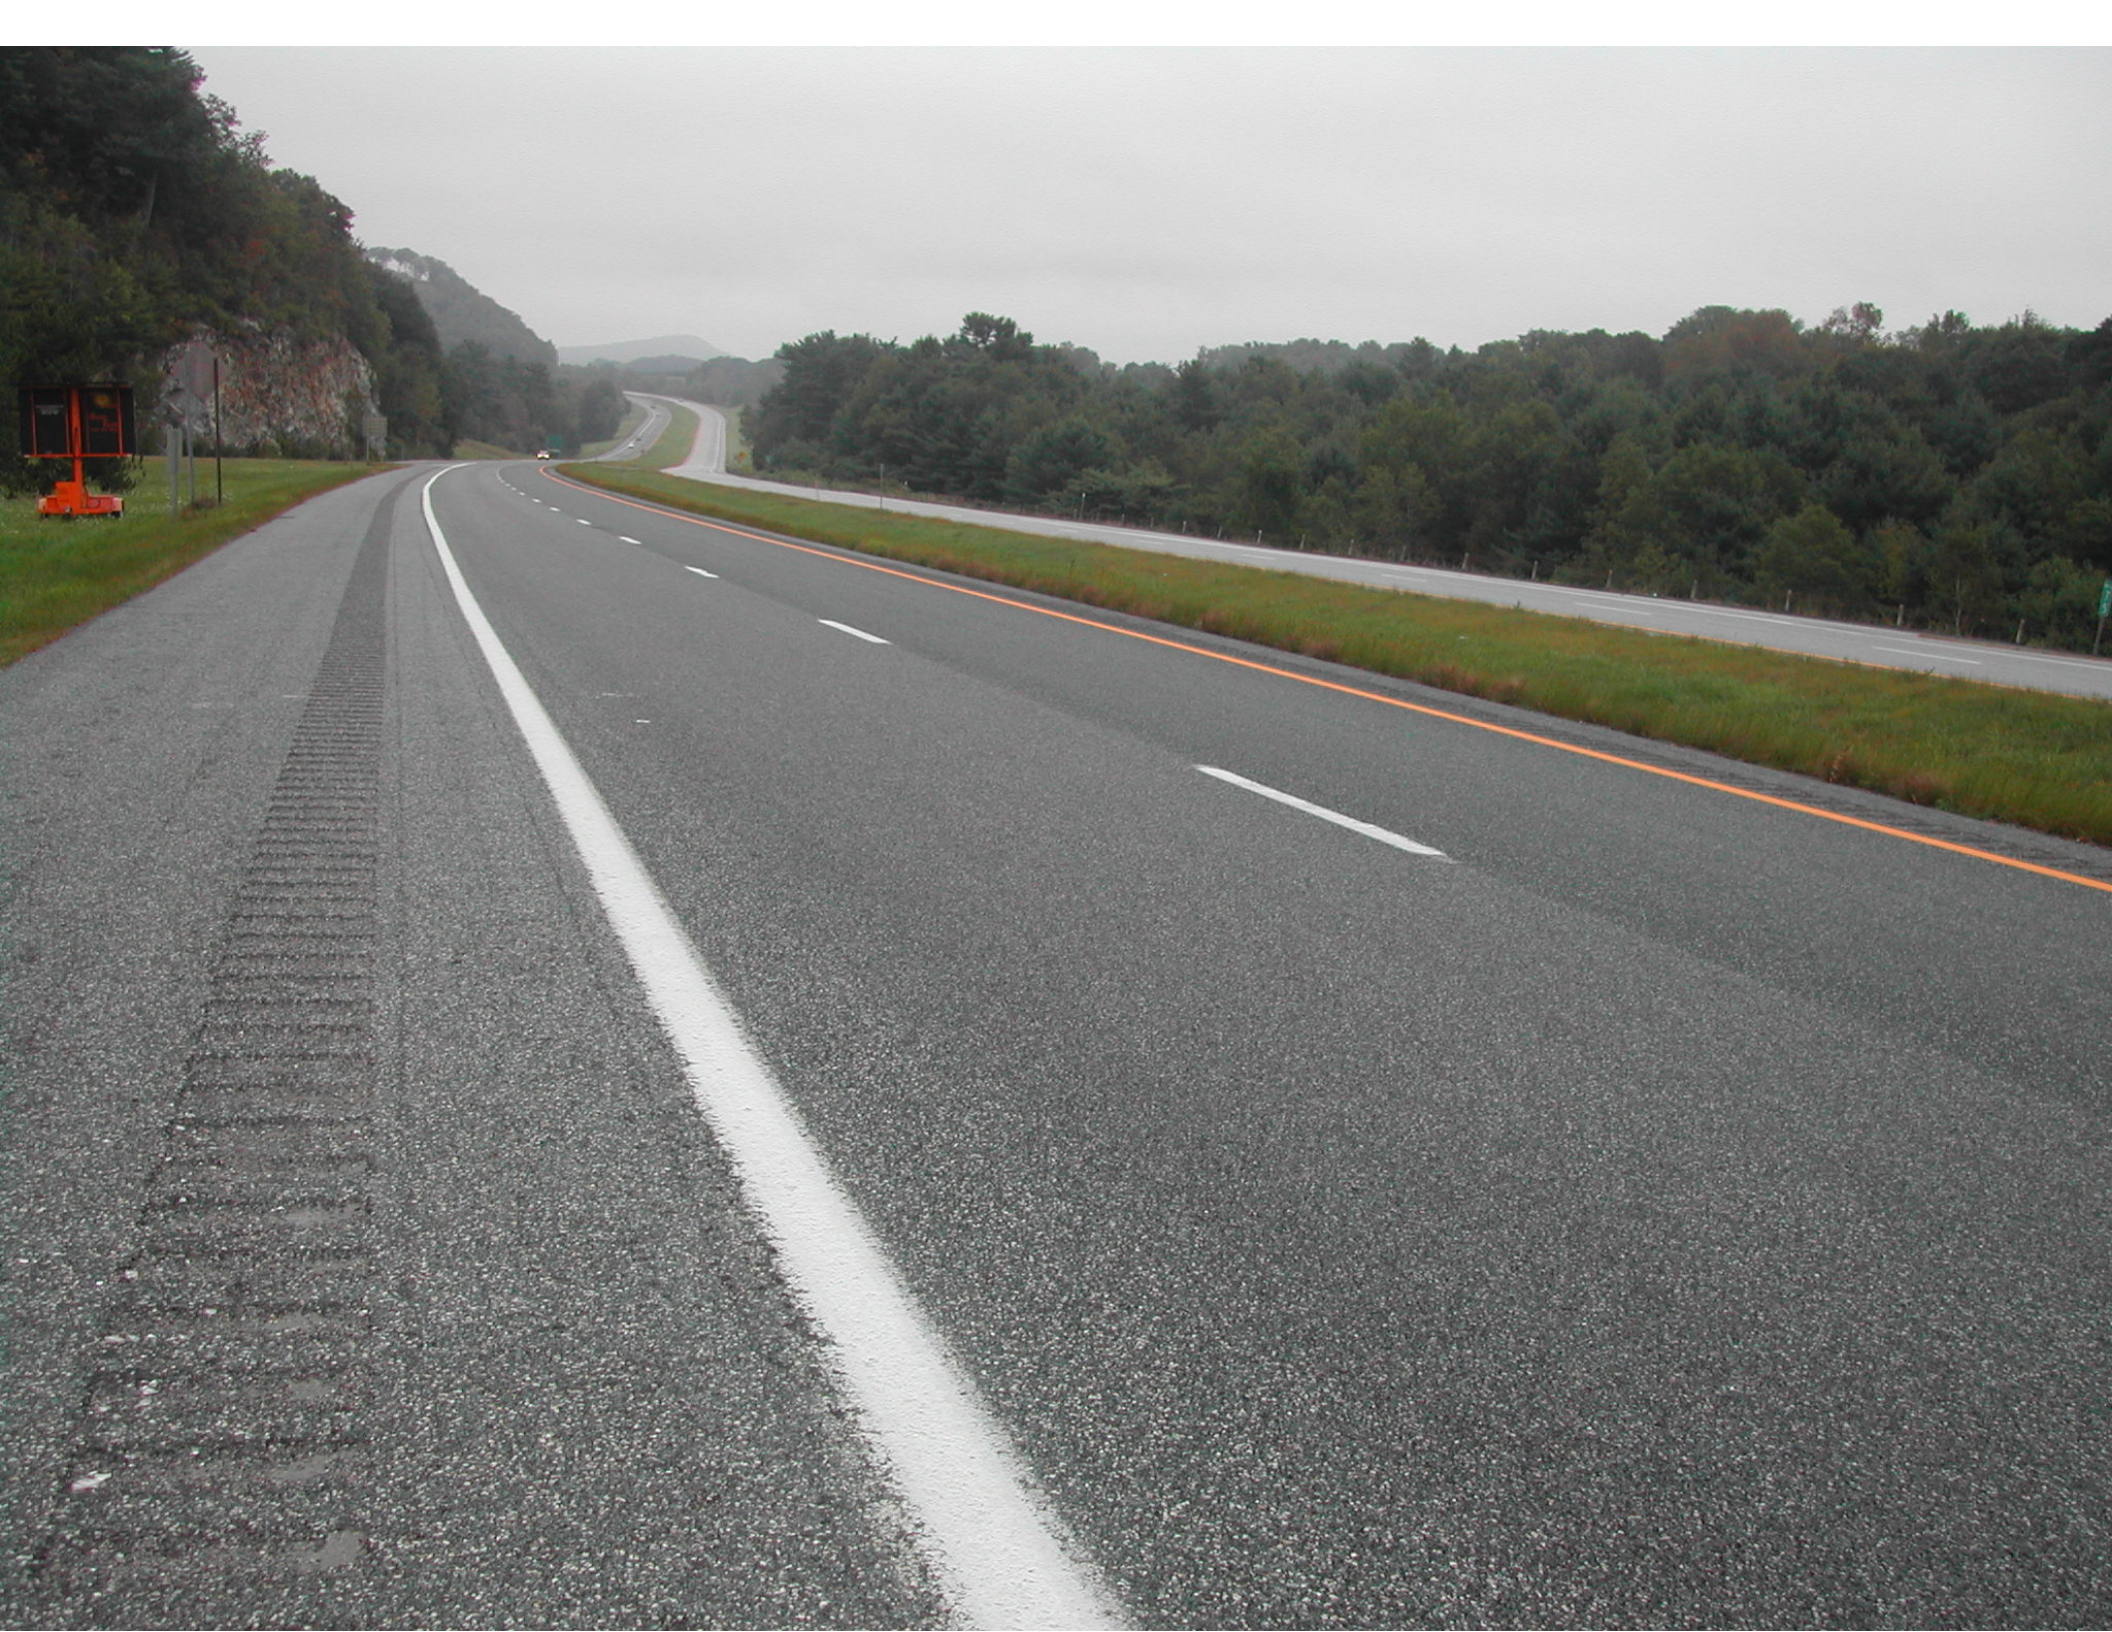
Trees in channel at outlet need to be
