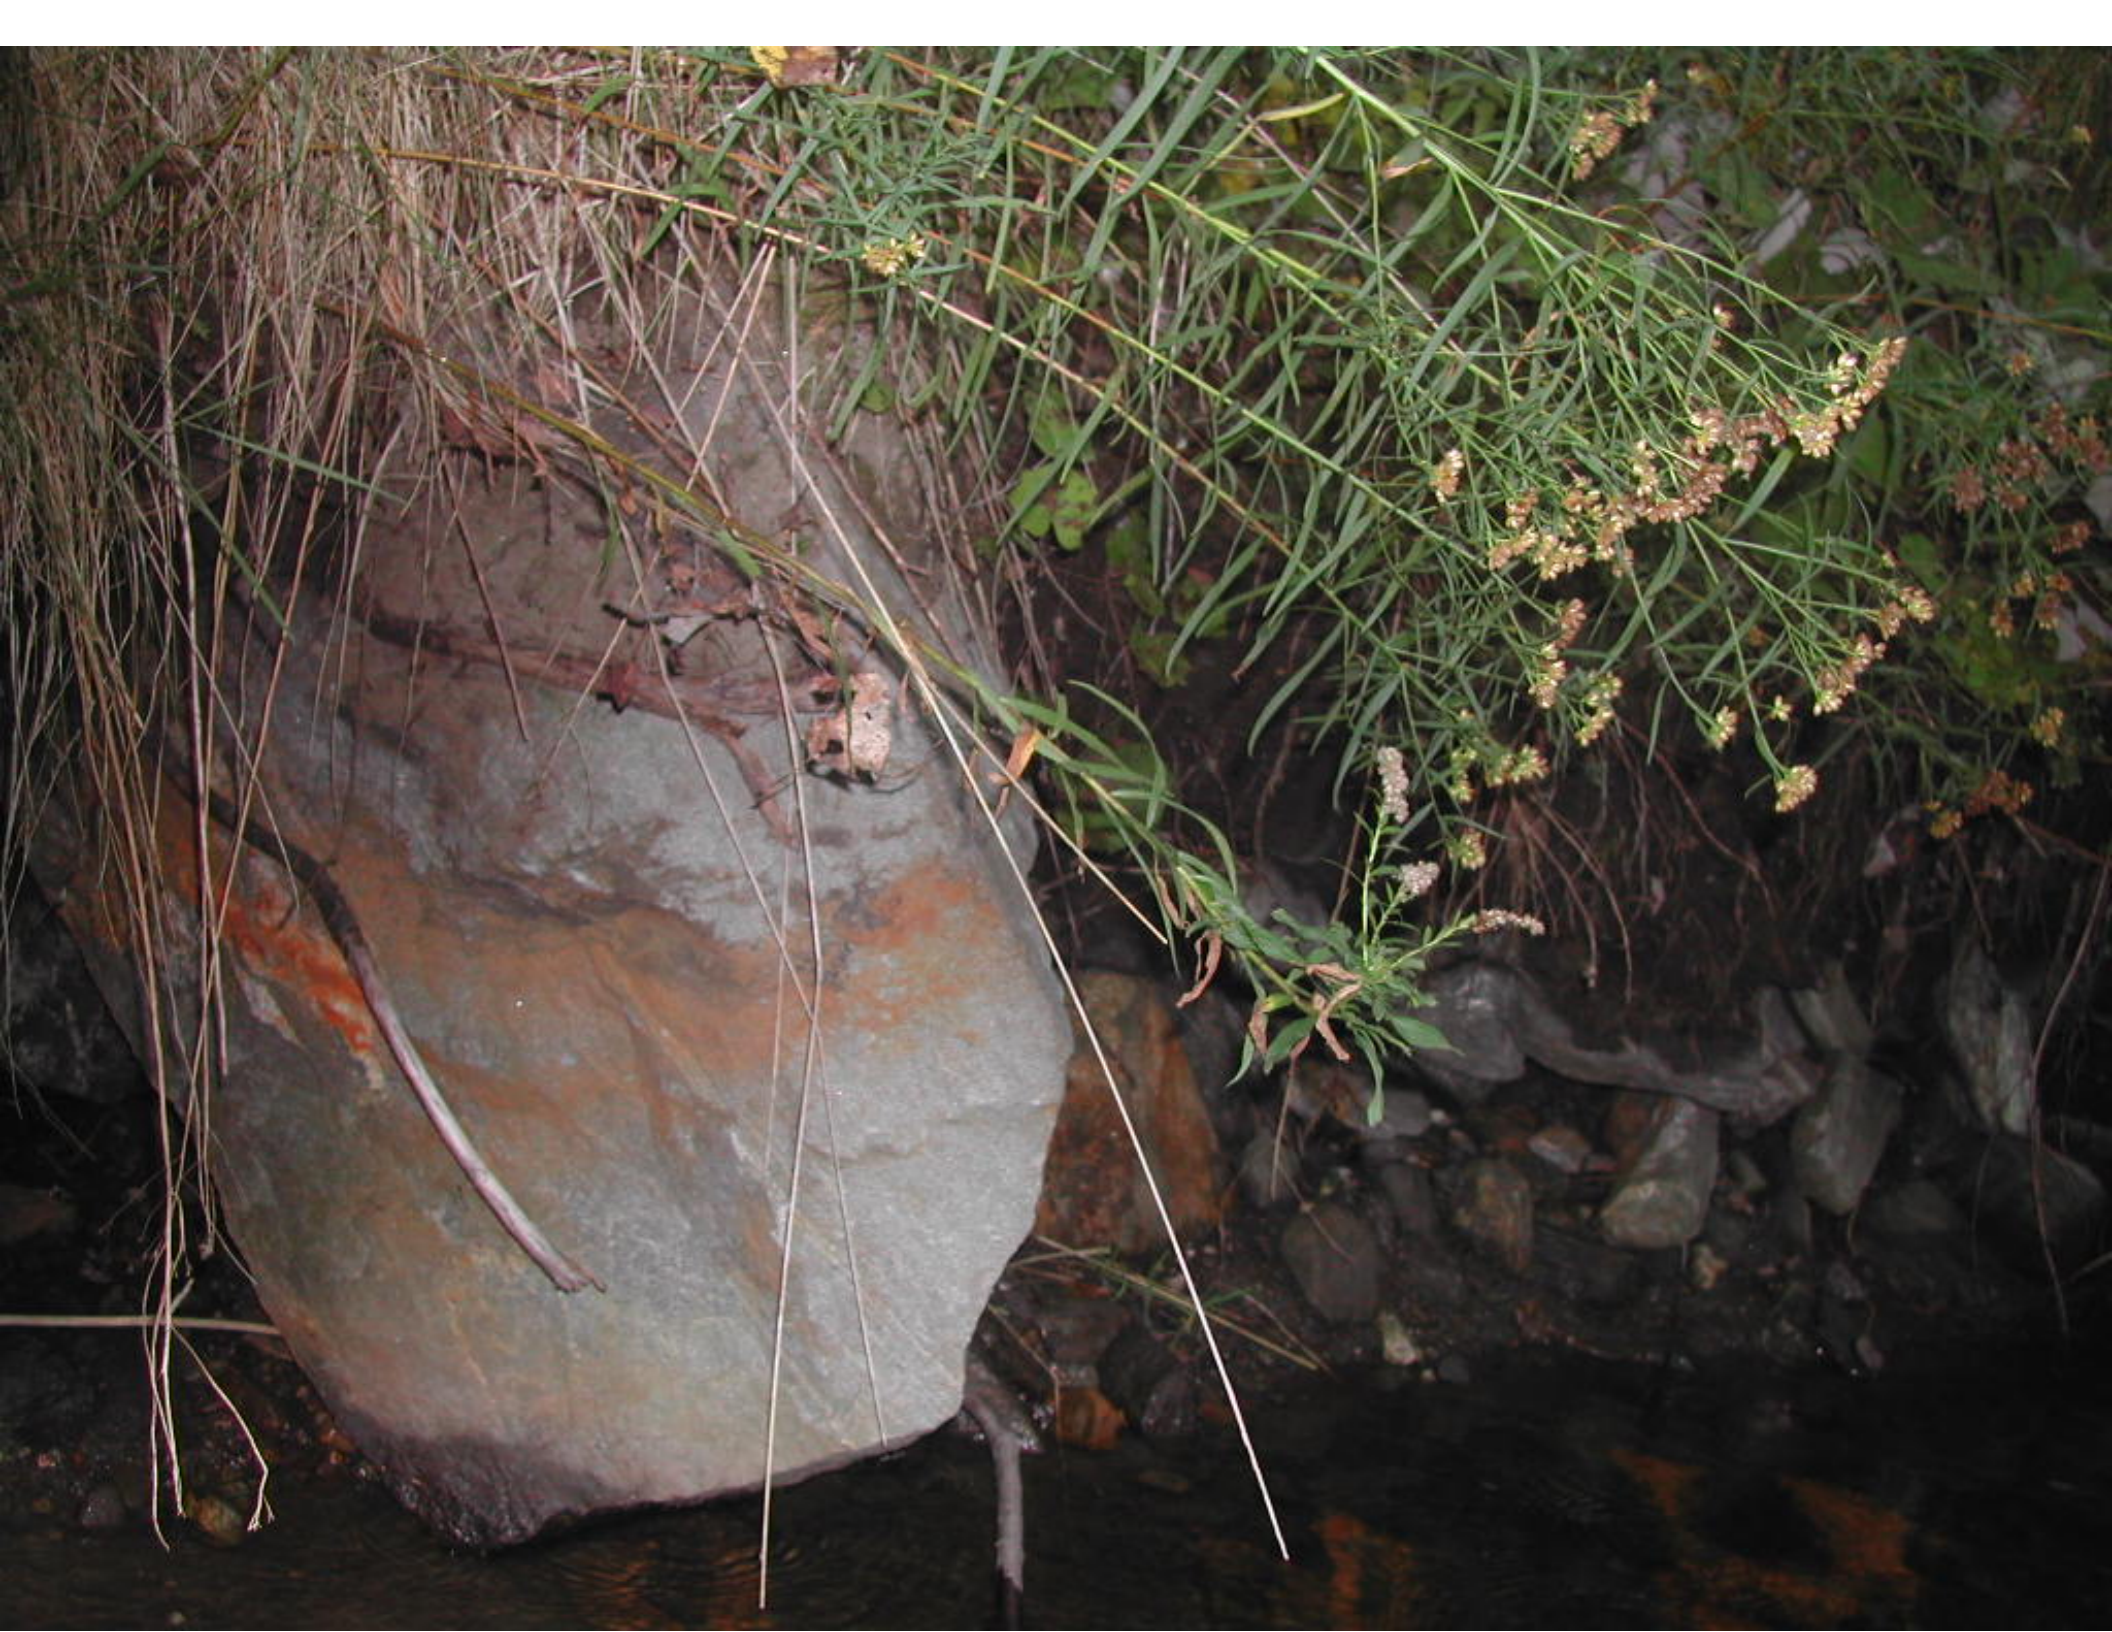
Headwall need repointing

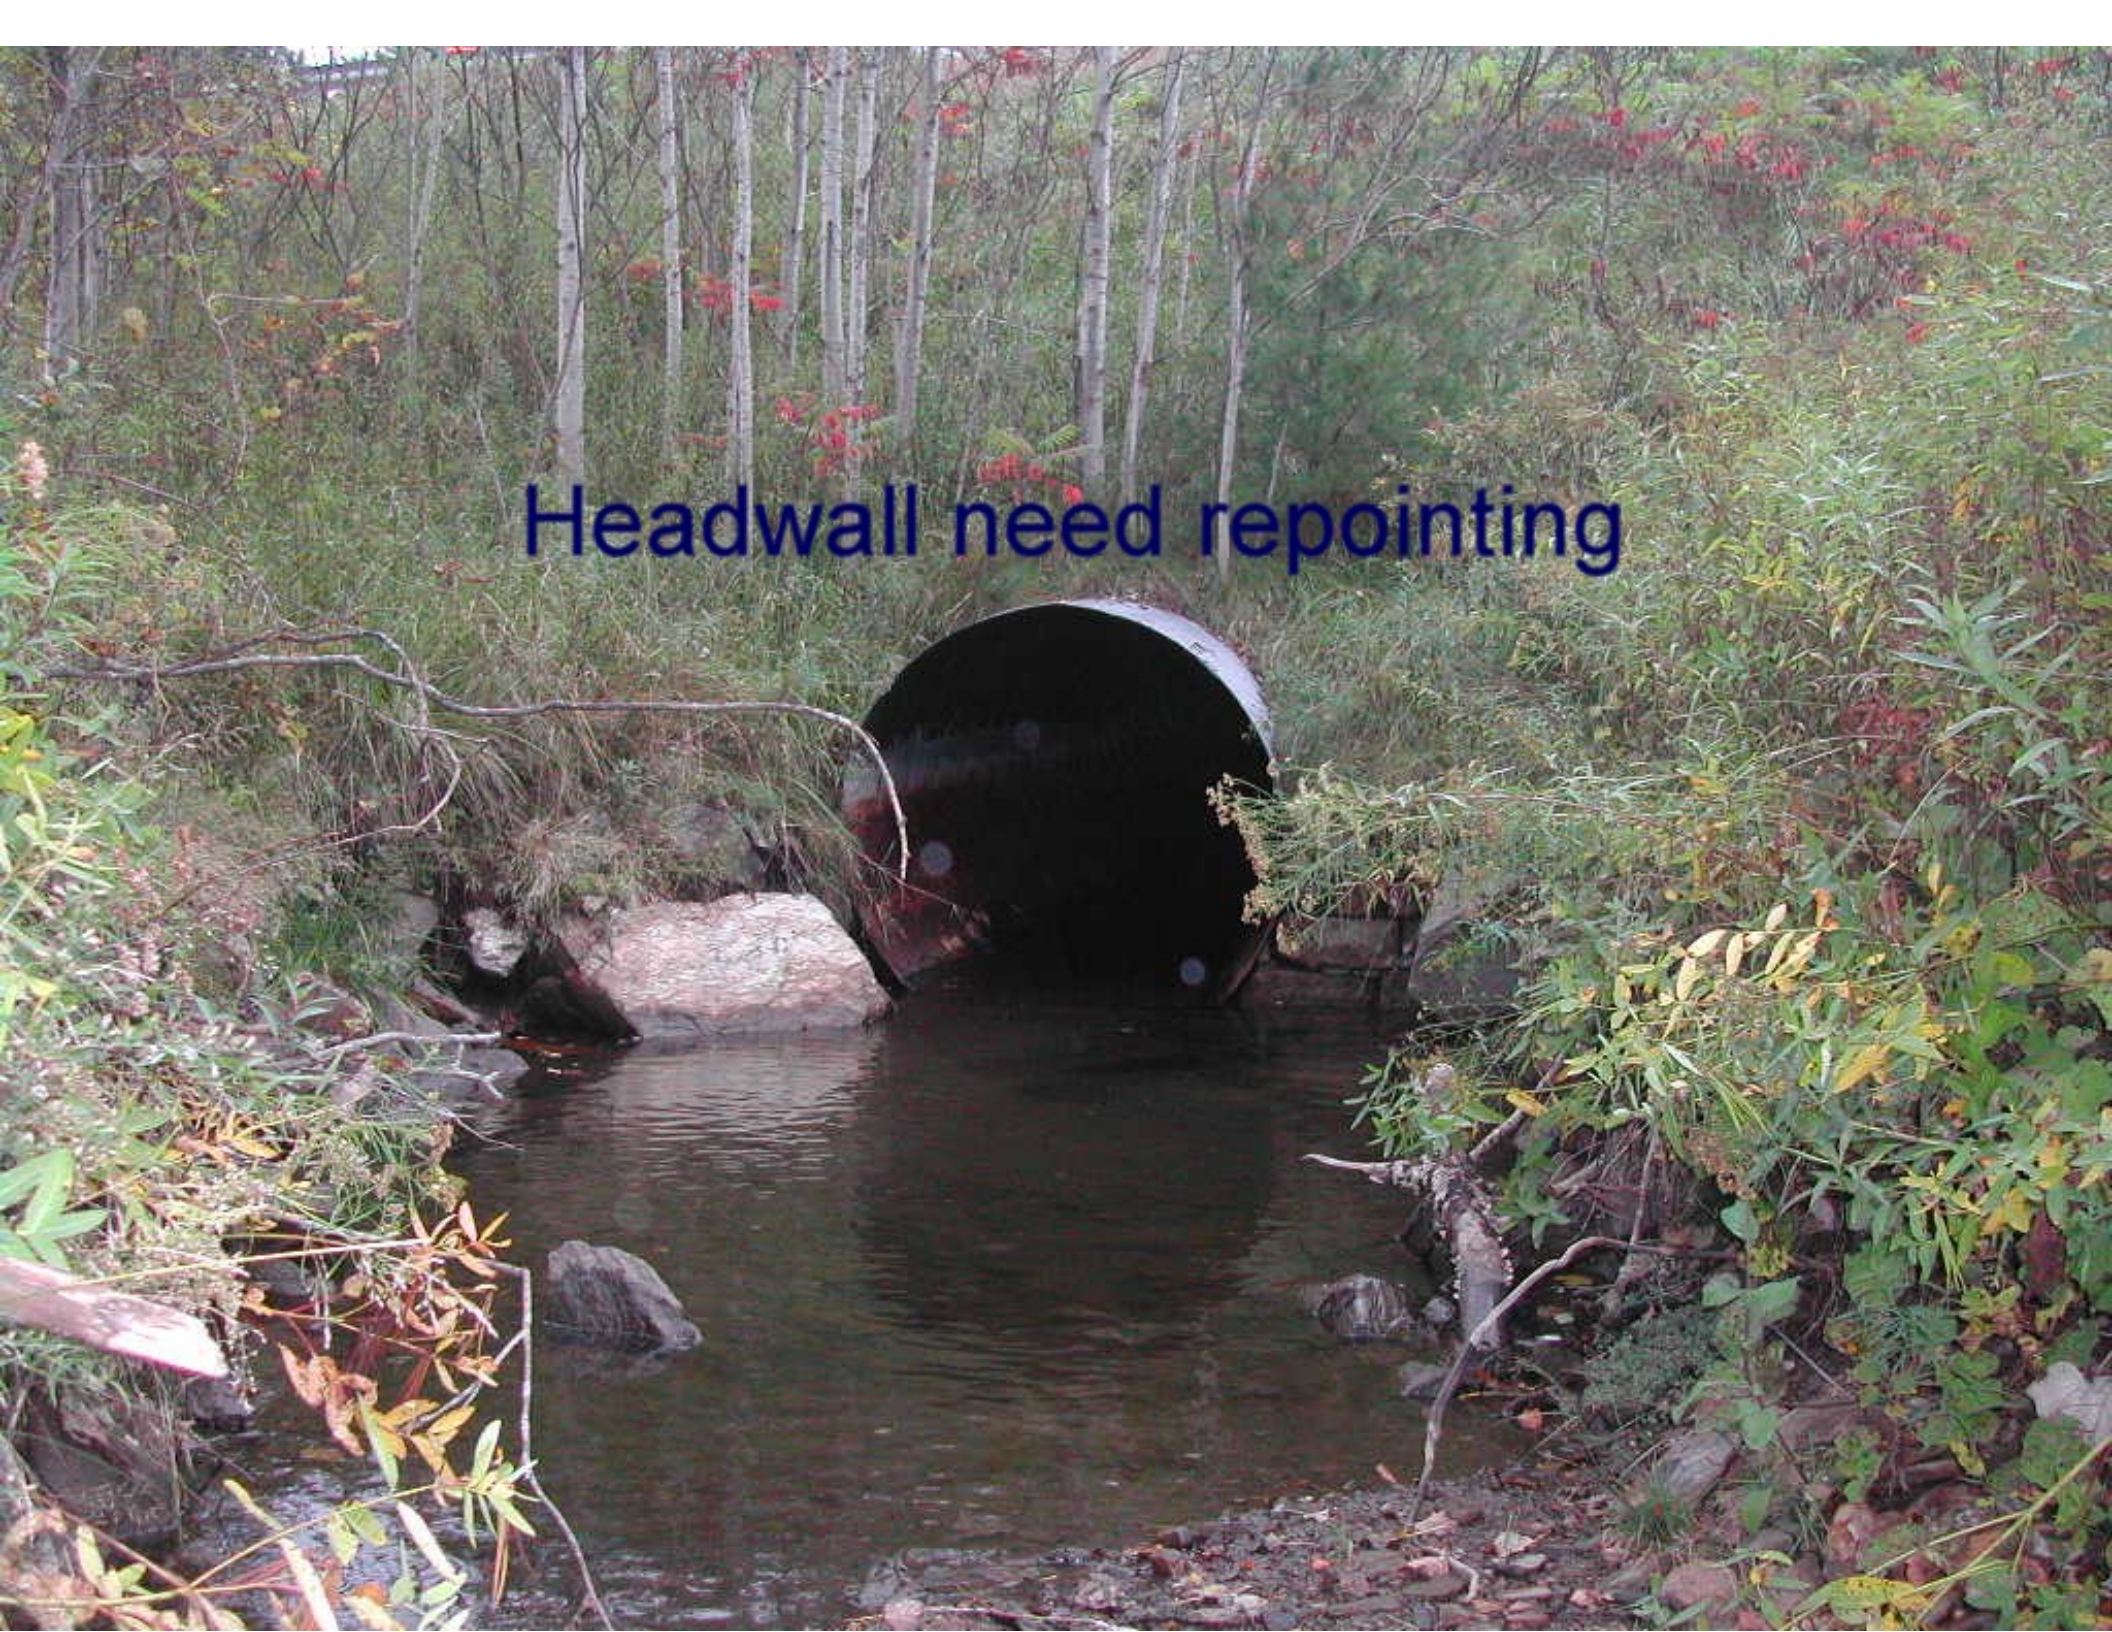
Needs bank protection at outlet
