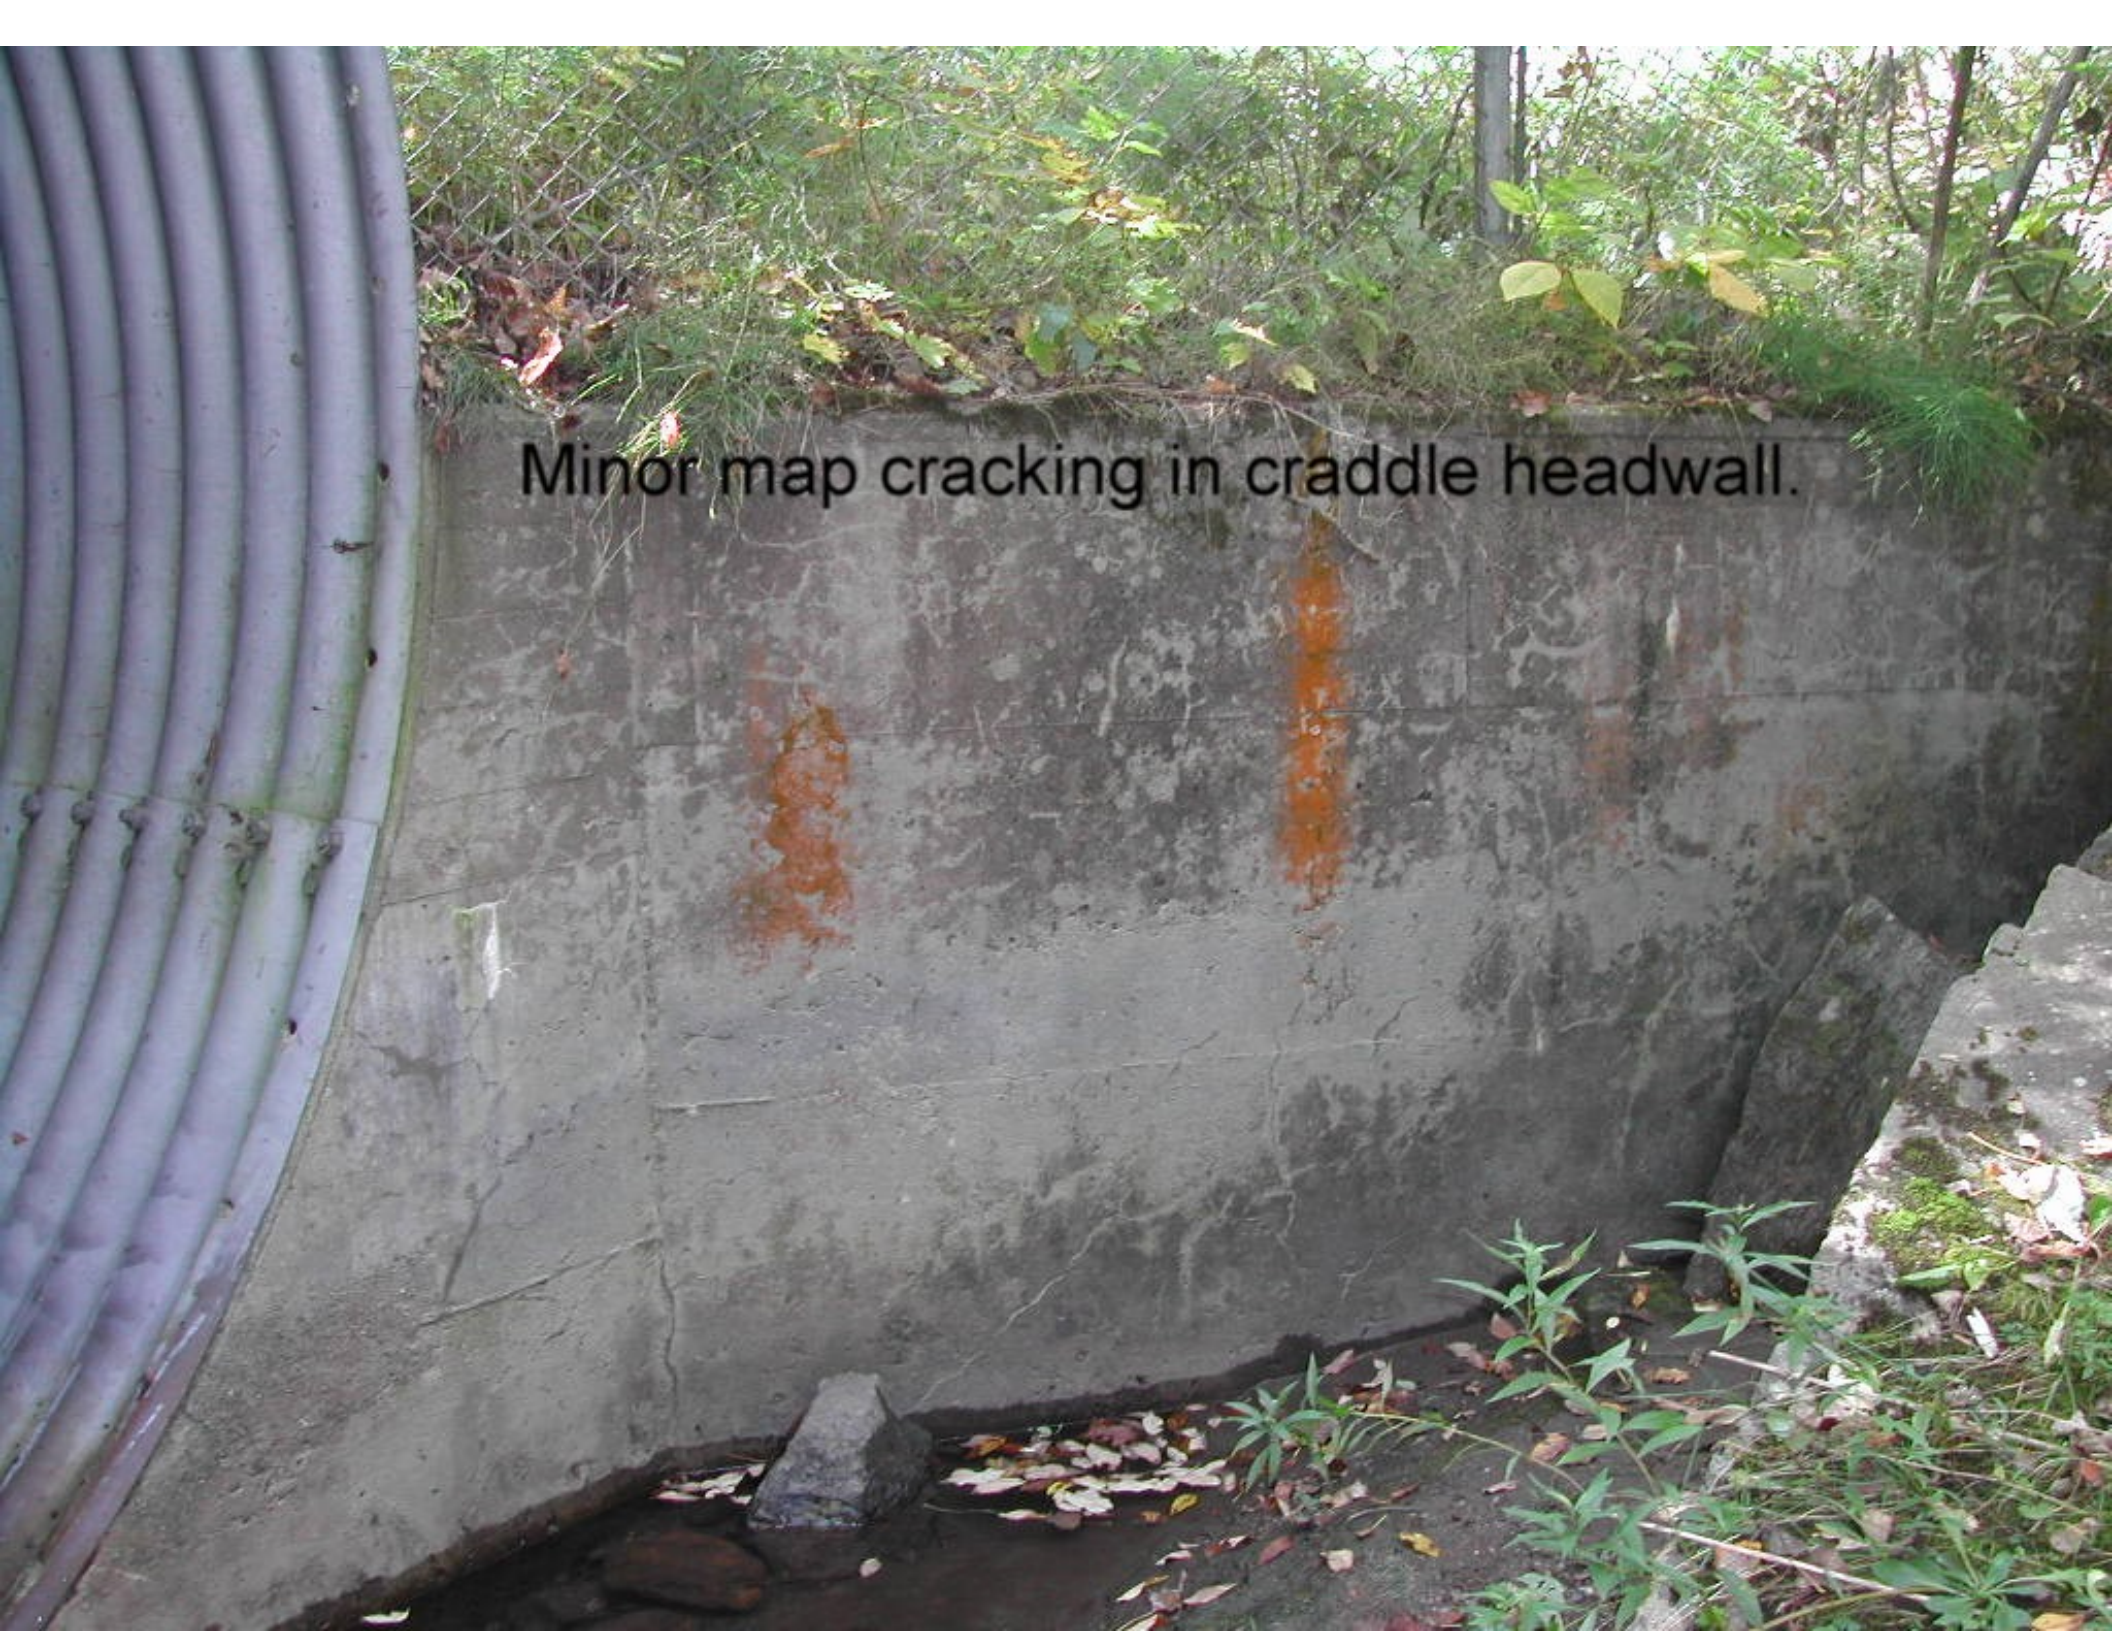
Minor map cracking in craddle headwall.
