**STATE OF VERMONT  
AGENCY OF TRANSPORTATION**

| Town Of | HARTLAND | Bridge No. | 38 |
| PIER NO. 4 | | | |
| REPAIR AREAS | | | |

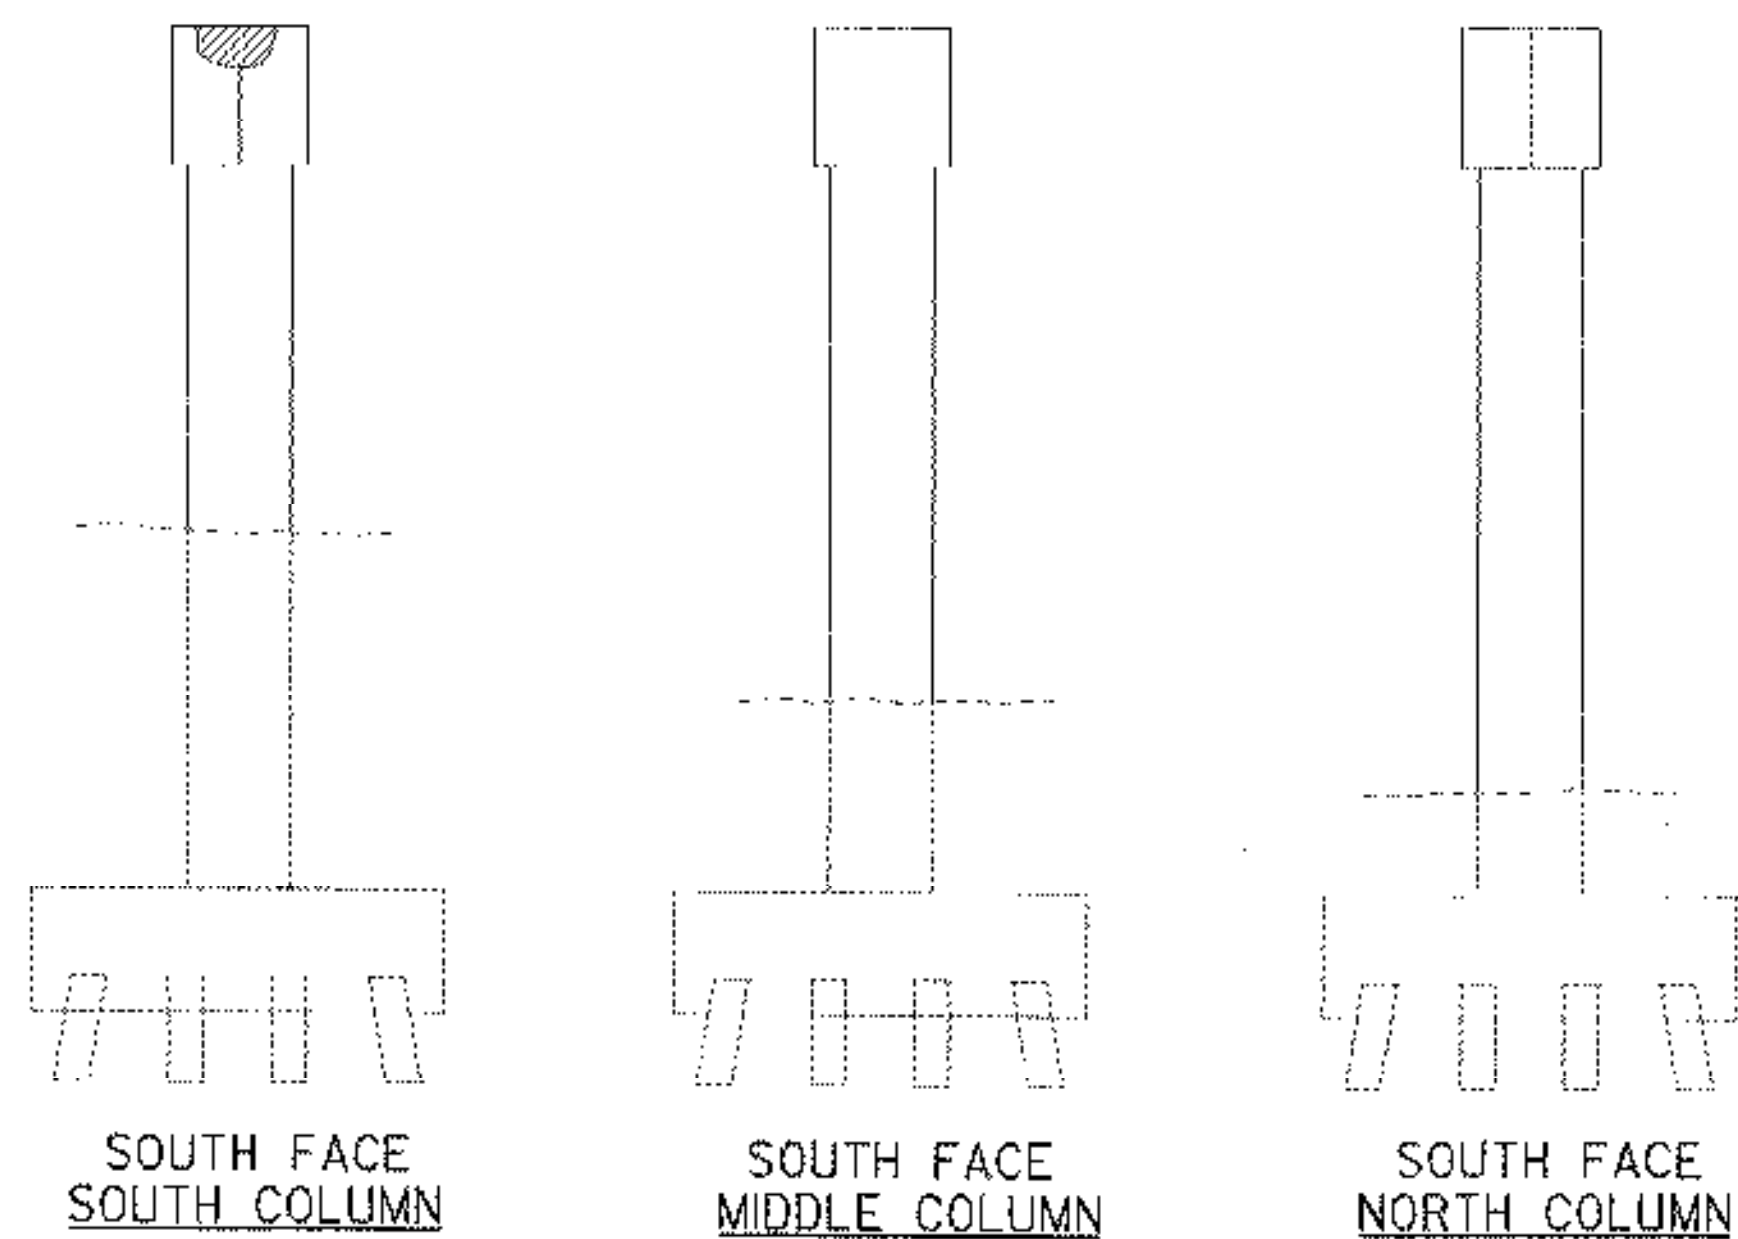
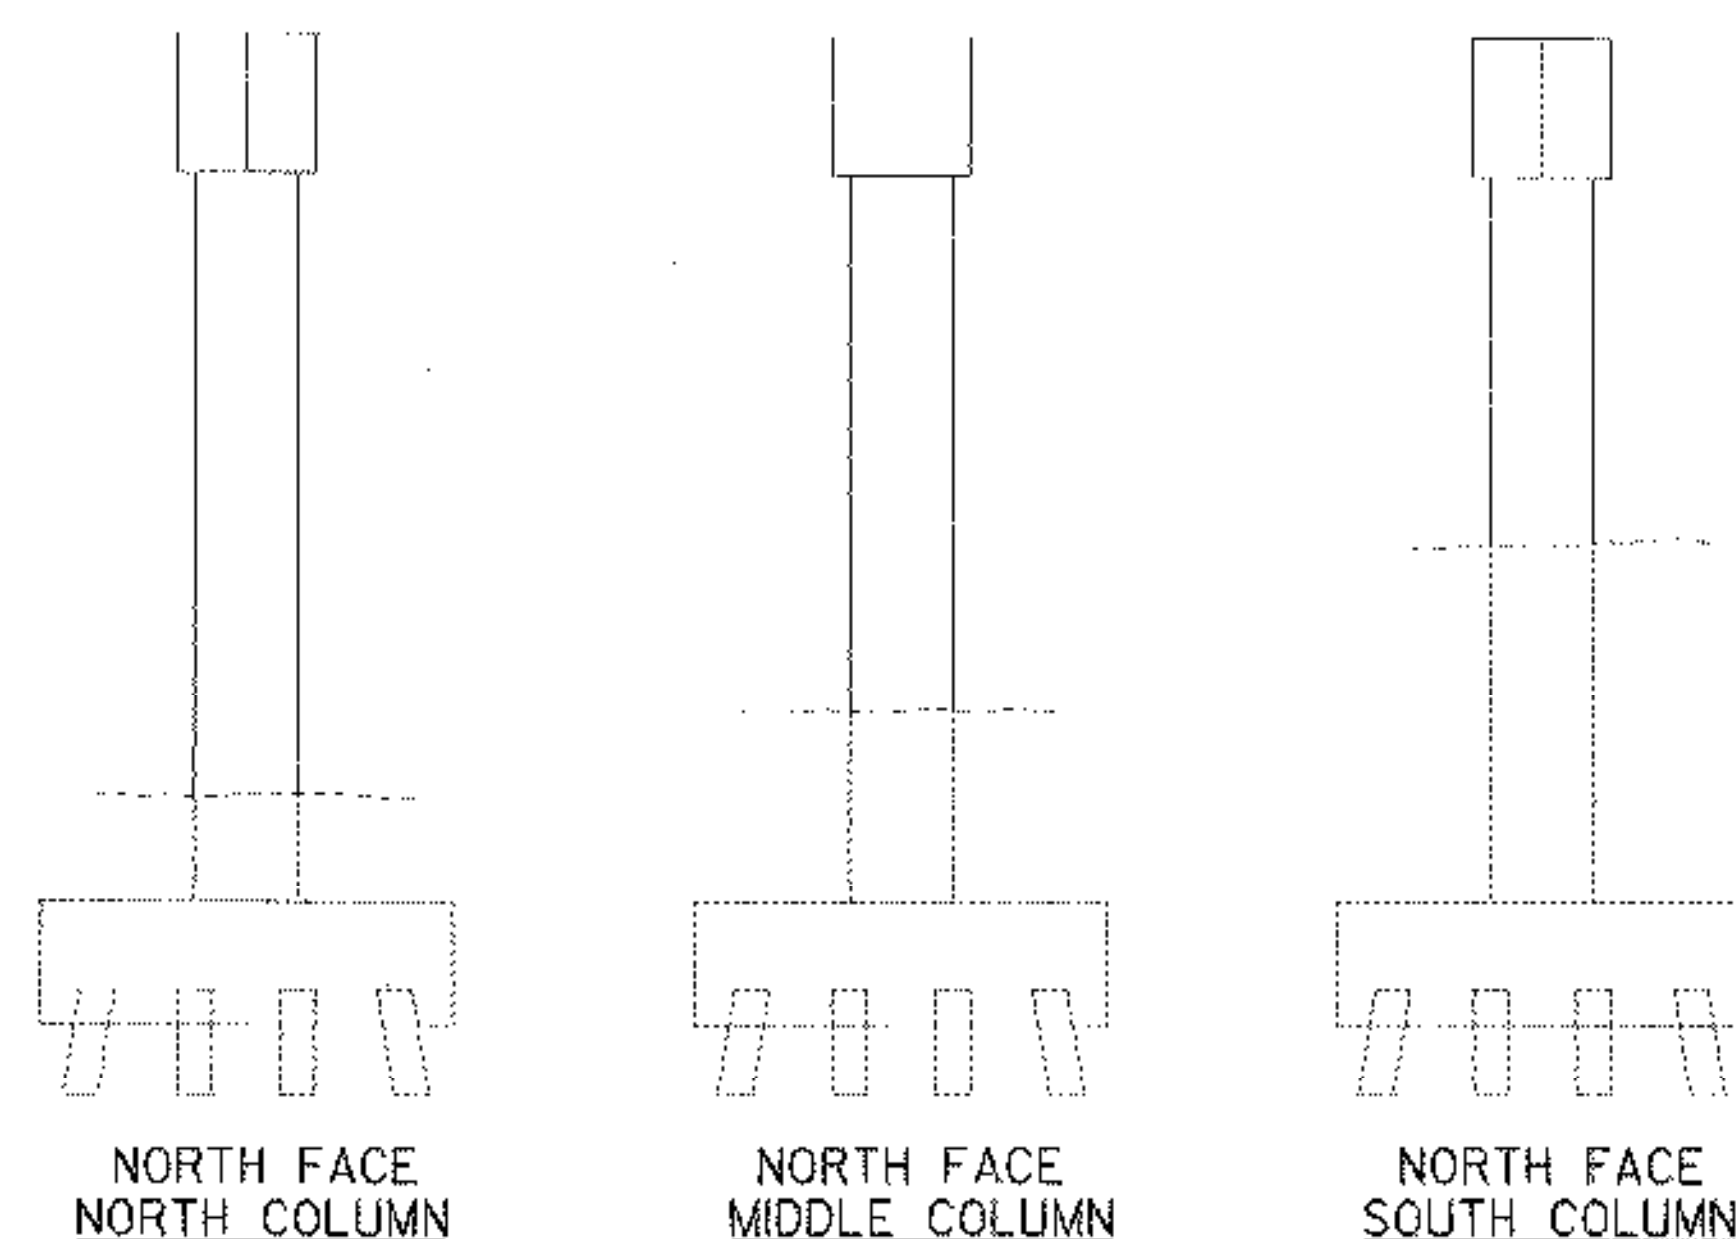
- SPALL
- DELAMINATION
- SURFACE CRACK

1. ELEVATIONS ARE REFERENCE ELEVATIONS BASED ON SURVEY DATA.
2. REMOVE AND REBUILD NOTED PEDESTALS PER DETAILS GIVEN ON SHEET 36.
3. REFER TO SHEET 36 FOR THE PIER BEAM SEAT ELEVATIONS.
4. PROVIDE A SHIM IN ACCORDANCE WITH THE DETAILS GIVEN ON SHEET 21 WHEN THE PIER BEAM SEAT ELEVATION IS HIGHER THAN THE EXISTING PIER BEAM SEAT ELEVATION AND THE PEDESTAL IS NOT BEING REBUILT PER NOTE 2.
