GUARDRAIL REPLACEMENT GUIDELINES

PROJECT NAME: ROXBURY-NORTHFIELD

PROJECT NUMBER: STP FPAV(6)

GUARDRAIL REPLACEMENT DETAIL SHEET 2

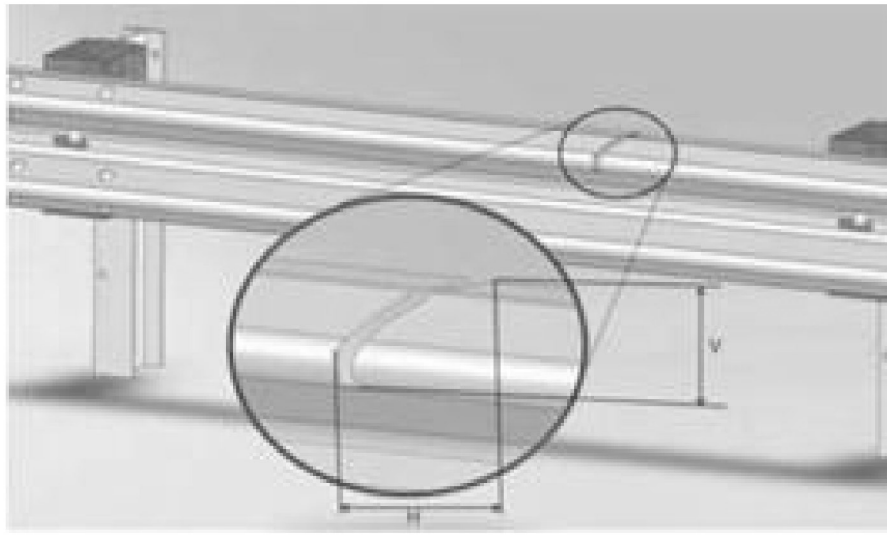
| DAMAGE TYPE | REPAIR THRESHOLD | RELATIVE PRIORITY | MEASUREMENT |
|---|---|---|---|
| VERTICAL TEAR | ANY LENGTH VERTICAL (TRANSVERSE) TEAR | HIGH | |

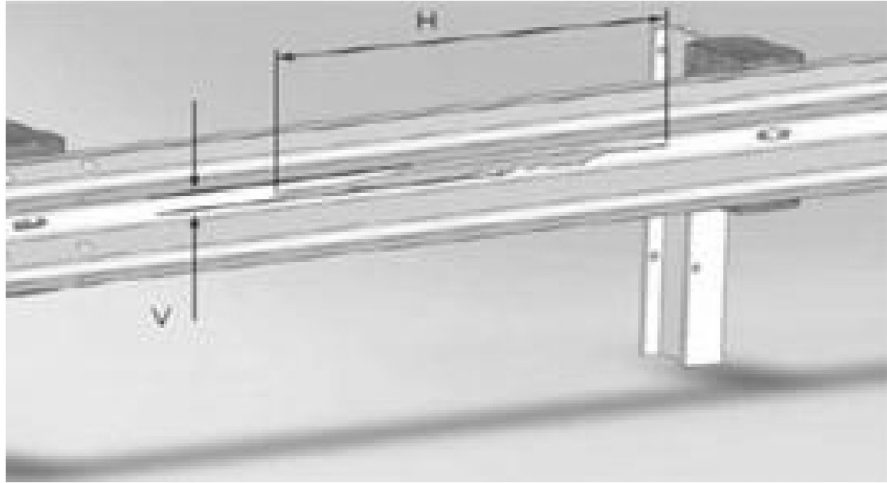
| DAMAGE TYPE | REPAIR THRESHOLD | RELATIVE PRIORITY | MEASUREMENT |
|---|---|---|---|
| HORIZONTAL TEAR | HORIZONTAL (LONGITUDINAL) GREATER THAN 12 IN. LONG AND GREATER THAN 0.5 IN. WIDE<br><br>NOTE: FOR HORIZONTAL TEARS LESS THAN 12 IN. IN LENGTH OR LESS THAN 0.5 IN. IN HEIGHT, USE THE NON-MANUFACTURED HOLES GUIDELINES | MEDIUM | |

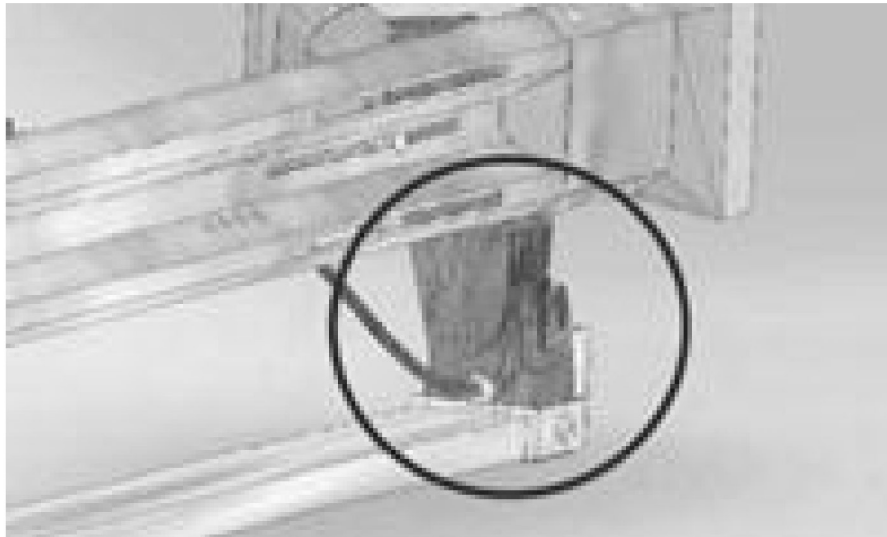
| DAMAGE | REPAIR THRESHOLD | RELATIVE PRIORITY | MEASUREMENT |
|---|---|---|---|
| DAMAGED END POST | NOT FUNCTIONAL (SHEARED, ROTTED CRACKED ACROSS THE GRAIN) | HIGH | |

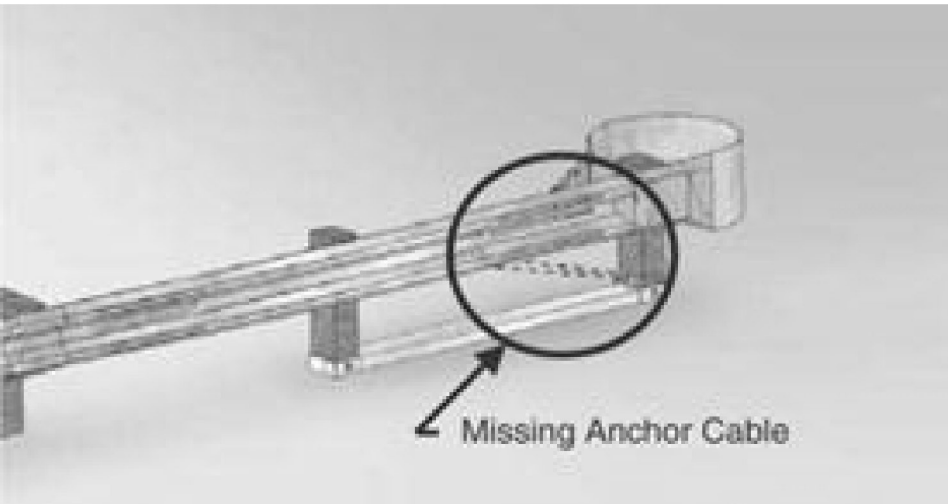
| DAMAGE | REPAIR THRESHOLD | RELATIVE PRIORITY | MEASUREMENT |
|---|---|---|---|
| ANCHOR CABLE | MISSING | HIGH | |

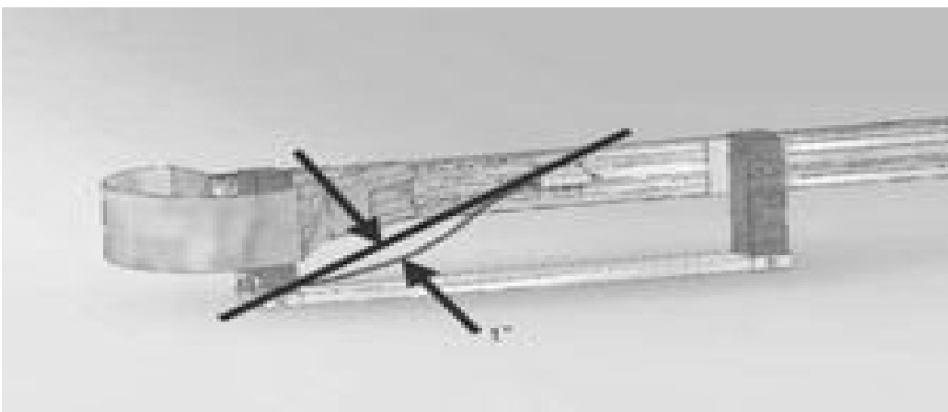
| DAMAGE | REPAIR THRESHOLD | RELATIVE PRIORITY | MEASUREMENT |
|---|---|---|---|
| ANCHOR CABLE | LOOSE - MORE THAN 1 IN. OF MOVEMENT WHEN PUSHED DOWN BY HAND | MEDIUM | |

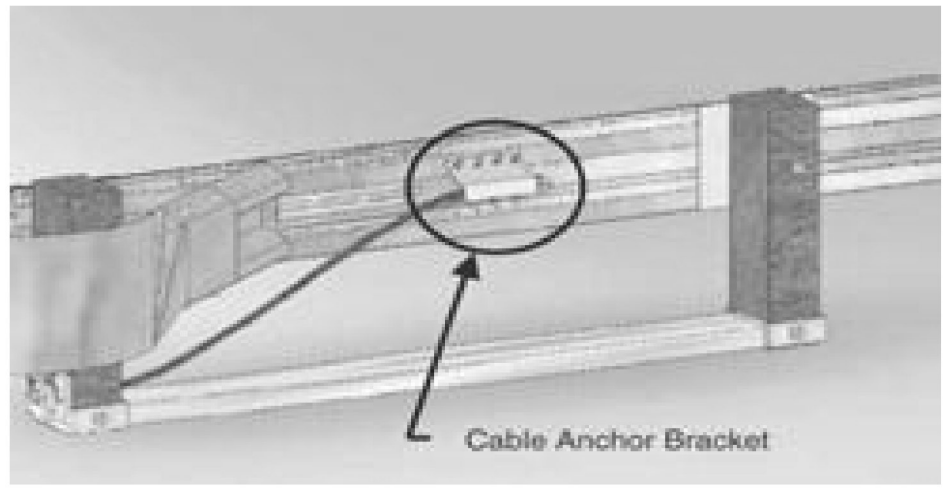
| DAMAGE | REPAIR THRESHOLD | RELATIVE PRIORITY | MEASUREMENT |
|---|---|---|---|
| CABLE ANCHOR BRACKET | LOOSE OR NOT FIRMLY SEATED IN RAIL | MEDIUM | |

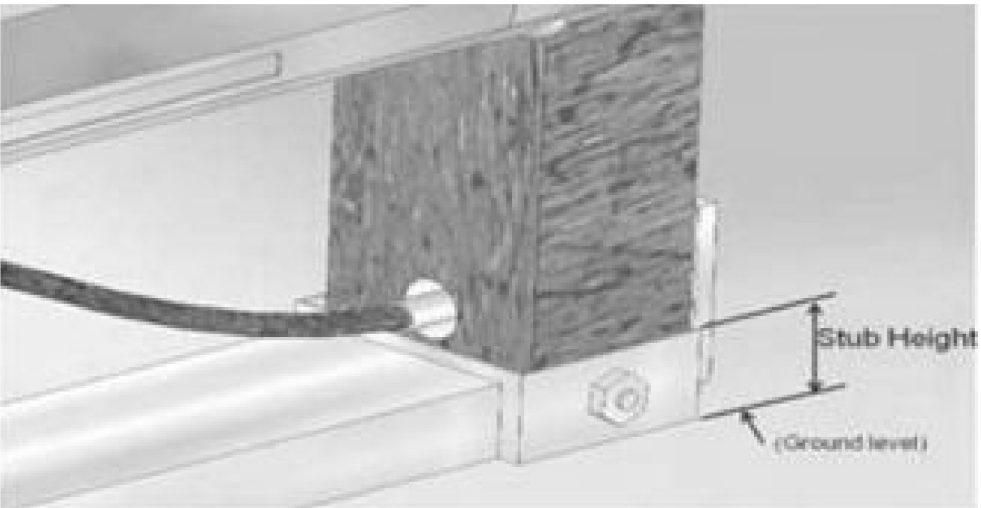
| DAMAGE | REPAIR THRESHOLD | RELATIVE PRIORITY | MEASUREMENT |
|---|---|---|---|
| STUB HEIGHT | HEIGHT WHICH EXCEEDS 4 IN. | MEDIUM | |

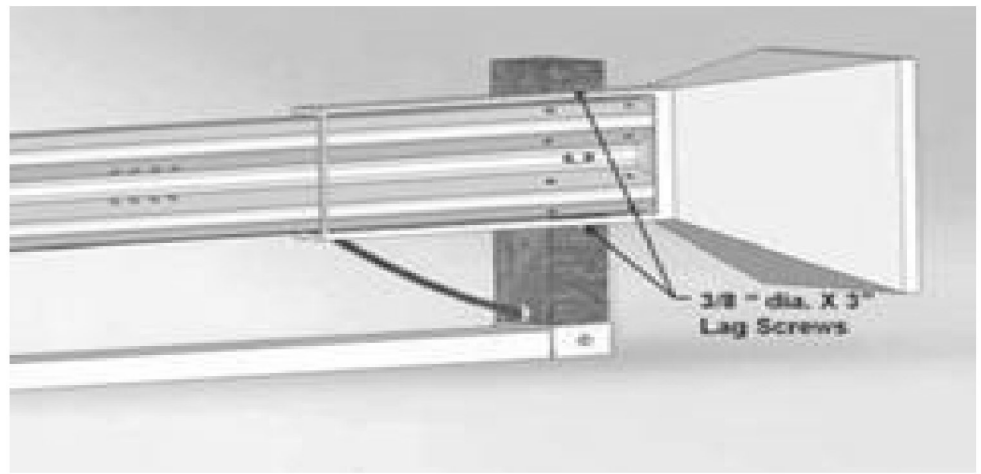
| DAMAGE | REPAIR THRESHOLD | RELATIVE PRIORITY | MEASUREMENT |
|---|---|---|---|
| LAG SCREWS (ENERGY ABSORBING TERMINALS ONLY) | MISSING OR FAILED LAG SCREWS | HIGH | |

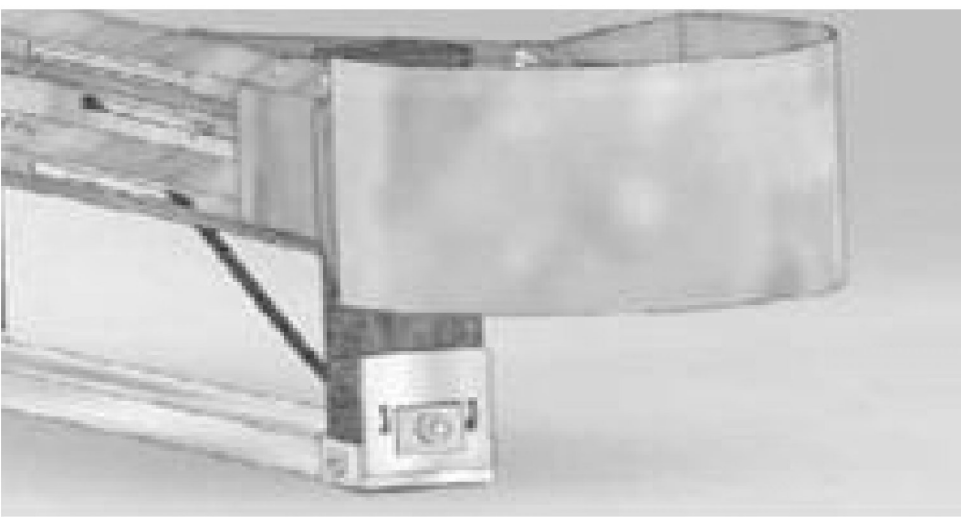
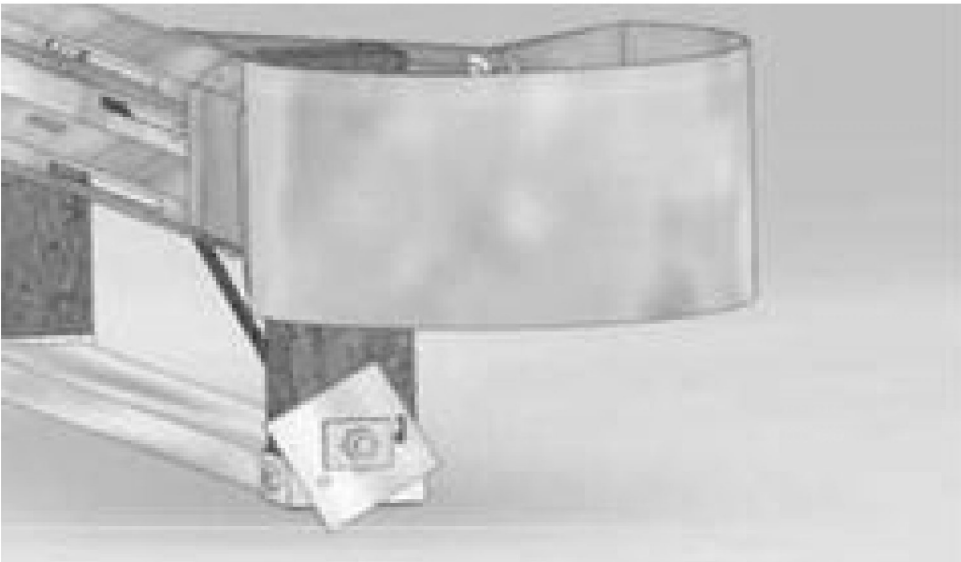
| DAMAGE | REPAIR THRESHOLD | RELATIVE PRIORITY | MEASUREMENT |
|---|---|---|---|
| BEARING PLATE | LOOSE OR MISALIGNED | MEDIUM | <br>(CORRECT BEARING PLATE)<br><br>(MISALIGNED BEARING PLATE) |

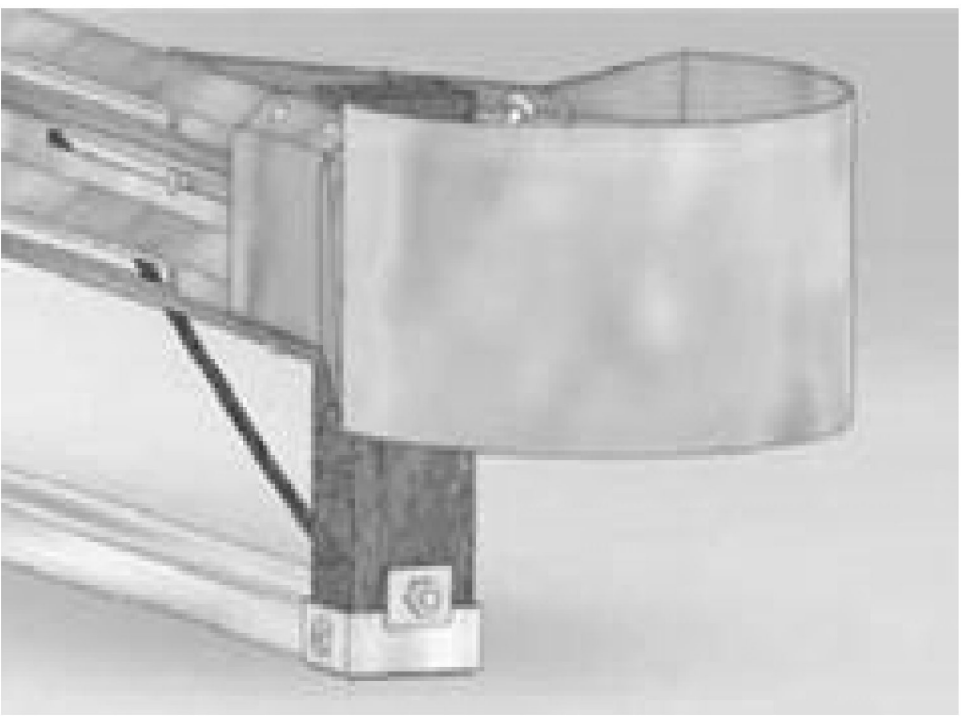
| DAMAGE | REPAIR THRESHOLD | RELATIVE PRIORITY | MEASUREMENT |
|---|---|---|---|
| | MISSING BEARING PLATE | HIGH | <br>(MISSING BEARING PLATE) |
