TOWN OF WARREN  
WARREN, VERMONT

BLUEBERRY LAKE DAM  
REHABILITATION PROJECT

SITE PLAN

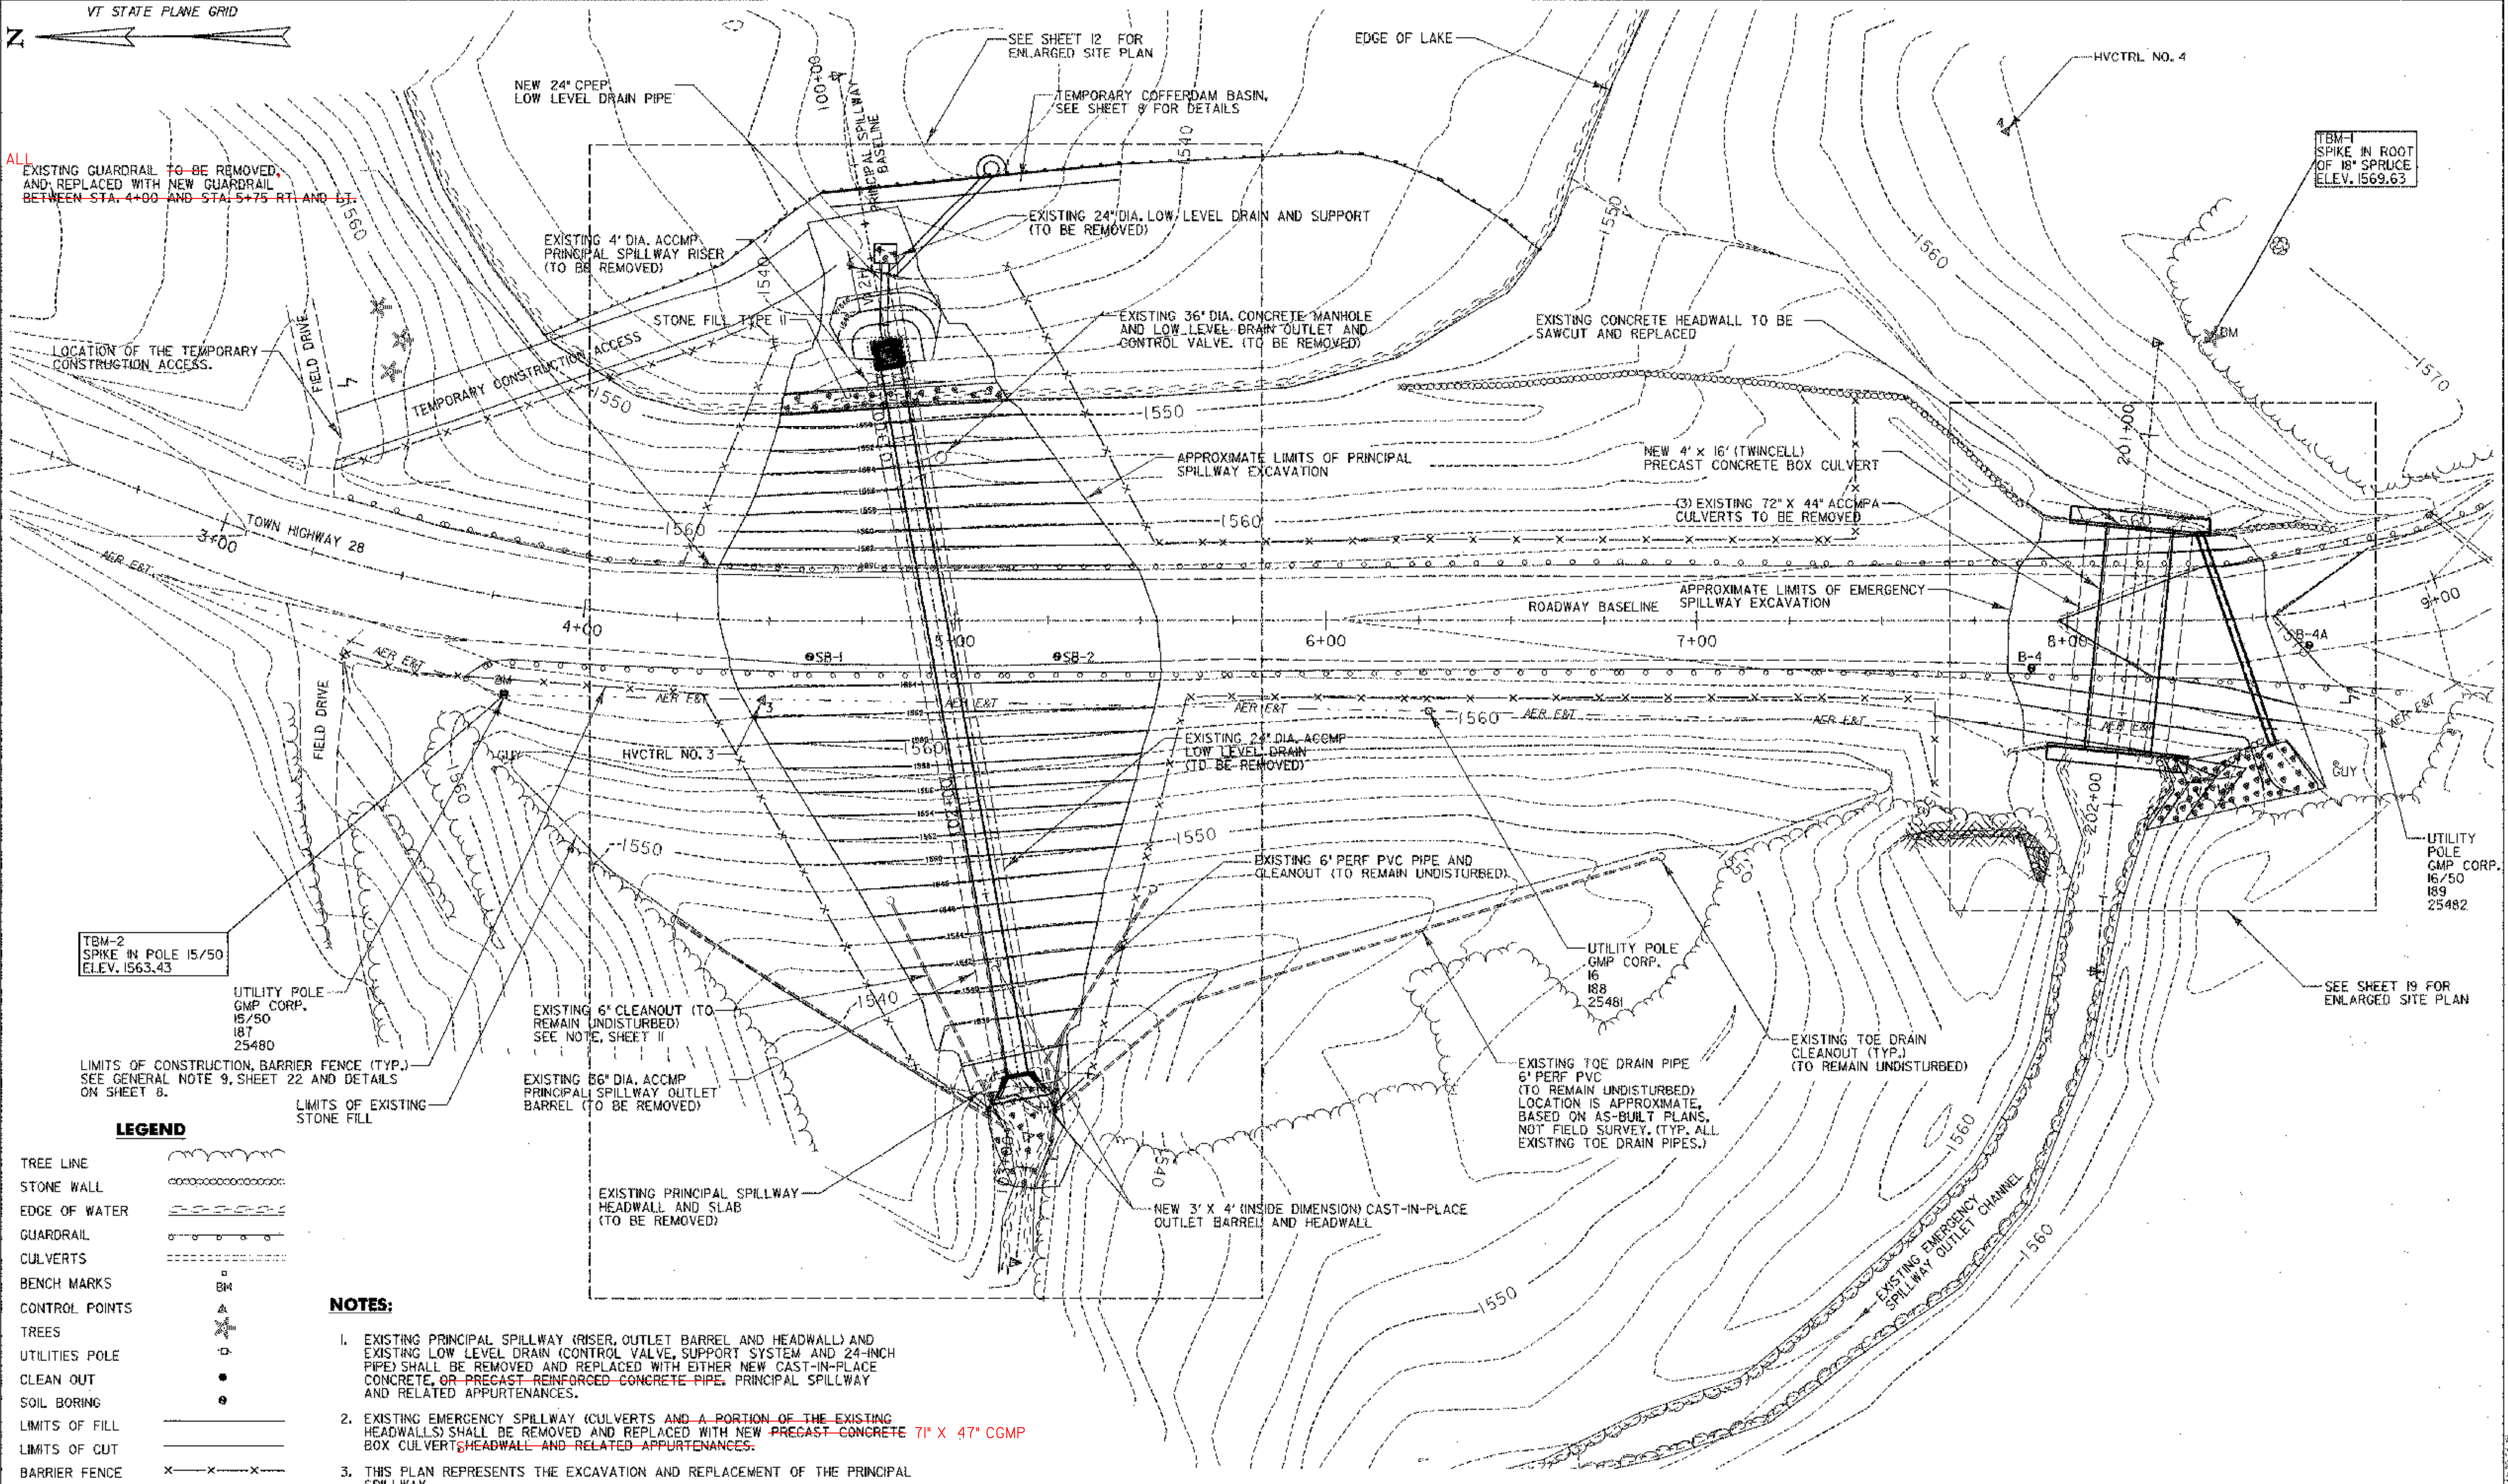
ALL EXISTING GUARDRAIL TO BE REMOVED, AND REPLACED WITH NEW GUARDRAIL BETWEEN STA. 4+00 AND STA. 5+75 RT. AND LT.

- NOTES:**
- EXISTING PRINCIPAL SPILLWAY (RISER, OUTLET BARREL AND HEADWALL) AND EXISTING LOW LEVEL DRAIN (CONTROL VALVE, SUPPORT SYSTEM AND 24-INCH PIPE) SHALL BE REMOVED AND REPLACED WITH EITHER NEW CAST-IN-PLACE CONCRETE, OR PRECAST REINFORCED CONCRETE PIPE, PRINCIPAL SPILLWAY AND RELATED APPURTENANCES.
  - EXISTING EMERGENCY SPILLWAY (CULVERTS AND A PORTION OF THE EXISTING HEADWALLS) SHALL BE REMOVED AND REPLACED WITH NEW PRECAST CONCRETE 71" X 47" CGMP BOX CULVERTS, HEADWALL AND RELATED APPURTENANCES.
  - THIS PLAN REPRESENTS THE EXCAVATION AND REPLACEMENT OF THE PRINCIPAL SPILLWAY.
